LIMITED OCCURRENCE INVESTIGATION REPORT – FINAL

Reference Number	CA18/2/3/10270					
Classification	Accident	Date	18 February 2023	Time	0755Z	
Type of Operation	Private (Part 141)					
Location						
Place of Departure	New Tempe Aerodrome (FATP), Free State Province		Place of Intended Landing	New Tempe Aerodrome (FATP), Free State Province		
Place of Occurrence	On Runway 10 at New Tempe Aerodrome (FATP), Free State Province					
GPS Co-ordinates	Latitude	29° 01'50.69"S	Longitude	026° 09'36.87"E	Elevation	5 432 ft
Aircraft Information						
Registration	ZS-EMH					
Make; Model; S/N	Mooney M-20F (Serial Number: 670077)					
Damage to Aircraft	Substantial		Total Aircraft Hours	4364.9		
Pilot-in-command						
Licence Type	Commercial Pilot Licence (CPL)		Gender	Male	Age	31
Licence Valid	Yes	Total Hours	1143.8	Total Hours on Type	4.6	
Total Hours 30 Days	3.6		Total Flying on Type Past 90 Days	3.6		
People On-board	2+0	Injuries	0	Fatalities	0	Other (on ground) 0

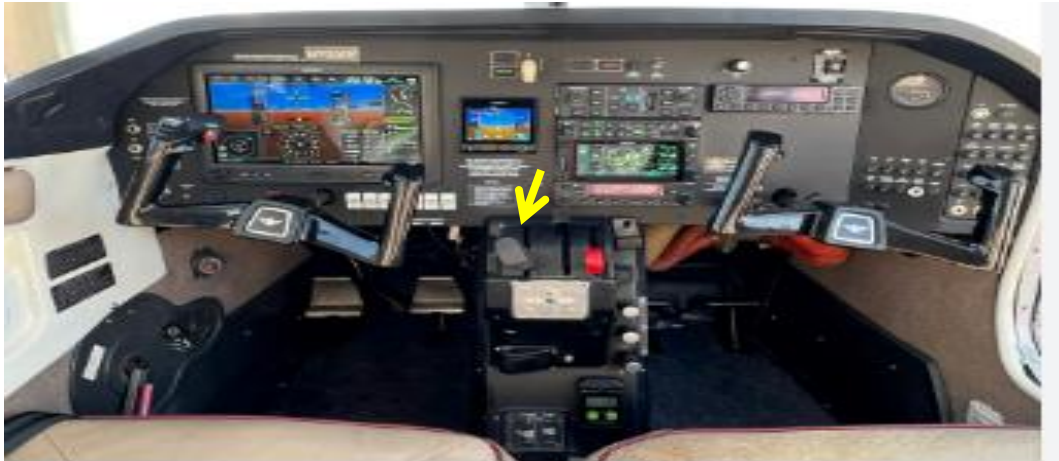
Figure 1: The instrument panel showing the landing gear control lever in the UP position.
(Source: Operator)

(vi) The landing gear selector lever was found in the 'up' position (retracted position) post-accident.

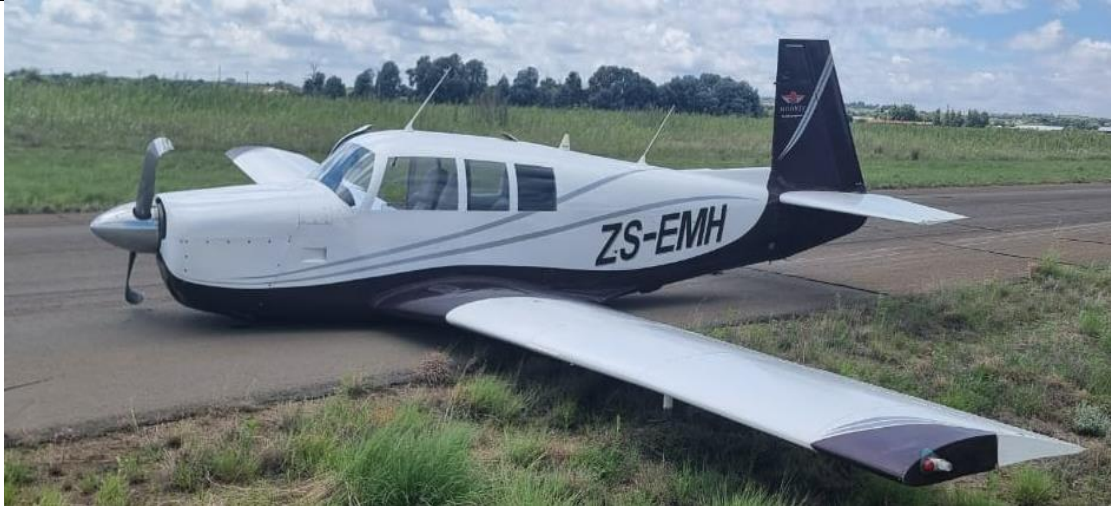
The aircraft sustained substantial damage to the underbelly skin and the landing gear doors, as well as the propeller blade tips. The occupants were not injured during the accident sequence.

Figure 2: The aircraft at the accident site. (Source: Operator)
