**AIRCRAFT ACCIDENT REPORT AND EXECUTIVE SUMMARY**

<b>Reference:</b>	<b>CA18/2/3/10271</b>			
<b>Aircraft Registration</b>	<b>ZS-NSY</b>	<b>Date of Accident</b>	21 February 2023		<b>Time of Accident</b>	0615Z		
<b>Type of Aircraft</b>	Beechcraft BE-76 Duchess			<b>Type of Operation</b>	Training (Part 141)			
<b>Pilot-in-command Licence Type</b>		Commercial Pilot Licence (CPL) Aeroplane	<b>Age</b>	61	<b>Licence Valid</b>	Yes		
<b>Pilot-in-command Flying Experience</b>		<b>Total Flying Hours</b>		2 451.7	<b>Hours on Type</b>	55		
<b>Last Point of Departure</b>		Wonderboom Airport (FAWB), Gauteng Province						
<b>Next Point of Intended Landing</b>		Grand Central Airport (FAGC), Gauteng Province						
<b>Damage to Aircraft</b>		Substantial						
<b>Location of the accident site with reference to easily defined geographical points (GPS readings if possible)</b>								
On Runway 17 at FAGC at Global Positioning System co-ordinates determined to be 25°59'08.06" South 028°08'24.55" East, at an elevation of 5 259 feet

The left-side main landing gear A-frame failed during the landing roll due to a fatigue fracture which initiated from the weld metal bead and progressed to the down-lock m

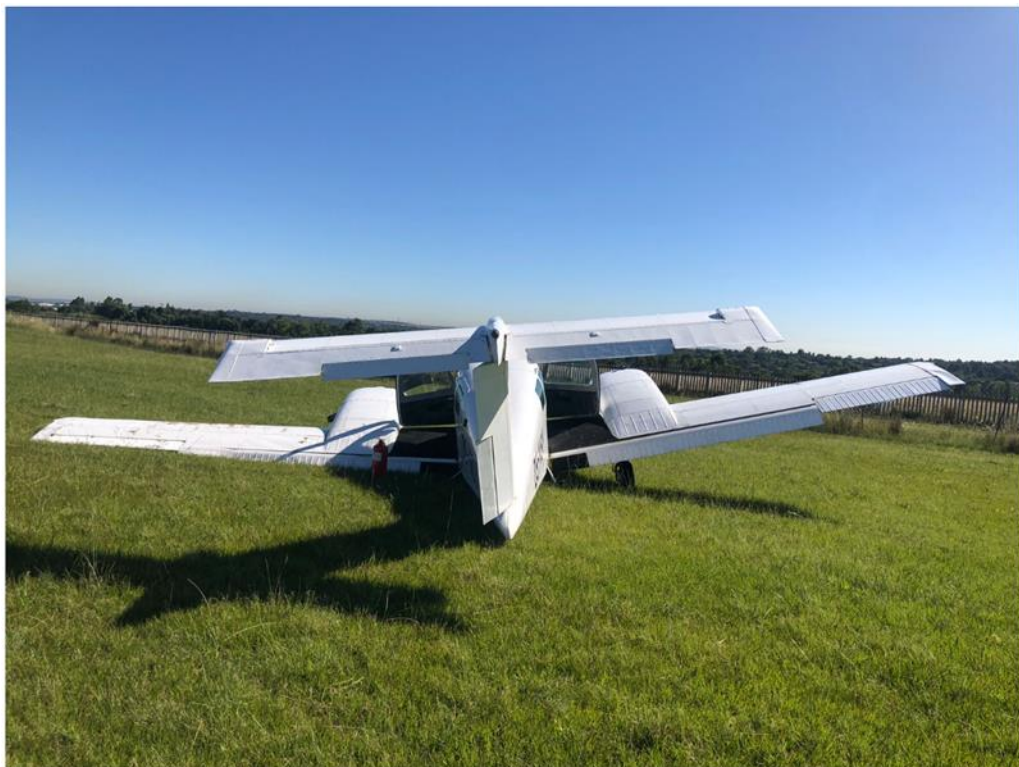
1.3.1. The aircraft was substantially damaged during the accident sequence.

**Figure 2:** The aircraft resting on the left-wing. (Source: FAGC Fire Department)

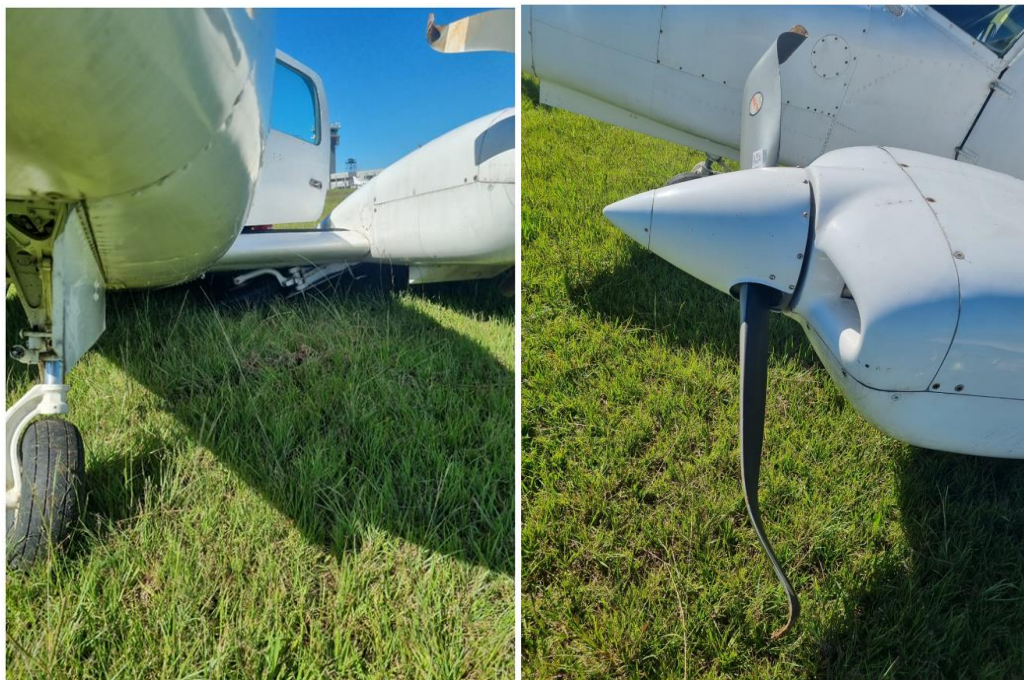
1.12.1 The aircraft landed safely at FAGC, however, during the landing roll the left-side main gear collapsed, and the left-side propeller impacted the ground, causing damage to the blade tips. During the accident sequence, the rotating left-side propeller contacted the runway surface, which resulted in damage to both propeller blades.

**Figures 3 and 4:** The collapsed landing gear (left) and the damaged propeller blades (right).  
(Source: FAGC Fire Department)

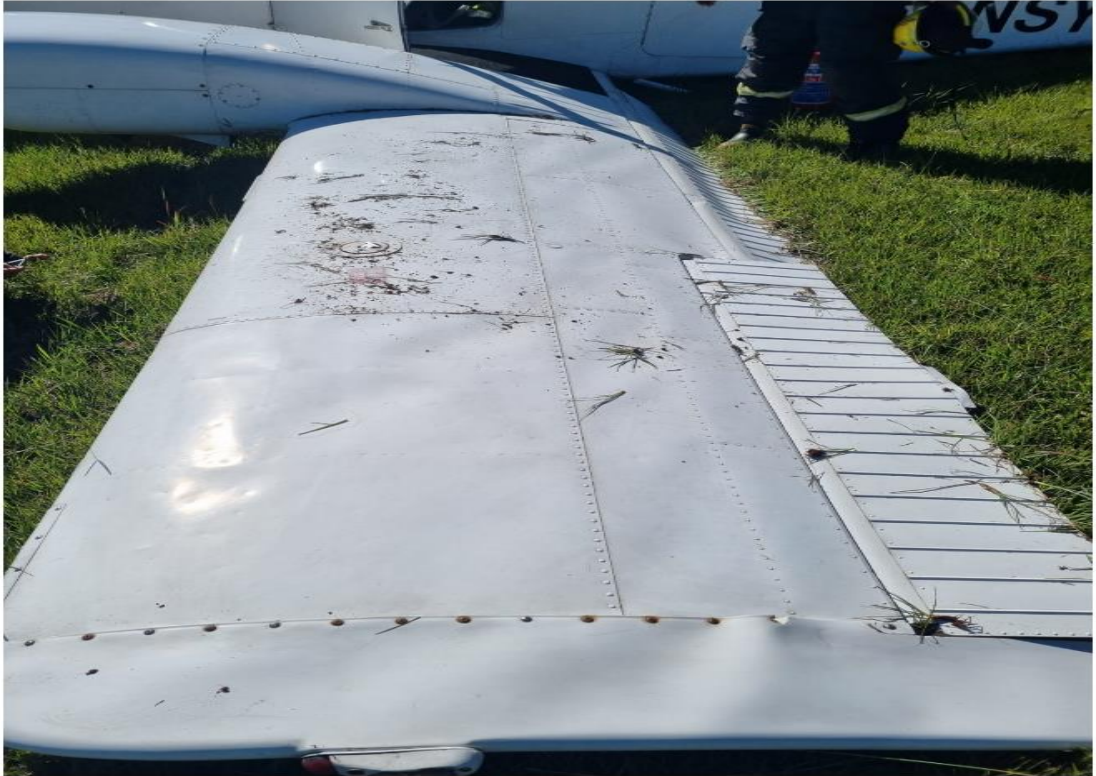
1.12.2 Damage was also caused to the left-side flap, left-side aileron and the under-surface of the rear part of the aircraft fuselage. The left-side wing contacted the ground during the accident sequence, which caused damage to the skin, aileron and flaps. The left wing upper surface skin exhibited buckling and compression loads caused by impact.

**Figure 5:** The damaged wing skin and the flight control surface. (Source: FAGC Fire Department)

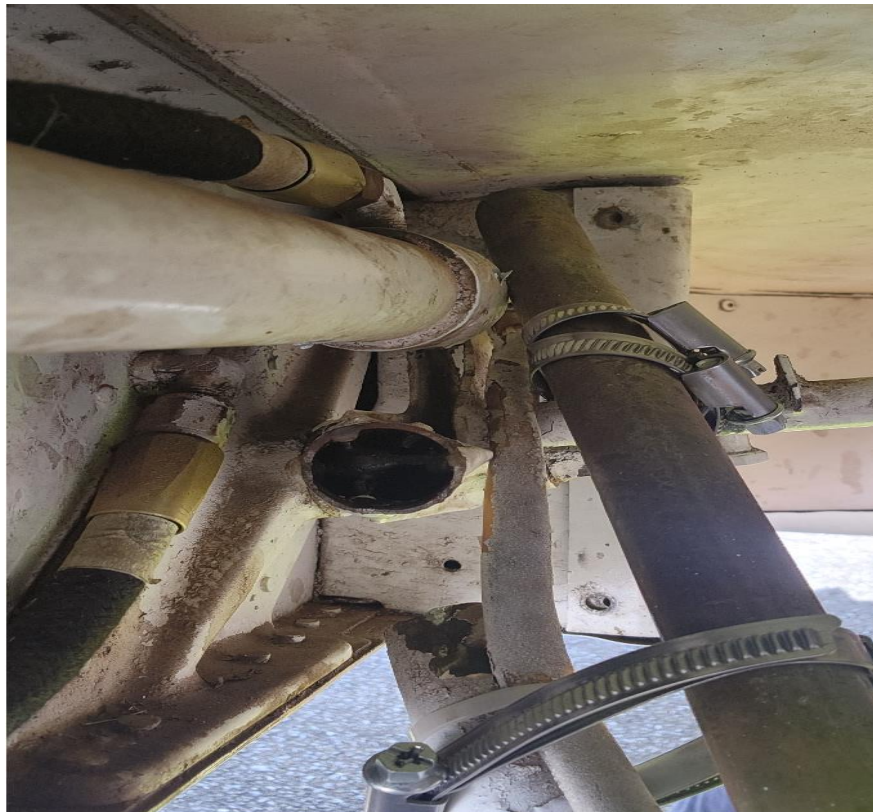
1.12.3 During recovery of the aircraft, it became evident that the left-side main landing gear (MLG) side brace, referred to as the A-frame assembly, failed. The down tube and the diagonal tube of the A-frame were both found with fractures (see Figures 6 and 7).

**Figure 6:** The top part of the drag brace.

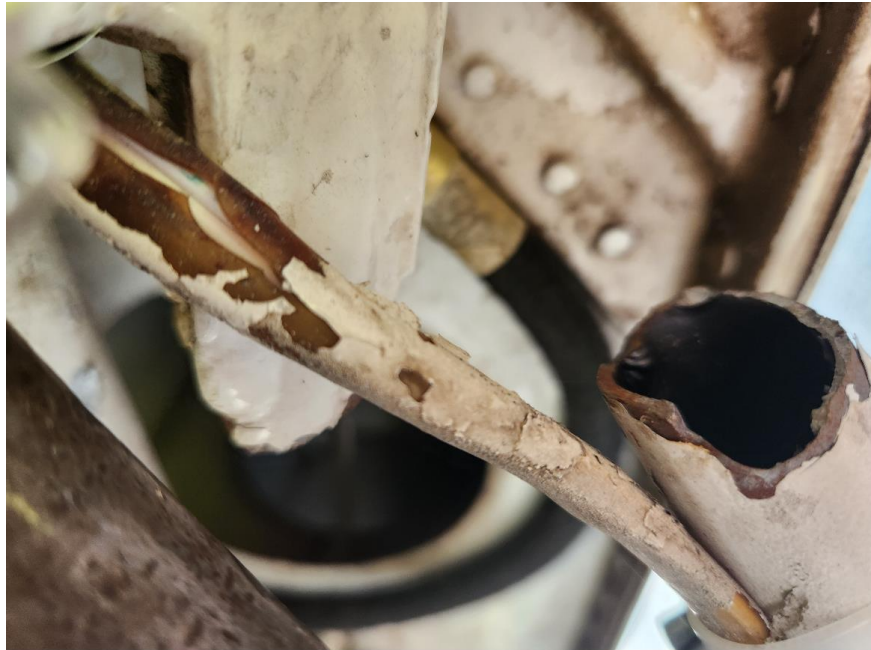
**Figure 7:** The failed bottom part of the drag brace.

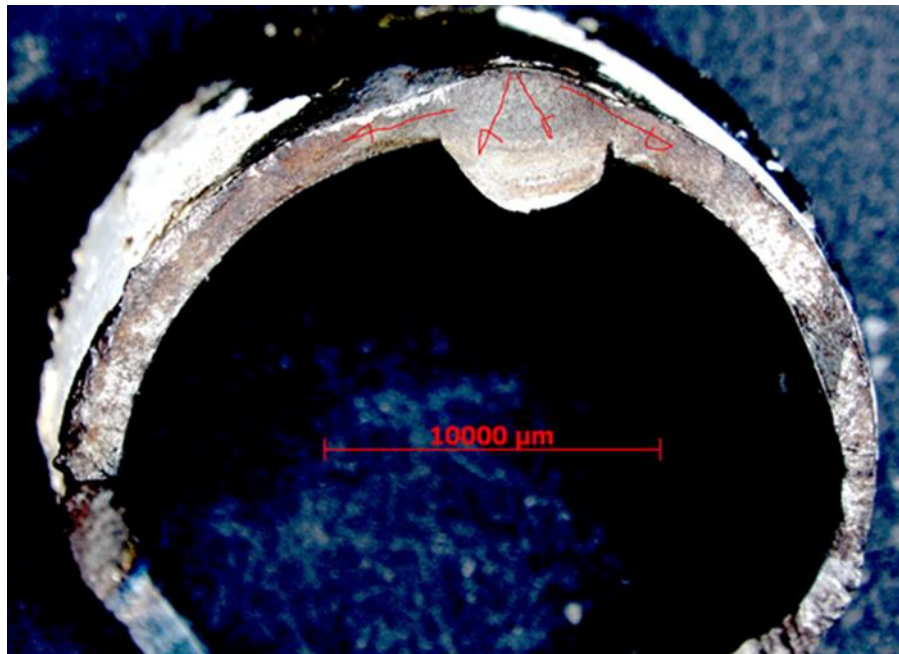
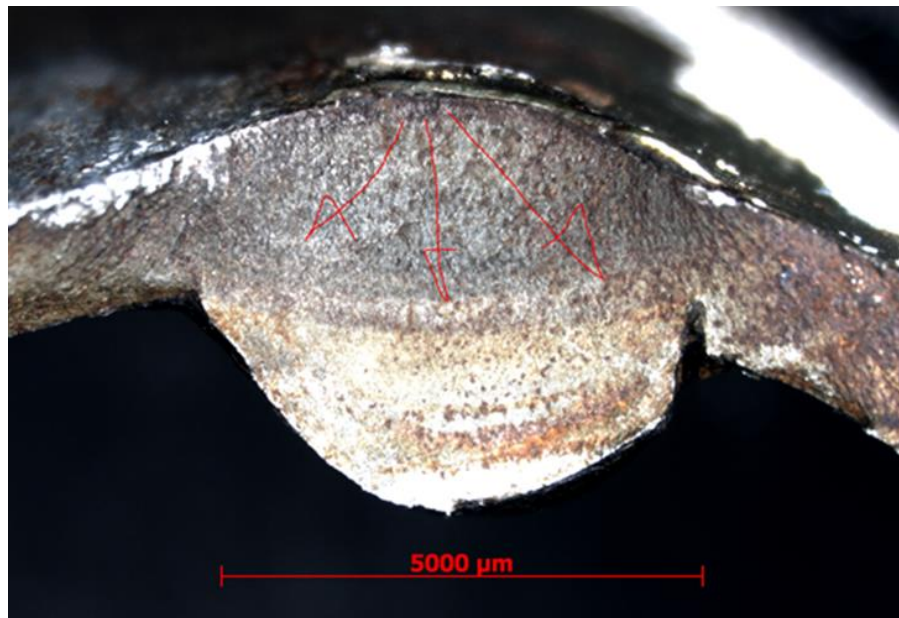
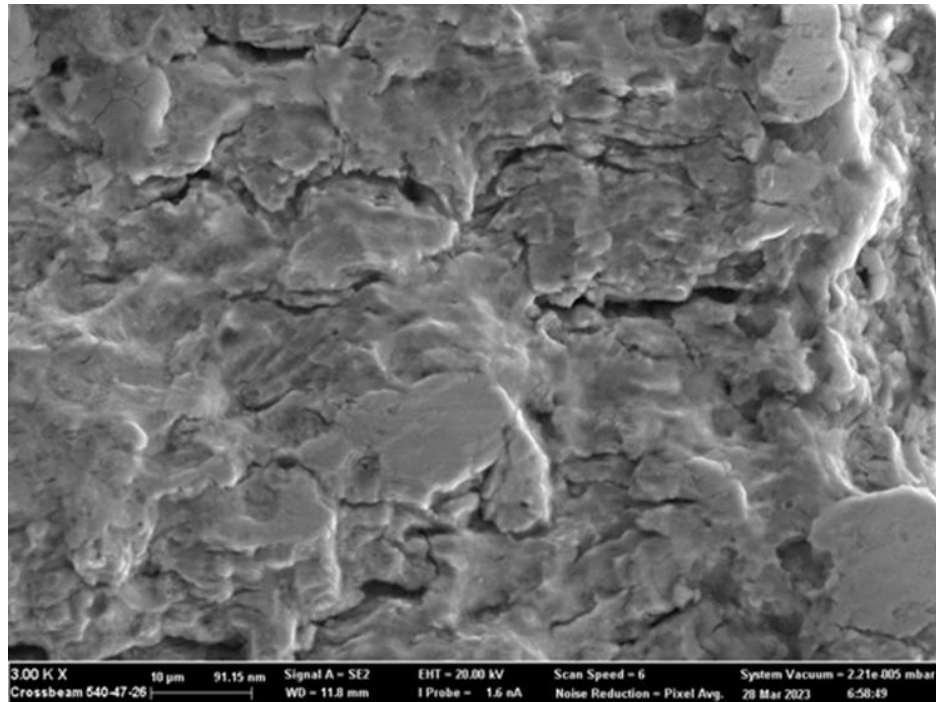
1. A fatigue mode fracture (Photo 3) initiated within the weld metal bead and progressed as indicated (Photos 1 and 2, red arrows).

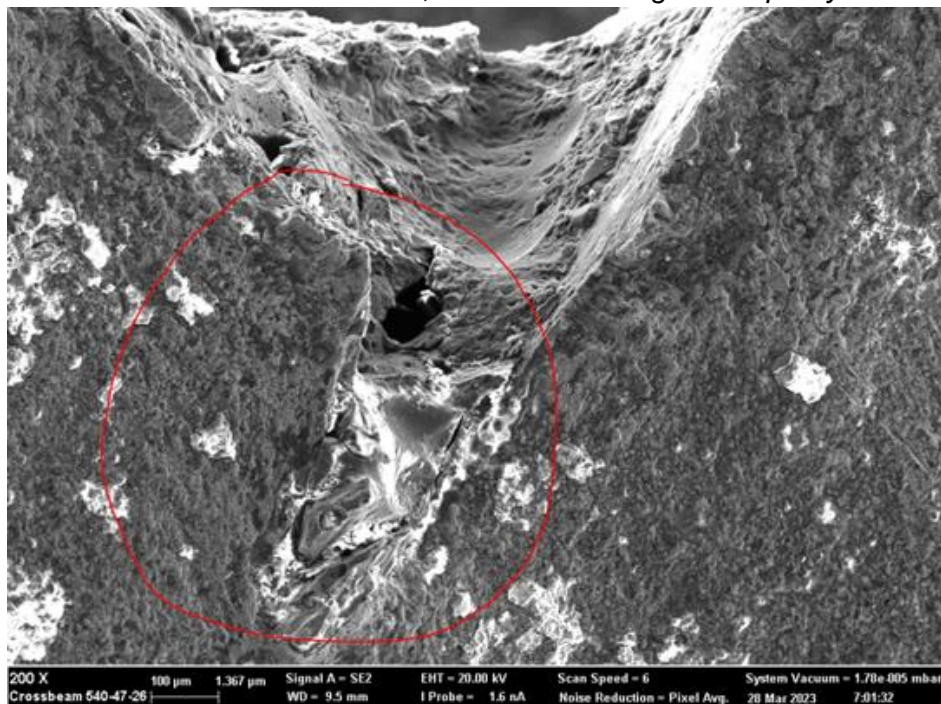
**Photo 4**

2. The weld itself revealed some defects i.e., under-cut relating to the quality thereof (Photo 4).

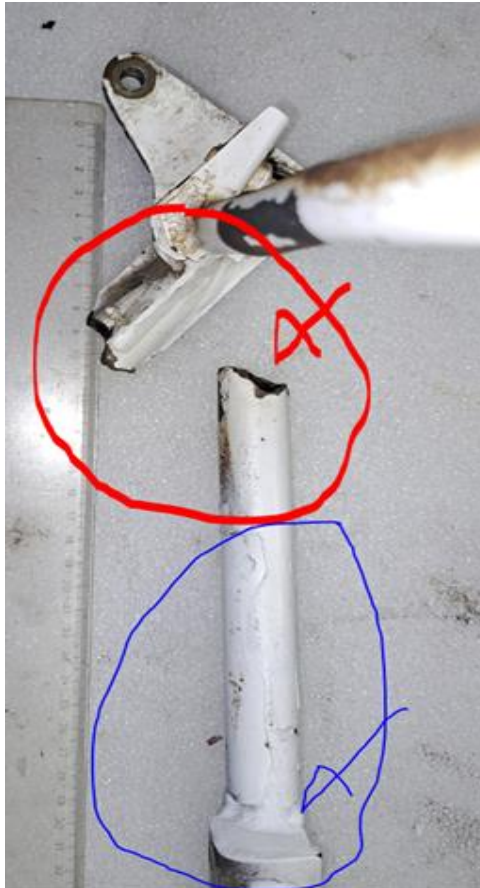
**Photo 5**

3. The Maintenance Manual/AD prescribes the removal of the painted layers prior to the NDT inspections - with repainting required afterwards. The paint surrounding the fracture (Photo 5, red arrow, and circle) suggest that it has been exposed for an extended time to the environment (old) while the paint layer surrounding another weldment in close proximity reveals a much newer layer (Photo 5, blue arrow, and circle). It may be an indication that an inspection was performed but possibly at the wrong location/weldment.

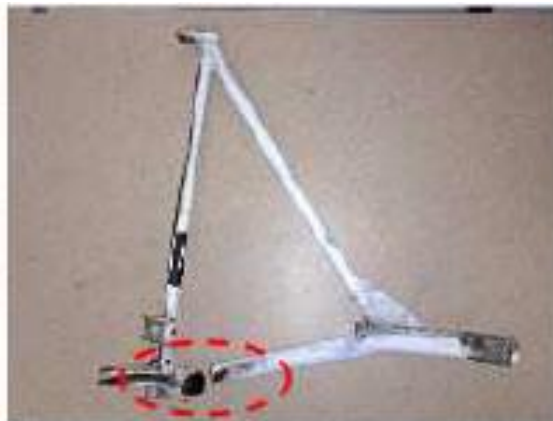
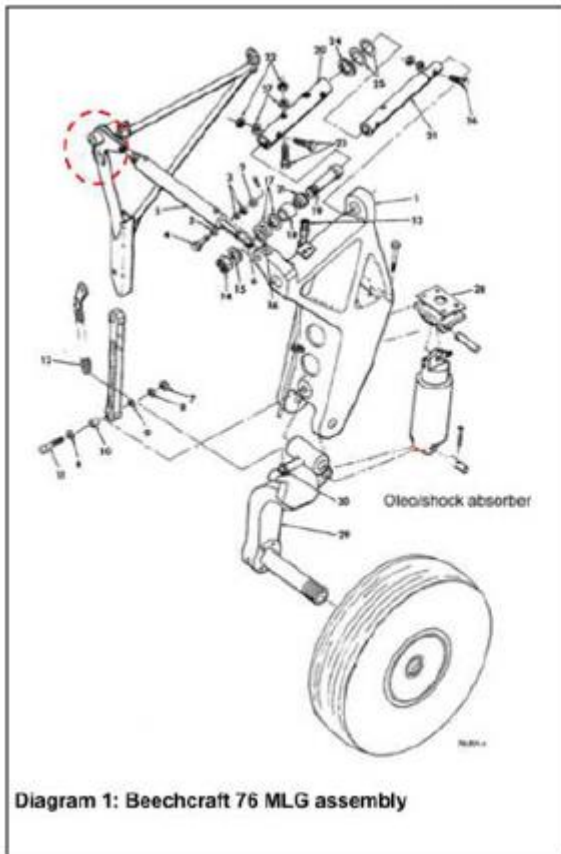
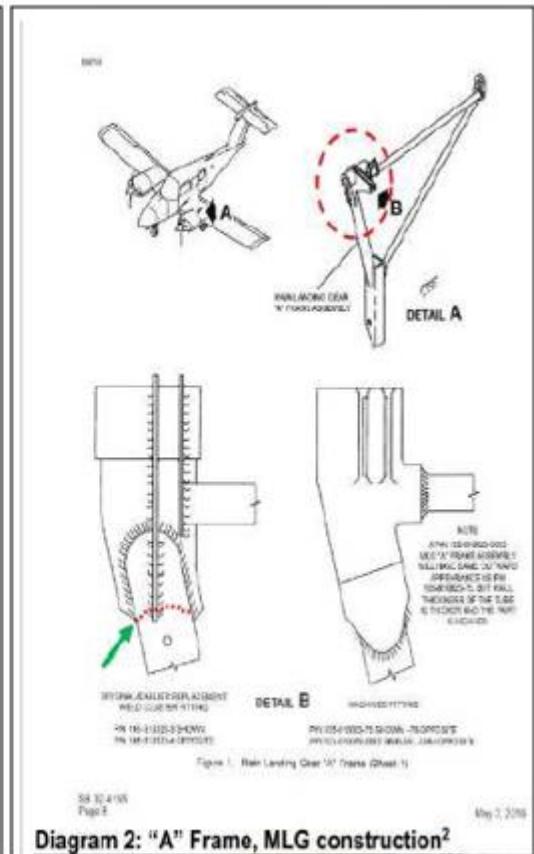
- *The visual inspection revealed a fracture within the tubular section of the MLG “A” frame (Photo 2, Diagram 2 1 and 2, red dashed circles) The fracture initiated within the weld metal area (Diagram 2, green arrow; Photos 3 and 4, red arrows).*

**Photo 2: Main Landing Gear Leg, as supplied (digital)**

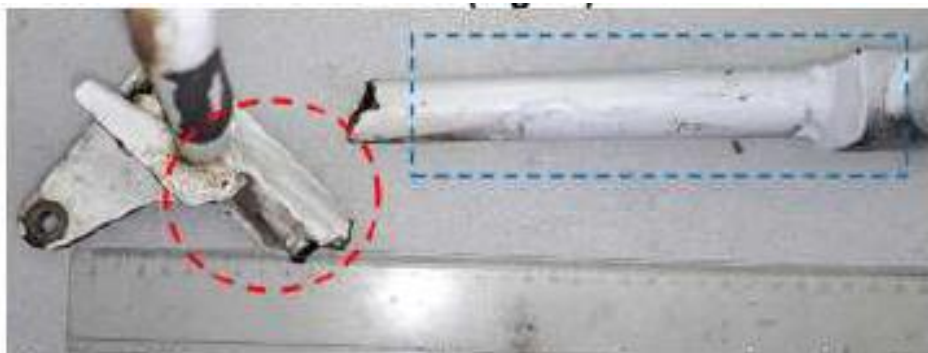
- The outer surface inspection revealed a relatively new painted layer (Photo 5, blue dashed square) surrounding another welded section while the paint layer surrounding the fracture initiation location revealed indications of extended environment time exposure (Photo 5, red dashed circle).

**Photo 5: Component surface showing repainted regions (stereo)**

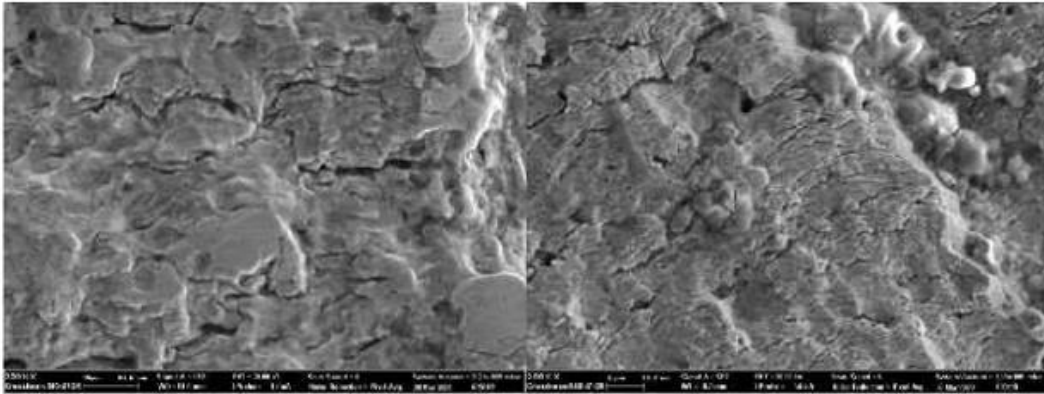
**Fractograph 5: Fracture surface morphology showing fatigue striations (2000-3000X, SE1, SEM)**

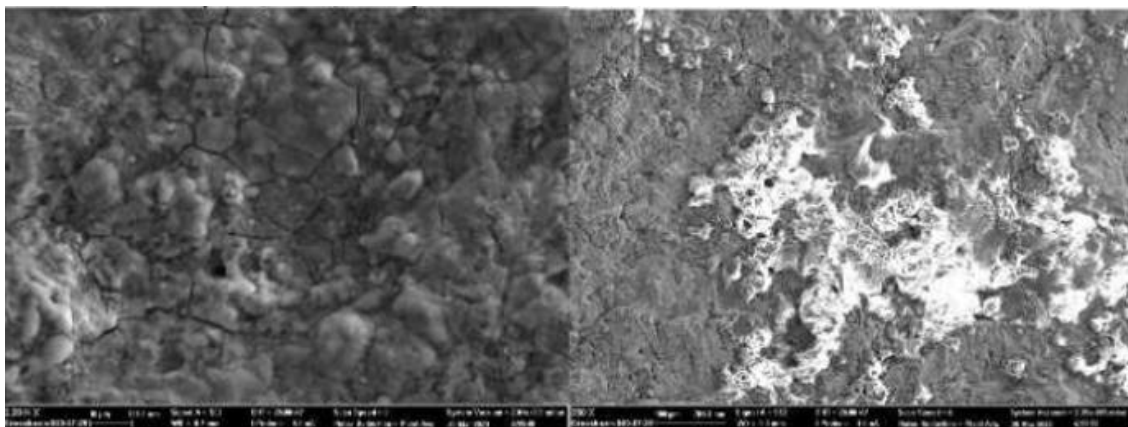
- Extensive foreign deposits on the original fatigue fracture surface morphology (Fractograph 4) supports the notion of an extended environmental exposure period.

**Fractograph 4: Fracture surface morphology showing foreign deposits (350-2000X, SE1, SEM)**

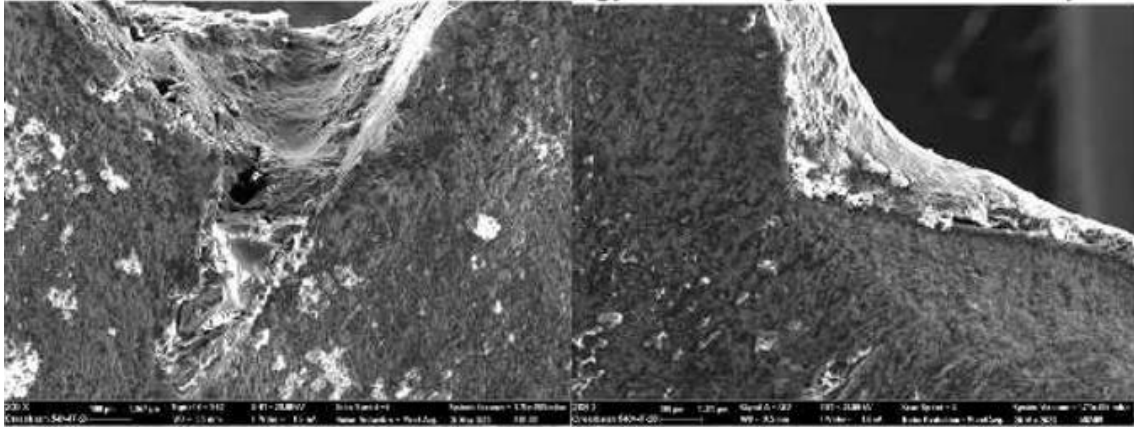
- Dimensional welding defects i.e., undercut, were noted at the foot of the cord (Fractograph 7).

**Fractograph 7: Fracture surface morphology showing welding induced defects (200-208X, SE1, SEM)**

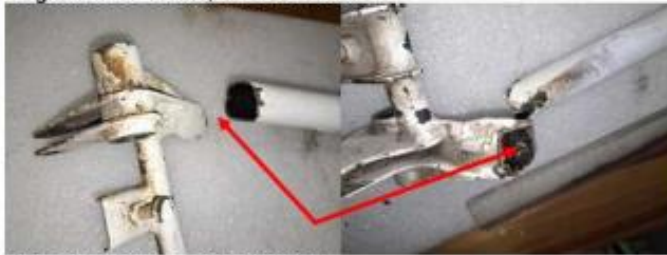
The visual inspection revealed a fracture within the tubular section of the MLG "A" frame (Photo 2, Doagrams2 1 and 2, red dashed circles). The fracture initiated within the weld metal area (Diagram 2, green arrow; Photos 3 and 4, red arrows).

Photo 3: Fracture location (digital)

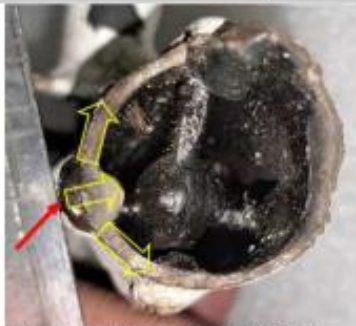
Photo 4: Fracture location (digital)

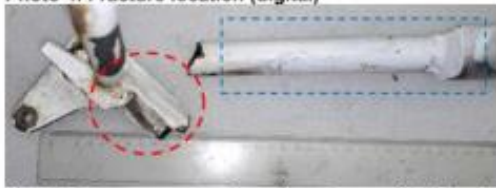
The outer surface inspection revealed a relatively new painted layer (Photo 5, blue dashed square) surrounding another welded section while the paint layer surrounding the fracture initiation location revealed indications of extended environmental time exposure (Photo 5, red dashed circle).

Photo 5: Component surface showing repainted regions (stereo)

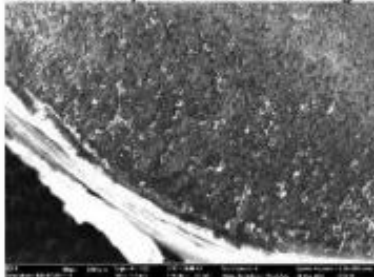
Higher magnification inspections revealed excessive foreign deposits at the fracture initiation zone (Fractographs 1, 2 and 3). This is indicative of exposure to the operating environment for an extended period.

Fractograph 1: Fracture surface morphology, initiation area (69X, SE1, SEM)

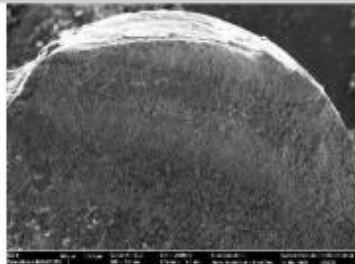
Fractograph 2: Fracture surface morphology, weld metal area (69X, SE1, SEM)

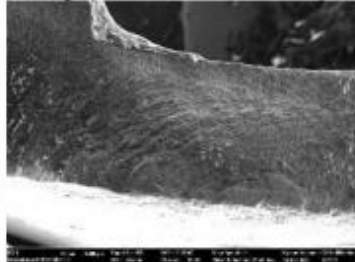
Clear beachmarks (Fractograph 3) and striations (Fractograph 5) sanctions the primary failure mode to be fatigue (compared to an overload morphology – Fractograph 6).

Fractograph 3: Fracture surface morphology, wall thickness, showing fatigue induced 'beachmarks' (80X, SE1, SEM)

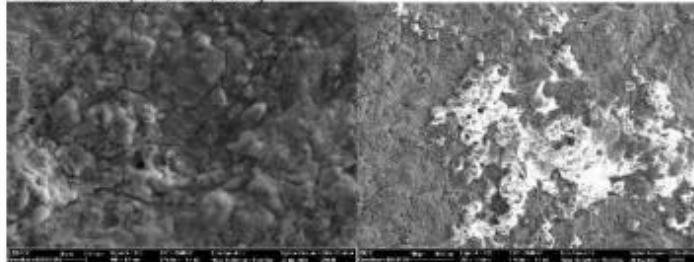
Extensive foreign deposits on the original fatigue fracture surface morphology (Fractograph 4) supports the notion of an extended environmental exposure period.

Fractograph 4: Fracture surface morphology showing foreign deposits (350-2000X, SE1, SEM)

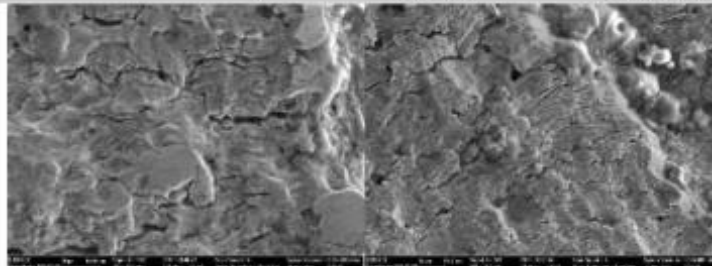
Fractograph 5: Fracture surface morphology showing Fatigue Striations (2000-3000X, SE1, SEM)

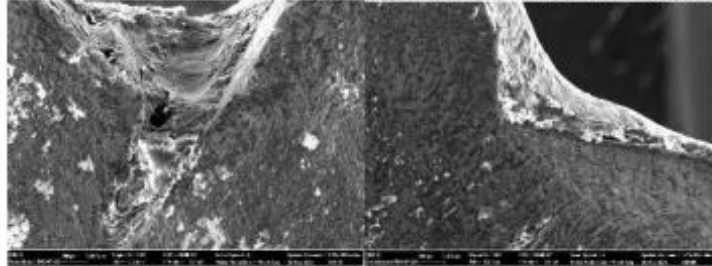
Dimensional welding defects i.e. undercut, where noted at the foot of the cord (Fractograph 7).

Fractograph 7: Fracture surface morphology showing welding induced defects (200-208X, SE1, SEM)

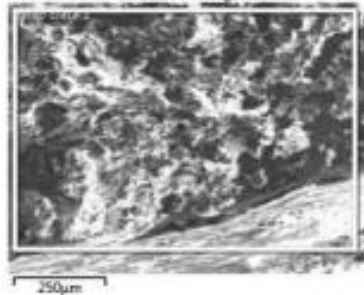
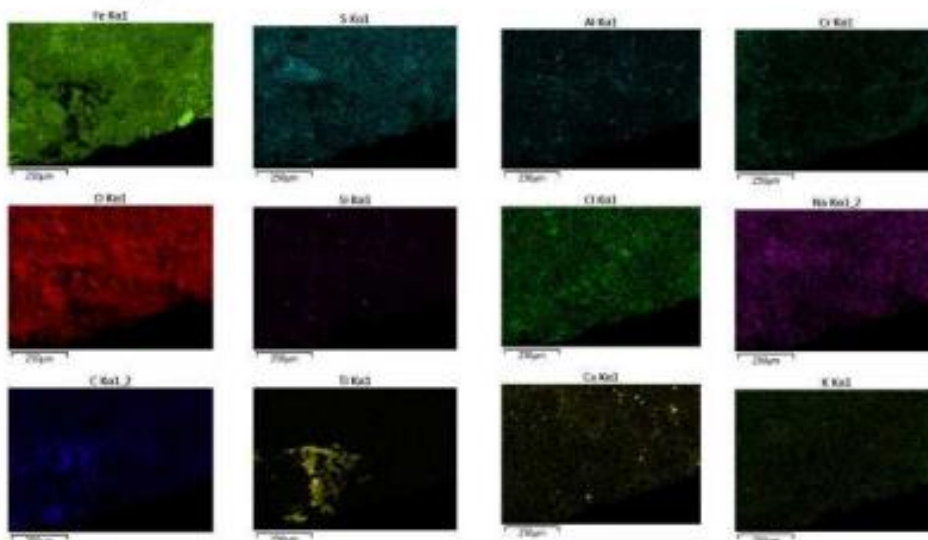
The EDS MAP results (EDS Result 1) confirmed the noted fracture surface foreign deposit elements to be related to typical environmental exposure - Si (sand particles), Na+Cl (salt), C (oil, soot) and Ti (paint).

EDS Result 1: MAP result from fracture surface contaminants (Oxford Aztec, 20kV, WD 5.5mm, SE)
