LIMITED OCCURRENCE INVESTIGATION REPORT – FINAL

Reference Number	CA18/2/3/10272					
Classification	Accident	Date	21 February 2023	Time	0620Z	
Type of Operation	Aerial Work Operations – Game Darting (Part 137)					
Location						
Place of Departure	Brisbane Farm near Pomfret, North West Province		Place of Intended Landing	Brisbane Farm near Pomfret, North West Province		
Place of Occurrence	Brisbane Farm near Pomfret in the North West Province					
GPS Co-ordinates	Latitude	25°42'28.10" S	Longitude	023°33'59.51" E	Elevation	3 575 ft
Aircraft Information						
Registration	ZS-RTH					
Make; Model; S/N	Robinson Helicopter Company; R44 Raven II (Serial Number: 10269)					
Damage to Aircraft	Substantial		Total Airframe Hours	2 630.0		
Pilot-in-command						
Licence Type	Private Pilot Licence (PPL)			Gender	Male	Age 64
Licence Valid	Yes	Total Hours on Type	2 412.0	Total Flying Hours	2 412.0	
Total Hours 90 Days	8.8		Total Hours on Type Past 90 Days	8.8

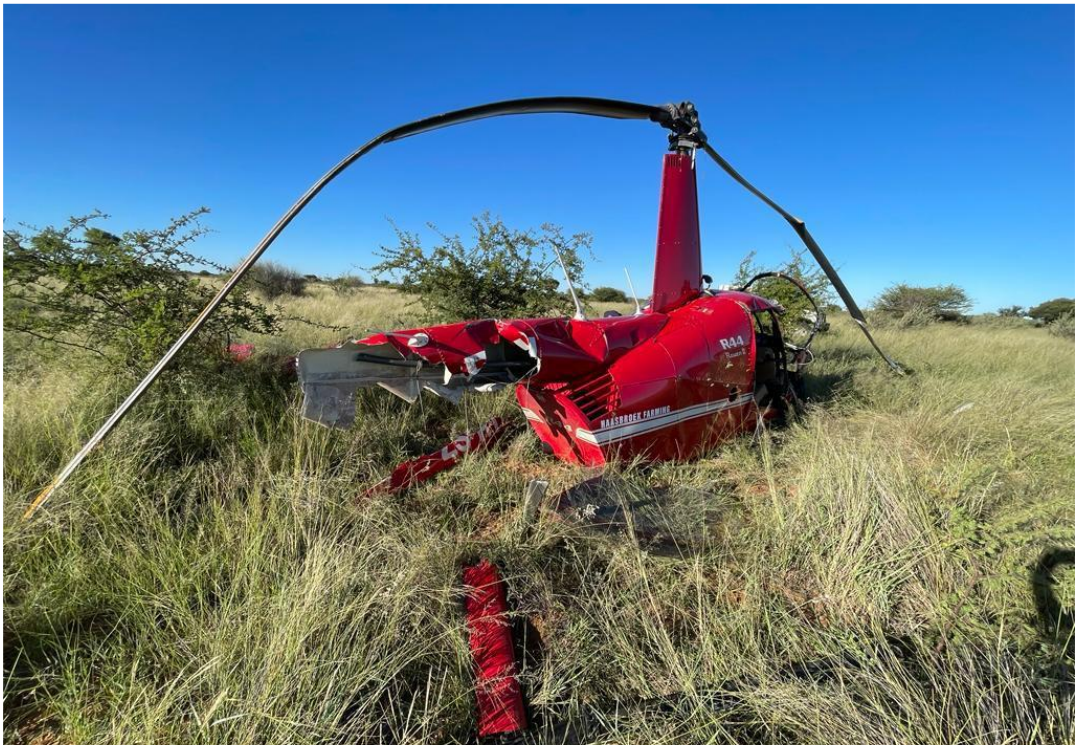
The helicopter was substantially damaged during the accident sequence. The pilot and the veterinarian were not injured; however, the veterinarian's right foot was trapped when the helicopter rolled over. He was freed by members of the ground team when the helicopter was brought to an upright position.

Figure 2: The helicopter after it was brought to an upright position. (Source: Pilot)

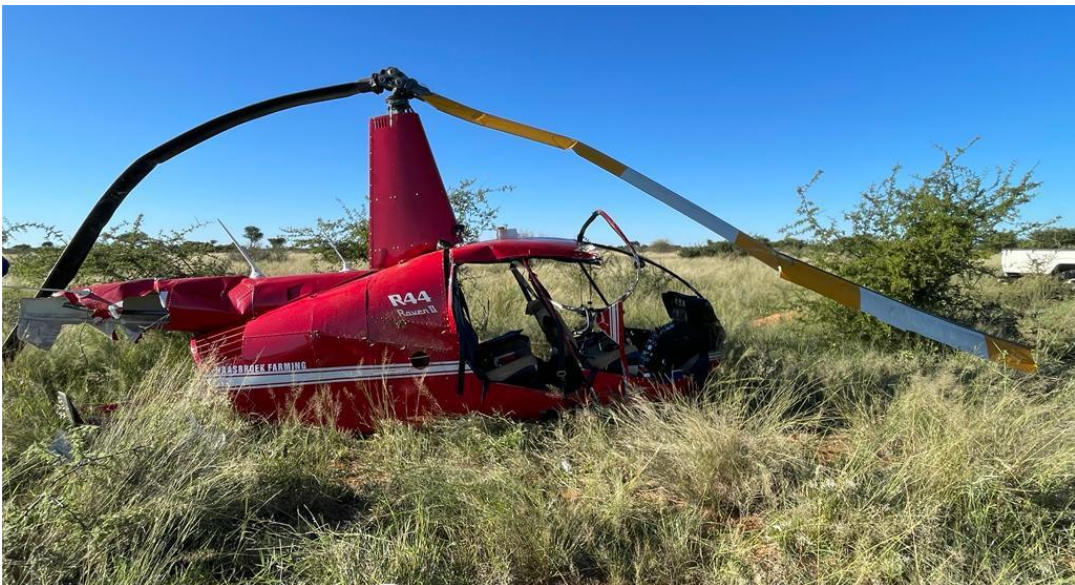
Figure 3: The right-side of the helicopter after it was positioned upright. (Source: Pilot)

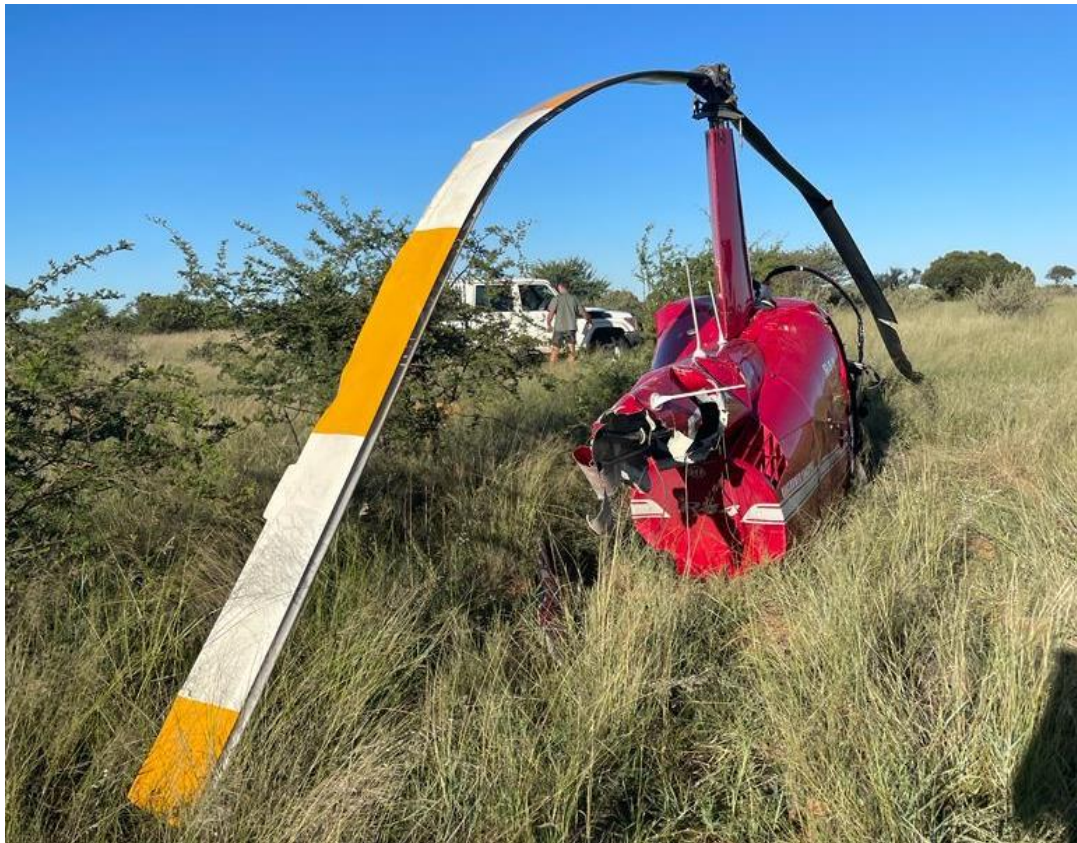
ground impact, the main rotor blades which were rotating below the normal operating range/speed flapped down and severed the aft tail boom. The helicopter came to rest after it rolled over to the right.

Figure 4: The aft view of the helicopter showing the severed tail boom. (Source: Pilot)

During a game darting operation whilst the pilot manipulated the flight controls, the main rotor RPM decayed, which resulted in the helicopter losing height, followed by a crash-landing as there was insufficient height available to restore the main rotor RPM to cushion the landing.
