**LIMITED OCCURRENCE INVESTIGATION REPORT – FINAL**

<b>Reference Number</b>	CA18/2/3/10274						
<b>Classification</b>	Accident	<b>Date</b>	22 February 2023	<b>Time</b>	0637Z		
<b>Type of Operation</b>	Aerial Photography (Part 101)						
<b>Location</b>							
Place of Departure	ArcelloMittal South Africa, Vanderbijlpark, Gauteng Province		Place of Intended Landing	ArcelloMittal South Africa, Vanderbijlpark, Gauteng Province			
Place of Occurrence	Area near ArcelloMittal steel factory in Vanderbijlpark, Gauteng Province						
GPS Co-ordinates	Latitude	26° 39' 31. 36" S	Longitude	27° 48'.32 75" E	Elevation	4 911 ft	
<b>Aircraft Information</b>							
Registration	ZT-XEA						
Make; Model; S/N	DJI Mavic 2 Enterprise Advanced (Serial Number: MAV0037)						
Damage to Aircraft	Substantial		Total Aircraft Hours	428. 31 minutes			
<b>Pilot-in-command</b>							
Licence Type	Remote Pilot Licence (RPL)		Gender	Male		Age	51
Licence Valid	Yes	Total Hours	1 939.11		Total Hours on Type	14.09

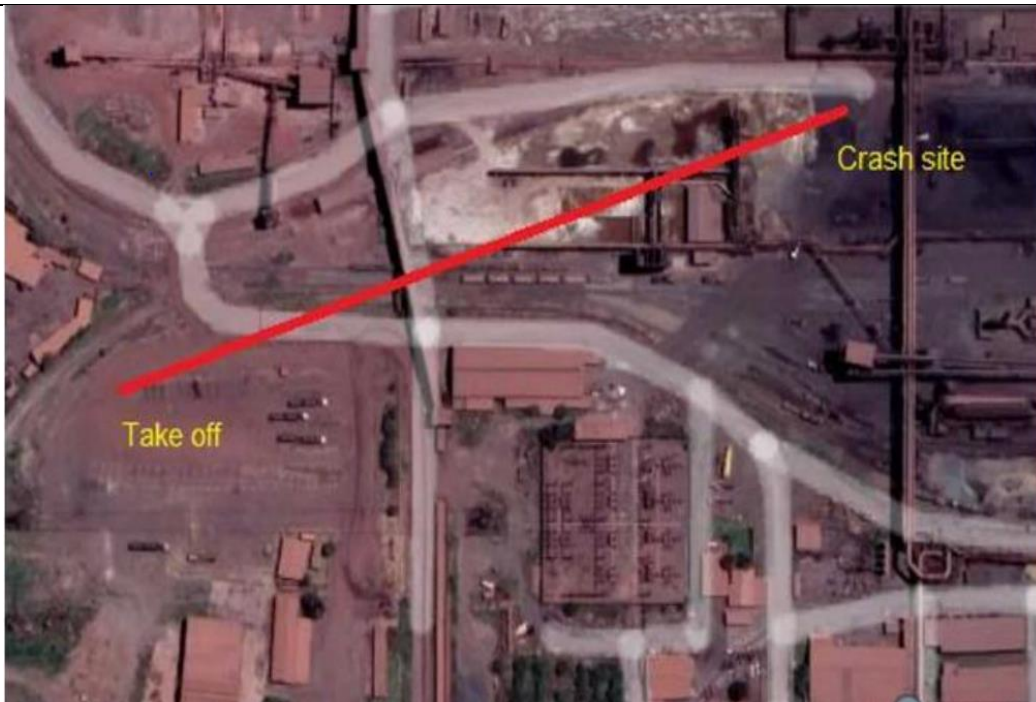
**Figure 1:** An aerial view showing the launch area and the accident site. (Source: Pilot).

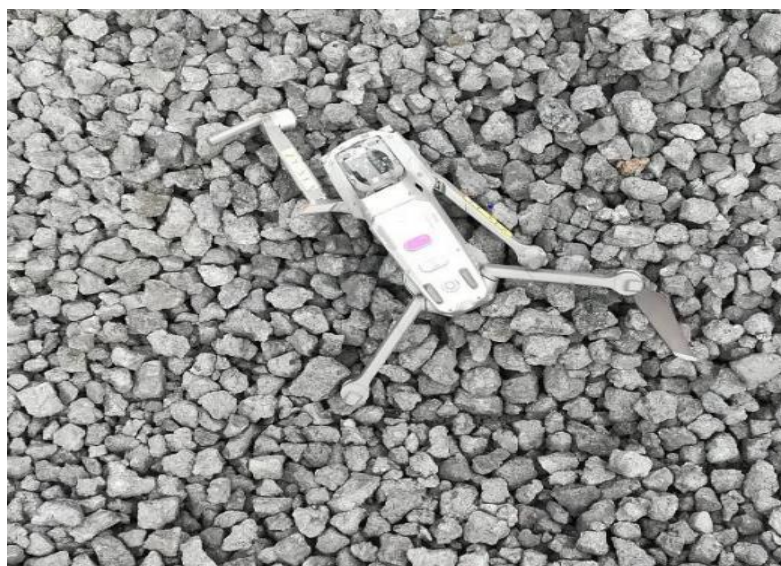
**Figure 2:** The RPA at the accident site. (Source: Pilot)

<p>x. The RPA sustained substantial damage during the accident sequence.</p> <p>xi. No person was injured on the ground during the accident.</p>
<p><b>Probable Cause</b></p>
<p>The pilot flew the RPA in sport mode for more than 5 minutes, which depleted the battery power; this caused the motors to stop operating, as well as interrupted the pilot's inputs from reaching the RPA.</p>
<p><b>Contributing Factor</b></p>
<p>Lack of awareness of the screen vitals and active flight modes.</p>
<p><b>Safety Action(s)</b></p>
<p>None.</p>
<p><b>Safety Message and/or Safety Recommendation/s</b></p>
<p>None.</p>
<p><b>About this Report</b></p>
<p><i>The decision to conduct a limited investigation is based on factors including whether the cause is known and the evidence supporting the cause is clear, the level of safety benefit likely to be obtained from an investigation and that will determine the scope of an investigation. For this occurrence, a limited investigation has been conducted, and the Accident and Incident Investigations Division (AIID) has relied on the information submitted by the affected person/s and organisation/s to compile this limited report. The report has been compiled using information supplied in the initial notification, as well as from follow-up desk top enquiries to bring awareness of potential safety issues to the industry in respect of this occurrence, as well as possible safety action/s that the industry might want to consider in preventing a recurrence of a similar occurrence.</i></p> <p><i>All times given in this report are Co-ordinated Universal Time (UTC) and will be denoted by (Z). South African Standard Time is UTC plus 2 hours.</i></p>

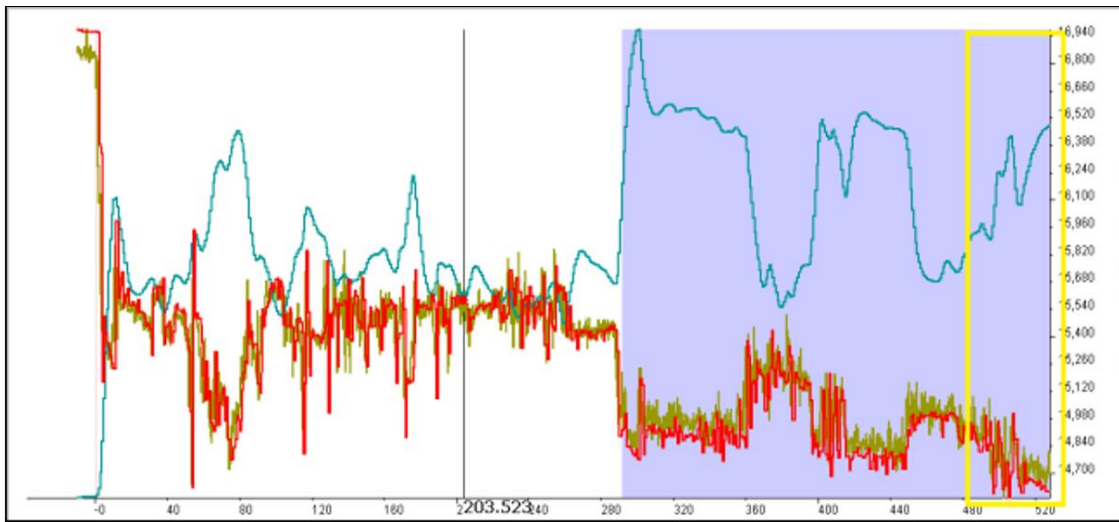
The operator provided a technical report of their post-accident findings. It was concluded that the pilot flew the RPA in sport mode for more than 5 minutes, which depleted the battery power. This caused the motors to stop operating, as well as interrupted the pilot's inputs from reaching the RPA.

**Figure 4:** The downloaded data showing the battery voltage (red line) depleting faster after it was switched to “sport” mode. (Source: Operator)

- viii. The RPA's Certificate of Registration (C of R) was issued to the present owner on 11 May 2021.
- ix. The operator concluded that the pilot flew the RPA in sport mode for more than 5 minutes, which depleted the battery power; this caused the motors to stop operating, as well as interrupted the pilot's inputs from reaching the RPA.
