LIMITED OCCURRENCE INVESTIGATION REPORT – FINAL

Reference Number	CA18/2/3/10275						
Classification	Accident	Date	3 March 2023		Time	2205Z	
Type of Operation	Remotely Piloted Aircraft System – Surveillance (Part 101)						
Location							
Place of Departure	African Explosives and Chemical Industries (AECI) Modderfontein, Gauteng Province		Place of Intended Landing		African Explosives and Chemical Industries (AECI) Modderfontein, Gauteng Province		
Place of Occurrence	AECI Modderfontein, Gauteng Province						
GPS Co-ordinates	Latitude	26°04'26.29" S	Longitude	28°10'16.68" E	Elevation	5 305ft	
Aircraft Information							
Registration	ZT-YHM						
Make; Model; S/N	DJI Matrice, 300 RTK (Serial Number: DOMT3-03/Class 4A)						
Damage to Aircraft	Substantial			Total Aircraft Hours	267.44		
Pilot-in-command							
Licence Type	Remote Pilot Licence (RPL)		Gender	Male		Age	25
Licence Valid	Yes	Total Hours	238.29		Total Hours on Type	233.55	
Total Hours 30 Days	27.57		Total Flying on Type Past 90 Days	57.03

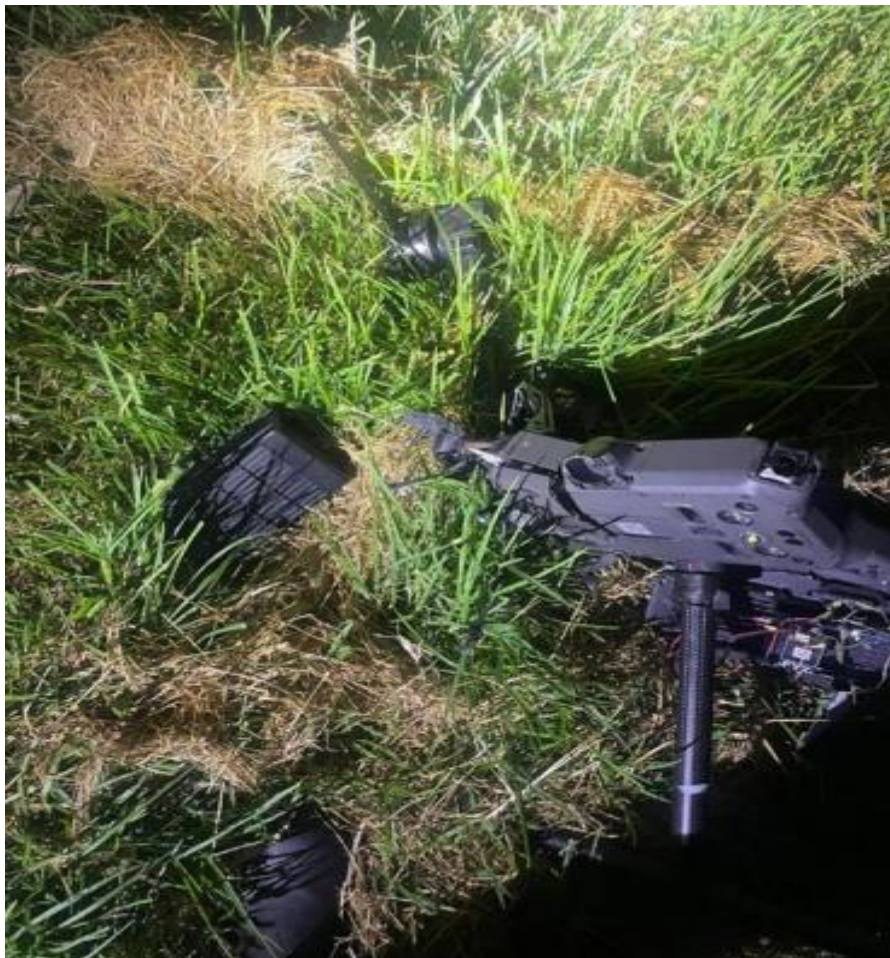
controller. Thereafter, the RPA entered a spiral dive until it impacted the ground. The distance between the RPA and the pilot was approximately 400m at that time (therefore, he had visual of the RPA). Thus, the pilot observed the RPA descend uncontrollably to the ground without his input. The pilot stated that he attempted to regain control by performing an emergency landing which was unsuccessful, thereafter, he selected a return-to-home function, but the RPA crashed to the ground. The RPA sustained substantial damage and no people on the ground were reported injured.

Figure 1: Final resting position of the RPA. (Source: Operator)

Probable Cause(s)
Failure of the ESC due to a possible battery low voltage resulted in the loss of control and an un-commanded spiral dive.
Contributing Factor(s)
None.
Safety Action(s)
None.
Safety Message and/or Safety Recommendation/s
None.
About this Report
<p><i>The decision to conduct a limited investigation is based on factors including whether the cause is known and the evidence supporting the cause is clear, the level of safety benefit likely to be obtained from an investigation and that will determine the scope of an investigation. For this occurrence, a limited investigation has been conducted, and the Accident and Incident Investigations Division (AIID) has relied on the information submitted by the affected person/s and organisation/s to compile this limited report. The report has been compiled using information supplied in the initial notification, as well as from follow-up desk top enquiries to bring awareness of potential safety issues to the industry in respect of this occurrence, as well as possible safety action/s that the industry might want to consider in preventing a recurrence of a similar occurrence.</i></p> <p><i>All times given in this report are Co-ordinated Universal Time (UTC) and will be denoted by (Z). South African Standard Time is UTC plus 2 hours.</i></p>

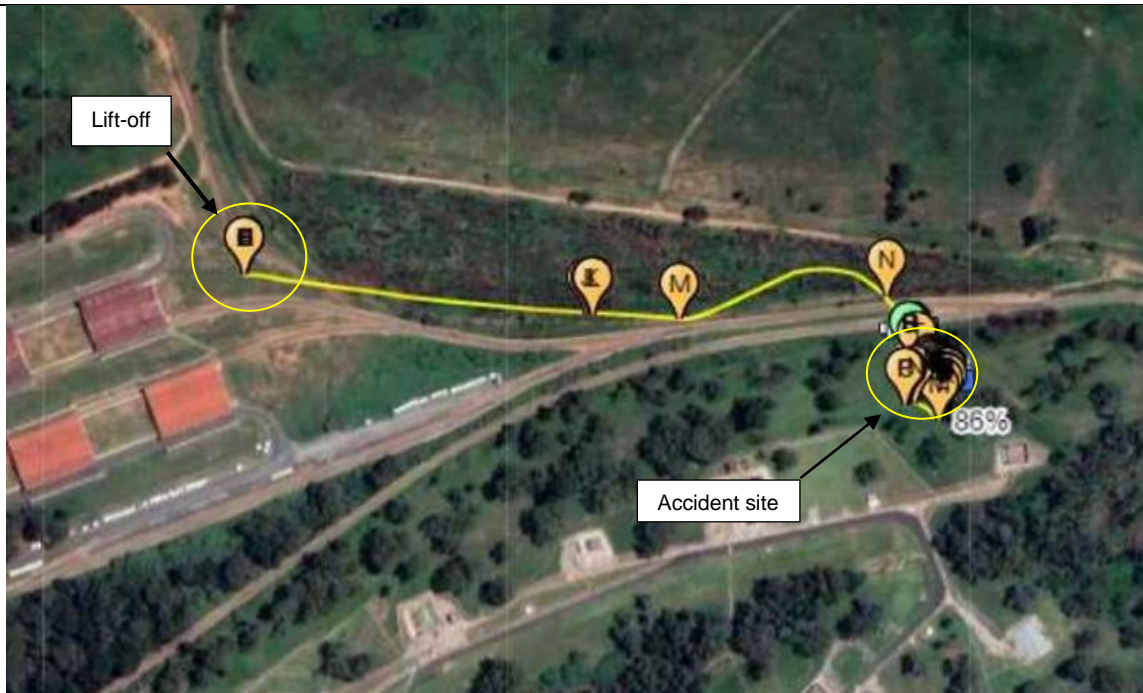
According to the flight log data (above), a new return-to-home altitude of 656 feet (ft) was set, and the home point was recorded at 00 minutes and 00 seconds. A 'horizontal and downward ambient light too low' message was recorded shortly thereafter. The RPA continued with surveillance over the area. At approximately 1 minute and 20 seconds, a 'not enough force/ESC error' messages appeared, followed by the 'high wind velocity' message at the altitude of 508 ft above ground level (AGL). Whilst at 567 ft, it detected a weak image transmission signal followed by a strong remote controller signal interference. At 3 minutes and 27 seconds, a 'side shock/possible collision' and 'aircraft rolling sharply to the right' messages were displayed, followed by 'propeller fell-off' warning message. Thereafter, a series of warning messages appeared (detected forward shock, motor 4 propeller detached, not enough force/ESC error and detected backward shock) on the controller unit. The mode was changed to emergency landing and the RPA altitude decreased rapidly from 567 ft to 43 ft in less than 7 seconds. The duration of the recording was 3 minutes and 45 seconds.

Figure 3: The flight path from lift-off until the crash. (Source: Operator)
