<b>LIMITED OCCURRENCE INVESTIGATION REPORT – FINAL</b>
--

<b>Reference Number</b>	CA18/2/3/10276						
<b>Classification</b>	Accident		<b>Date</b>	4 March 2023		<b>Time</b>	0645Z
<b>Type of Operation</b>	Private (Part 91)						
<b>Location</b>							
Place of Departure	Brakpan Aerodrome (FABB), Gauteng Province		Place of Intended Landing	Vereeniging Aerodrome (FAVV), Gauteng Province			
Place of Occurrence	Brakpan Aerodrome (FABB), Gauteng Province						
GPS Co-ordinates	Latitude	26° 34' 15.48" S	Longitude	027° 57' 32.38" E	Elevation	4 862 ft	
<b>Aircraft Information</b>							
Registration	ZS-DPN						
Make; Model; S/N	Piper 28-180 Cherokee (Serial Number: 28-1175)						
Damage to Aircraft	Substantial			Total Aircraft Hours	5 768.91		
<b>Pilot-in-command</b>							
Licence Type	Private Pilot Licence (PPL)		Gender	Male		Age	19
Licence Valid	Yes	Total Hours	74.48		Total Hours on Type	69.48	
Total Hours 30 Days	3.42		Total Flying on Type Past 90 Days	10.36			
<b>People On-board</b>	1+1	<b>Injuries</b>	0	<b>Fatalities</b>	0	<b>Other (on ground)</b>	0

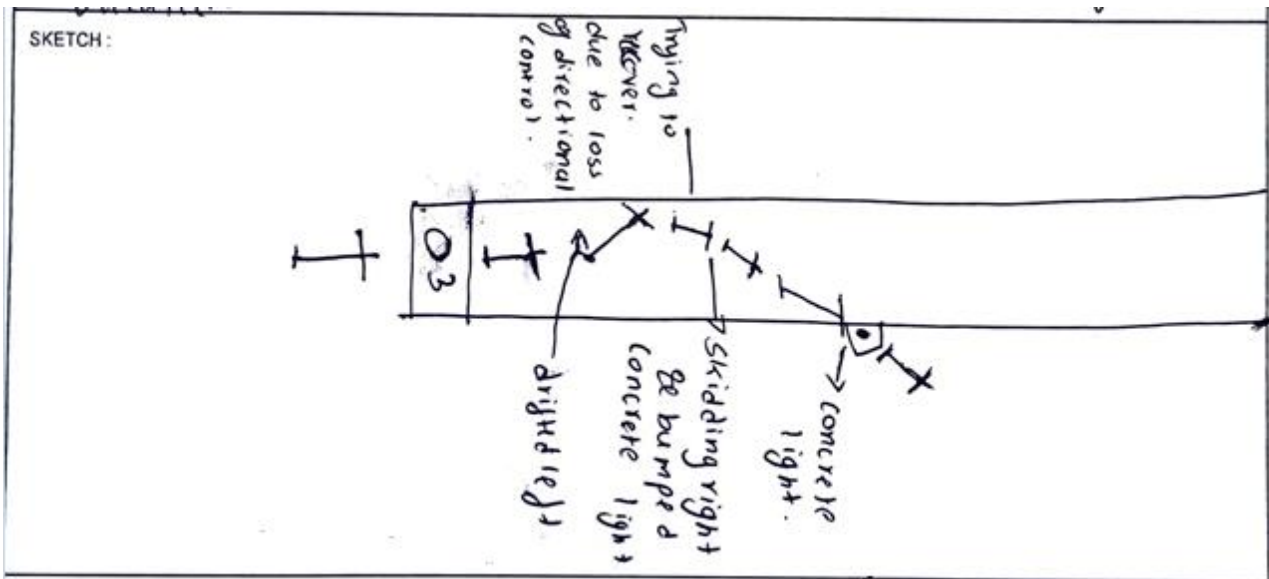
**Illustration 1:** The sketch of the sequence of events. (Source: Pilot questionnaire)

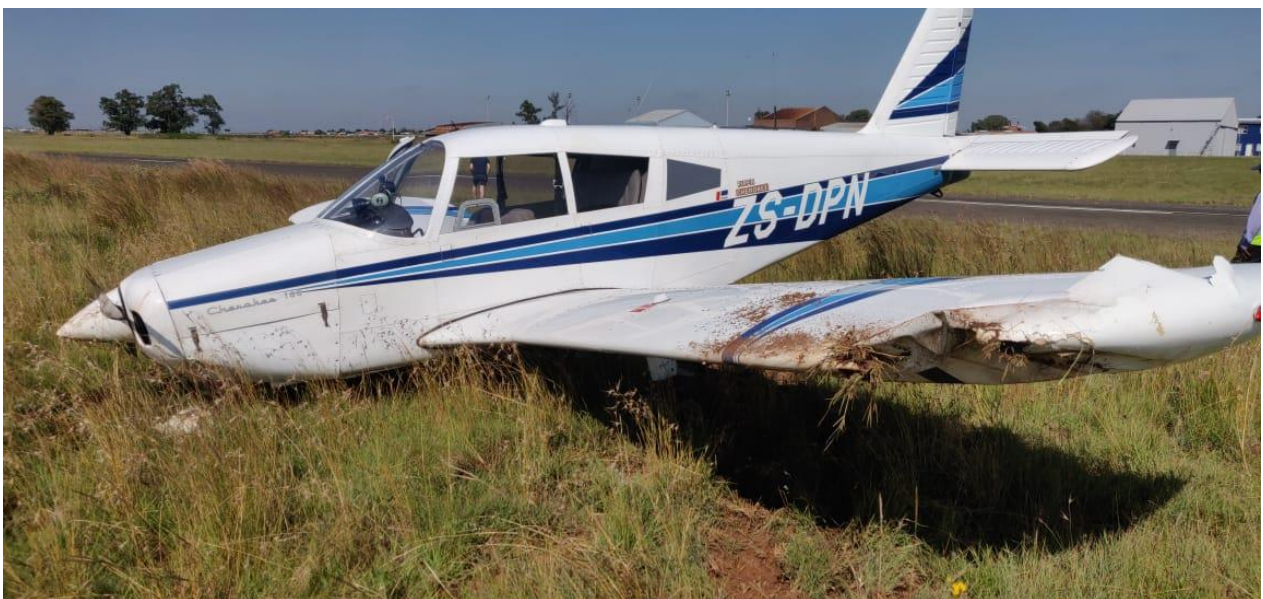
The aircraft sustained damage to the left-wing, nose gear, landing light and underbelly.

**Figure 1:** The aircraft at the accident site. (Source: Operator)

7. The pilot stated that he flared the aircraft too high, and it bounced and landed hard, followed by loss of directional control. The aircraft skidded to the right and exited the runway. The left-wing tip contacted the ground, and the nose gear and landing light broke.

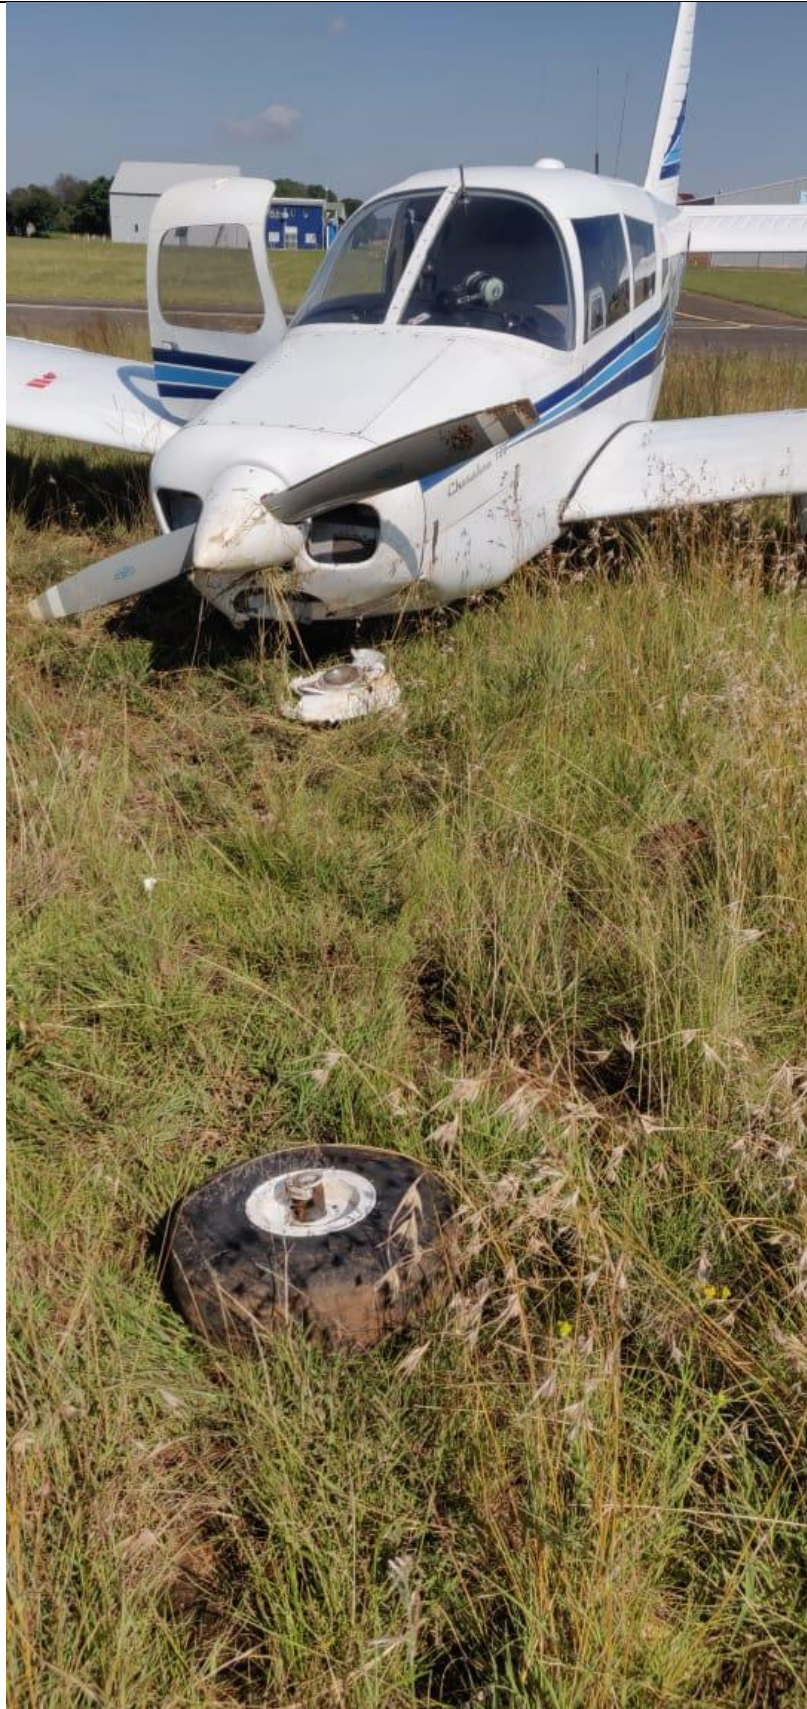
**Figure 2:** The front view of the aircraft and the nose wheel assembly that detached from the fork.  
(Source: Operator)

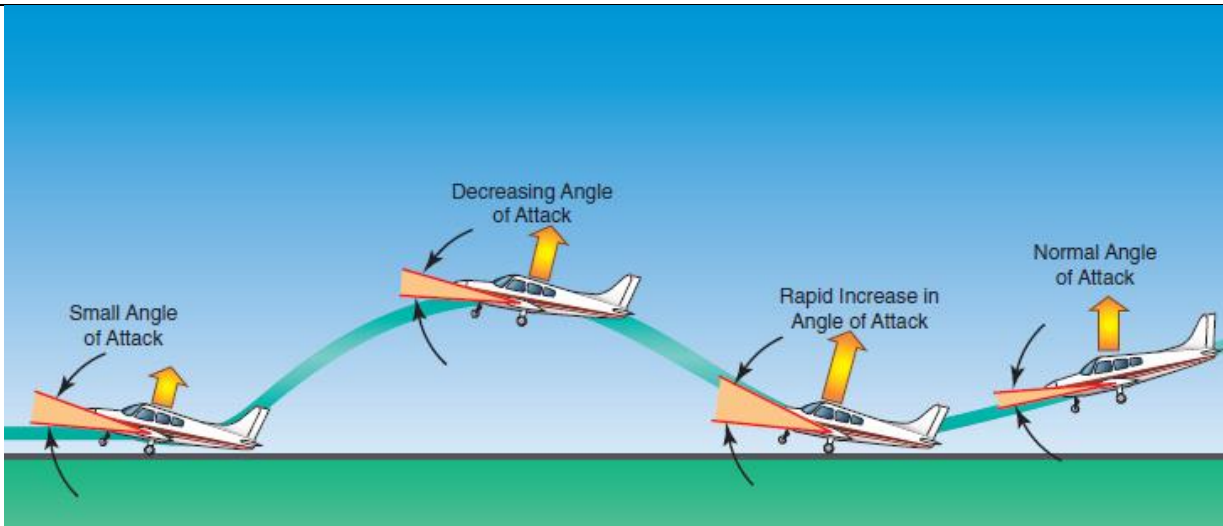
**Illustration 2:** Illustration depicting the bounce. (Source: Source: FAA-airplane flying handbook chapter 8)

8. The aircraft was high on approach and, therefore, the flaring was too high. As a result, the aircraft touched down hard on the runway and bounced.
<b>Probable Cause(s)</b>
The aircraft was flared too high during landing and, thus, landed hard and bounced; the pilot lost directional control and the aircraft exited the runway.
<b>Contributing Factor(s)</b>
Incorrect landing technique.
<b>Safety Action(s)</b>
None.
<b>Safety Message</b>
Pilots should be vigilant during critical stages of flight such as take-offs and landings.
<b>About this Report</b>
<i>The decision to conduct a limited investigation is based on factors including whether the cause is known and the evidence supporting the cause is clear, the level of safety benefit likely to be obtained from an investigation and that will determine the scope of an investigation. For this occurrence, a limited investigation has been conducted, and the Accident and Incident Investigations Division (AIID) has relied on the information submitted by the affected person/s and organisation/s to compile this limited report. The report has been compiled using information supplied in the initial notification, as well as from follow-up desk top enquiries to bring awareness of potential safety issues to the industry in respect of this occurrence, as well as possible safety action/s that the industry might want to consider in preventing a recurrence of a similar occurrence.</i>
