**LIMITED OCCURRENCE INVESTIGATION REPORT – FINAL**

<b>Reference Number</b>	CA18/2/3/10277						
<b>Classification</b>	Accident	<b>Date</b>	6 March 2023		<b>Time</b>	0840Z	
<b>Type of Operation</b>	Agricultural (Part 137)						
<b>Location</b>							
<b>Place of Departure</b>	Smalpunt Airstrip, Free State Province			<b>Place of Intended Landing</b>	Smalpunt Airstrip, Free State Province		
<b>Place of Occurrence</b>	Farm Klein Geluk, Swartfontein, Free State Province						
<b>GPS Co-ordinates</b>	<b>Latitude</b>	28° 00' 44.9" S	<b>Longitude</b>	28° 38' 08.6" E	<b>Elevation</b>	5 626 ft	
<b>Aircraft Information</b>							
<b>Registration</b>	ZS-LEK						
<b>Make; Model; S/N</b>	Ayres Corporation; S2R-T34 (Serial Number: T34-050DC)						
<b>Damage to Aircraft</b>	Destroyed			<b>Total Aircraft Hours</b>	10 213.85		
<b>Pilot-in-command</b>							
<b>Licence Type</b>	Commercial Pilot Licence (CPL)		<b>Gender</b>	Male		<b>Age</b>	73
<b>Licence Valid</b>	Yes	<b>Total Hours</b>	± 18 690		<b>Total Hours on Type</b>	± 16 690

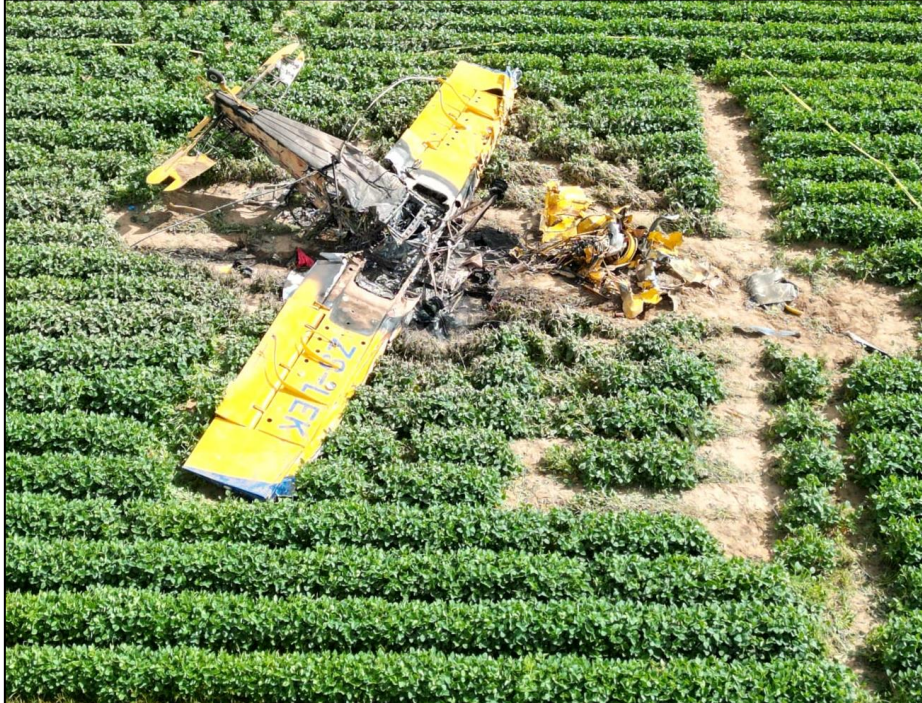
**Figure 1:** Aerial view of the wreckage distribution with the impression of the aircraft's first impact point on the soya vegetation. (Source: Operator)

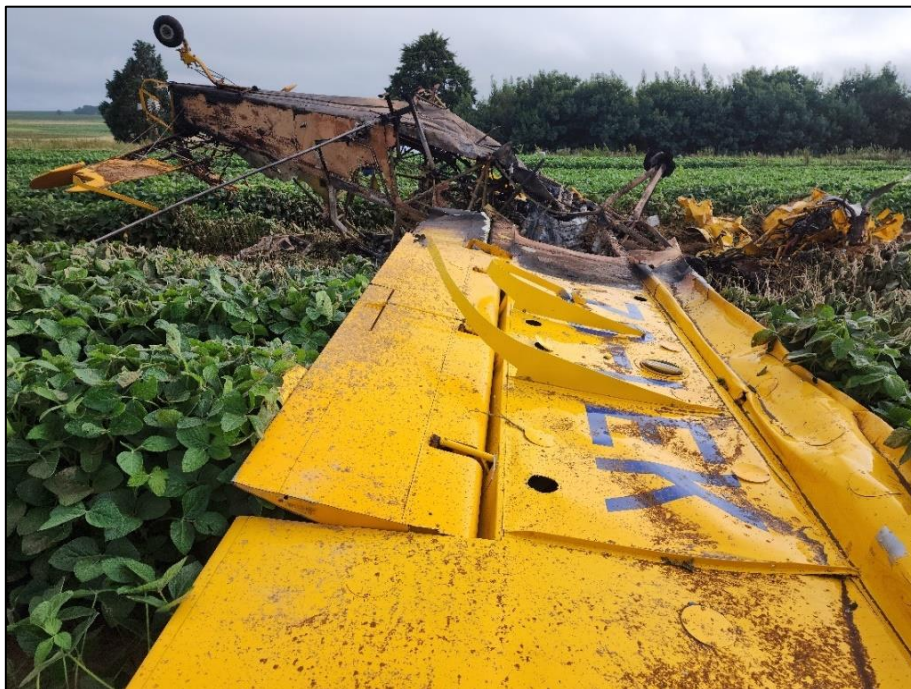
The aircraft was found in an inverted attitude and consumed by fire. Upon inspection of the wreckage, a high-tension electrical earth conductor wire (top wire) was found entangled to the left landing gear.

The aircraft was destroyed, and the pilot was fatally injured during the accident.

**Figure 2:** A close view of the ZS-LEK aircraft post-accident.

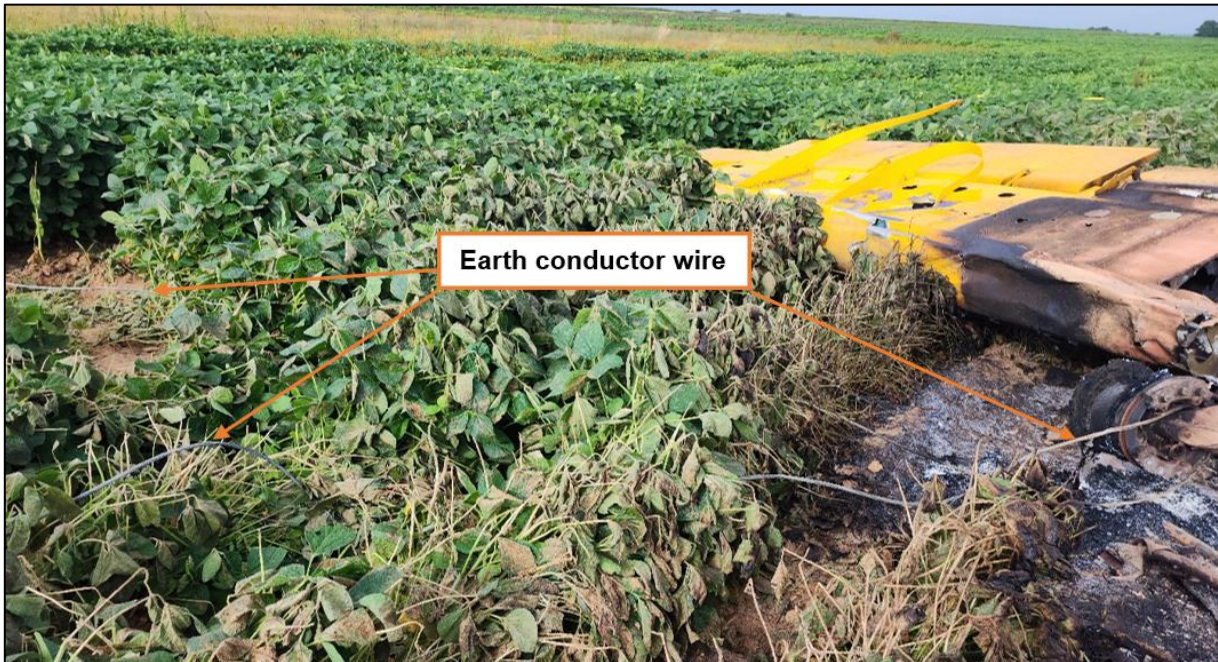
- 3.1. There were no eyewitnesses to the accident. Damage observed on the wreckage indicated that the engine was operating at full power, confirmed by two of the three propeller blades which became dislodged from the flange after impact; they were found buried in the soft ground, each located approximately 2 and 3 metres from the engine.
- 3.2. Observation of the wreckage indicated that the aircraft was caught on an electric wire with its left main landing gear strut. Metallic striation marks indicative of a wire strike were observed on the leading edge of the left wing and the left gear strut, and a section of the high-tension earth conductor wire was still attached to the landing gear wheel assembly as shown in Figure 3.

**Figure 3:** Earth conductor (top wire) of high-tension electrical wire is attached to the left landing gear.

- 3.3. The left landing gear strut was bent at a 90-degree angle from its original position in comparison to the right landing gear.
- 3.4. The post-accident assessment report of the engine revealed the following (Source: AMO Engine inspection technical report):

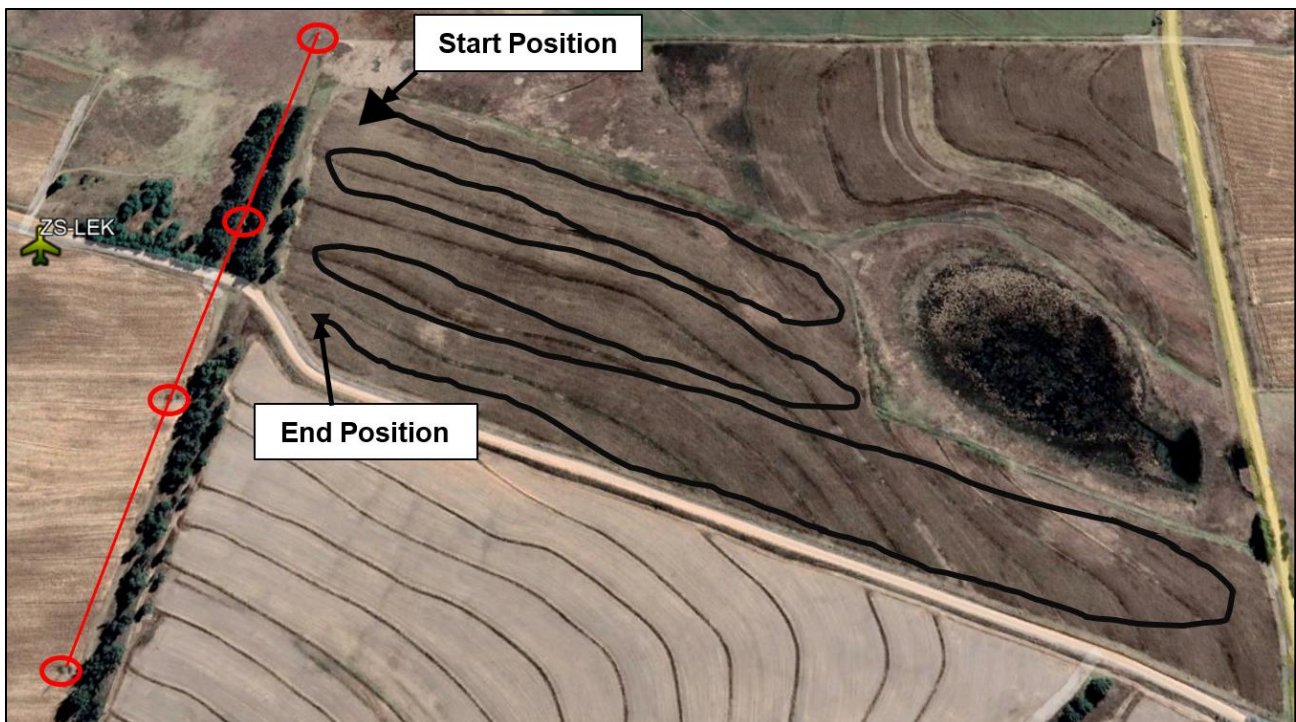
4.3. According to the operator, crop-spraying is conducted to achieve optimised efficiency. This means that pilots conduct crop-spraying based on two factors that need to be considered: **efficiency** – the most efficient way to spray the land; and **safety** – the safest way to spray the crops. Therefore, the most probable spray pattern the pilot would have chosen is the longest part of the land (shown as the black line in Figure 4).

**Figure 4:** The black line depicts ZS-LEK’s most probable flight path before collision with the wire. The red line and circles show power lines and poles. (Source: Google Earth)

- 5.1. During the crop-spraying detail, the aircraft would have been flown about 3m – 5m above ground level (AGL) and the pilot would have had to apply full power and pitch the aircraft’s nose up to clear obstacles. The power lines, which blended with terrain and located behind the trees were adjacent to the aircraft’s flight path. Therefore, due to the profile of the nose-up pitch, it would have been difficult to see obstacles that would have been easily identified if the aircraft’s profile was horizontal.

- 5.2. It is likely that the pilot’s concentration was degraded after the final track on Farm Maria, which led to the loss of situational awareness, and forced the pilot to deviate from the planned route. Also, awareness of the previously checked wires was lost and, as a result, the pilot was unable to recognise the top tension wire when attempting to fly over the power lines from a low height.
