**AIRCRAFT ACCIDENT REPORT AND EXECUTIVE SUMMARY**

| | | | | <b>Reference:</b> | | <b>CA18/2/3/10278</b> | |
| <b>Aircraft Registration</b> | ZS-III | <b>Date of Accident</b> | 2 April 2023 | | <b>Time of Accident</b> | 1950Z | |
| <b>Type of Aircraft</b> | Cessna C310Q | | <b>Type of Operation</b> | | Private (Part 91) | | |

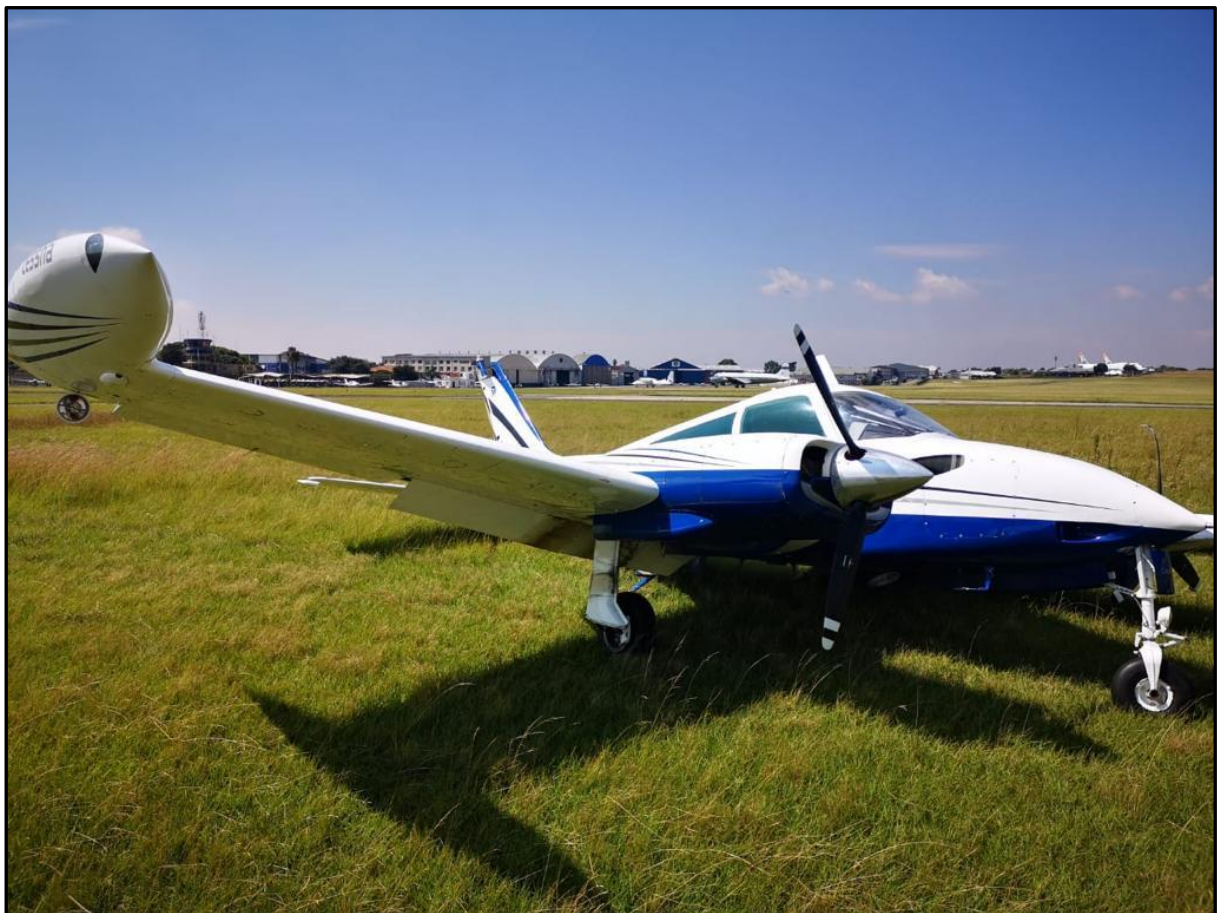
1.3.1. The aircraft sustained substantial damage to the left main landing gear, fuselage and left engine propeller blades.

**Figure 2:** The aircraft as it came to rest. (Source: Operator)

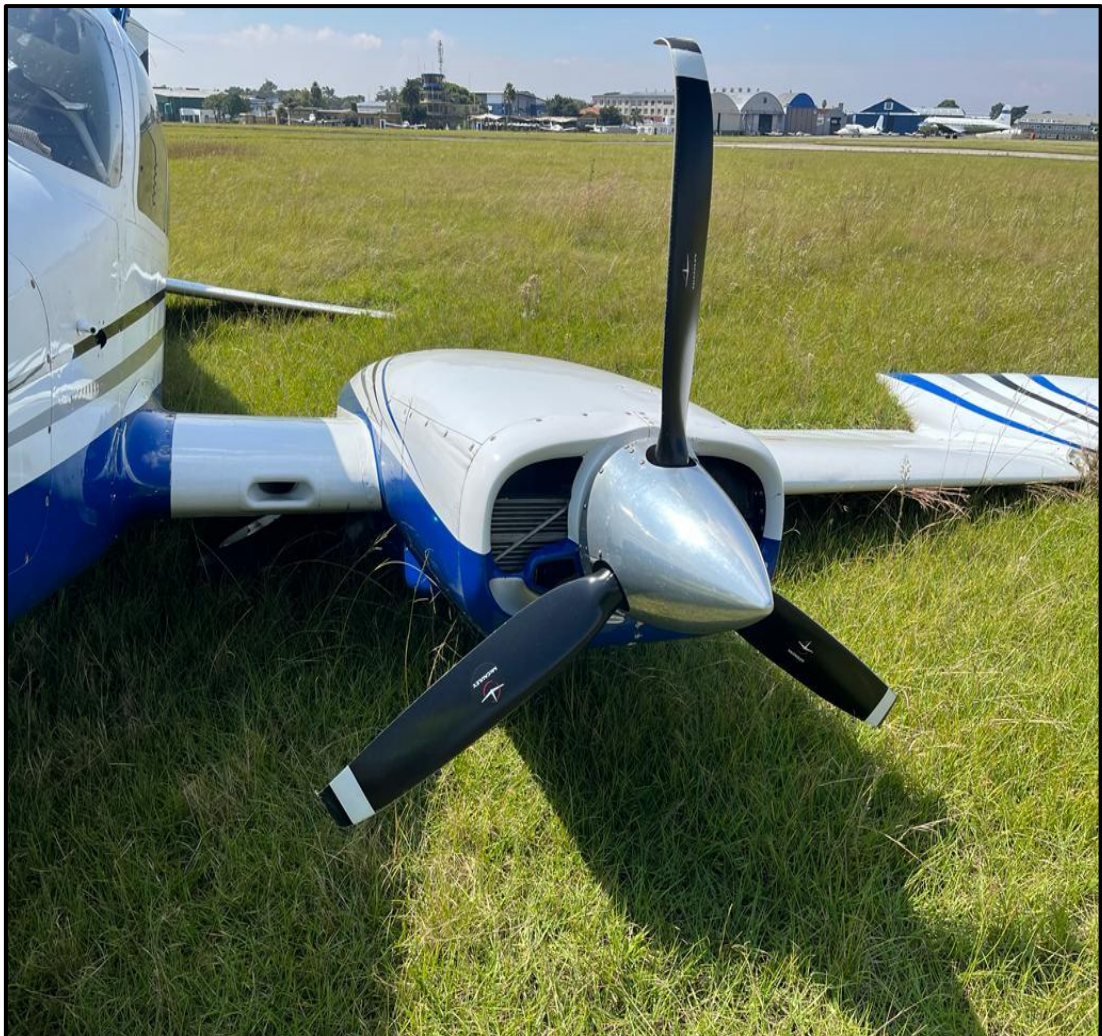
- There were two lines (scrape marks) in the direction of and directly proportional to the wing tip position and the left propeller. The wing tip and the propeller blades sustained damage as a result of contact with the ground.
- The wing attachment root outer skin was also damaged.
- The radio antenna and rear bottom structure were damaged due to scrapping on the runway surface.

**Figure 3:** Damage sustained by the propeller.

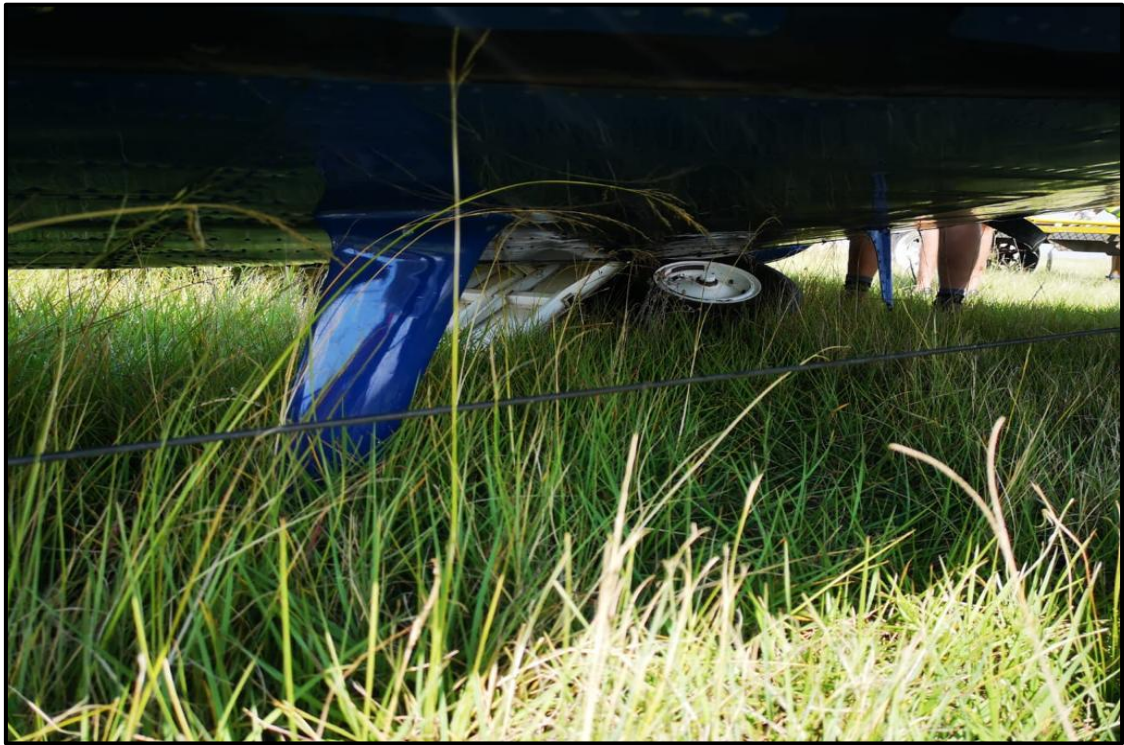
- The left main landing gear collapsed towards the retraction fold. The left landing gear door sustained damage when it scraped against the runway surface.

**Figure 4:** The collapsed left main landing gear.

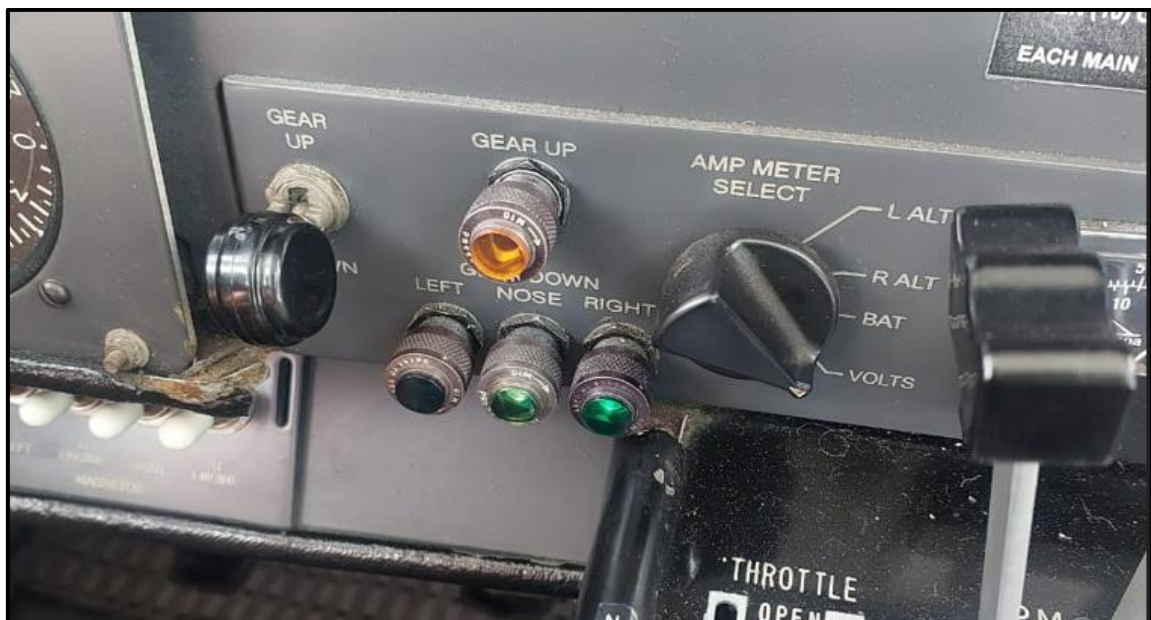
- The cockpit assessment revealed that the aircraft was shut down after the accident. The landing gear lever was set to 'down' position. When the master switch was selected to 'on' position, only two landing gear lights (right and the nose) turned green. This was because both the nose and the right landing gears were selected to 'down and locked' position (these lights came on during testing post-accident).

**Figure 5:** The cockpit landing gear controls and indicators.

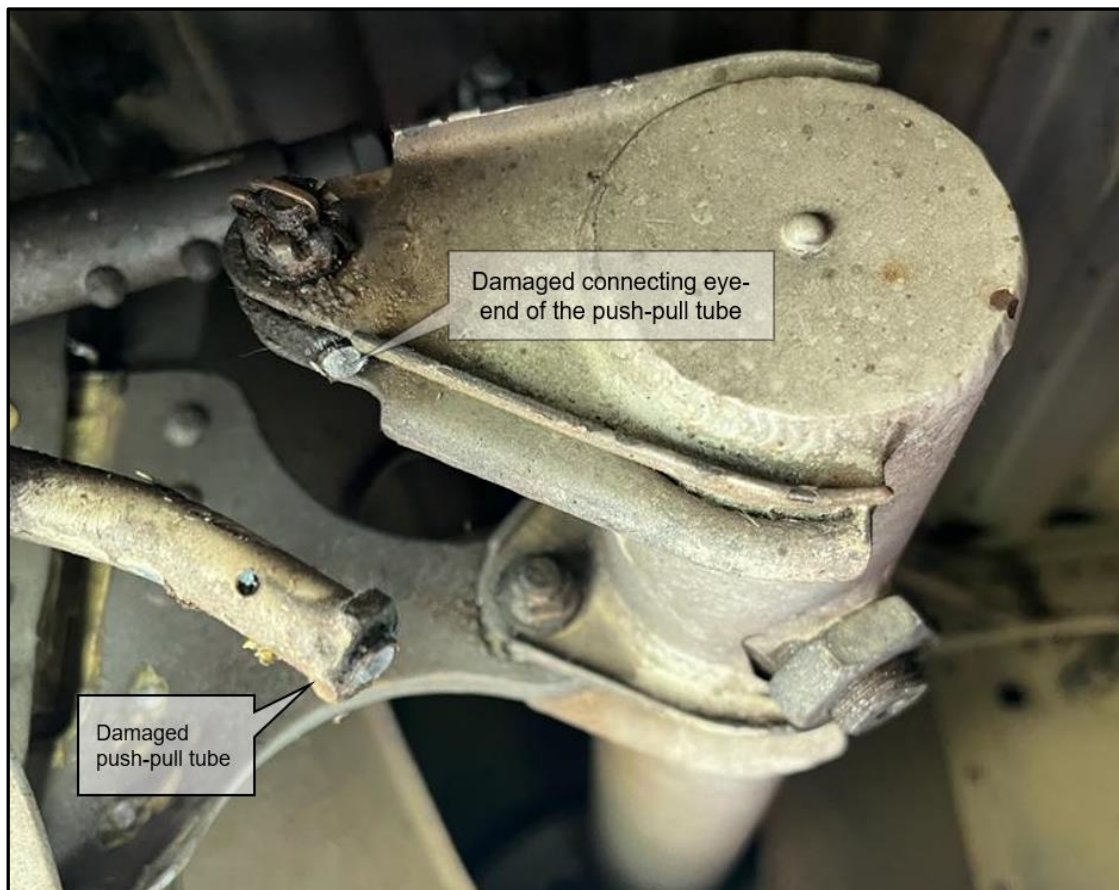
- The left wing was raised by the recovery team post-accident to level the aircraft and to conduct further observations and assessment of the damage. Figure 6 shows the torque tube with the damaged push-pull tube's connecting eye-end. The retraction and extension link (push-pull tube) had bent (damage) which was consistent with compression forces closer to the connection point towards the torque tube.

**Figure 6:** The failed push-pull tube on the left main landing gear torque tube.

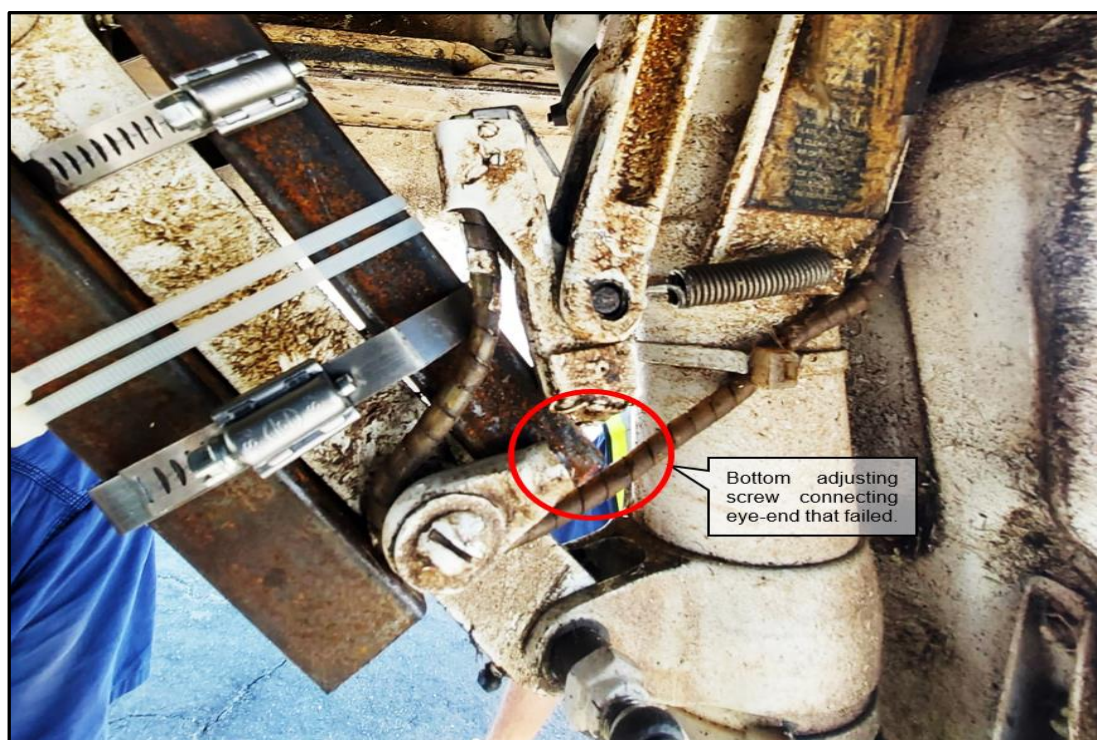
- Figure 7 shows the left main landing gear, in extended position, support steel bar on the upper and lower side link to keep it in the locked position. The bell-crank bottom adjusting screw's connecting eye-end broke off during the accident sequence. The damage exhibit instantaneous failure which is likely to have resulted from the tensile stress (forces).

**Figure 7:** The left main landing gear supported with steel bars and the damaged bottom adjusting screw connecting eye-end.

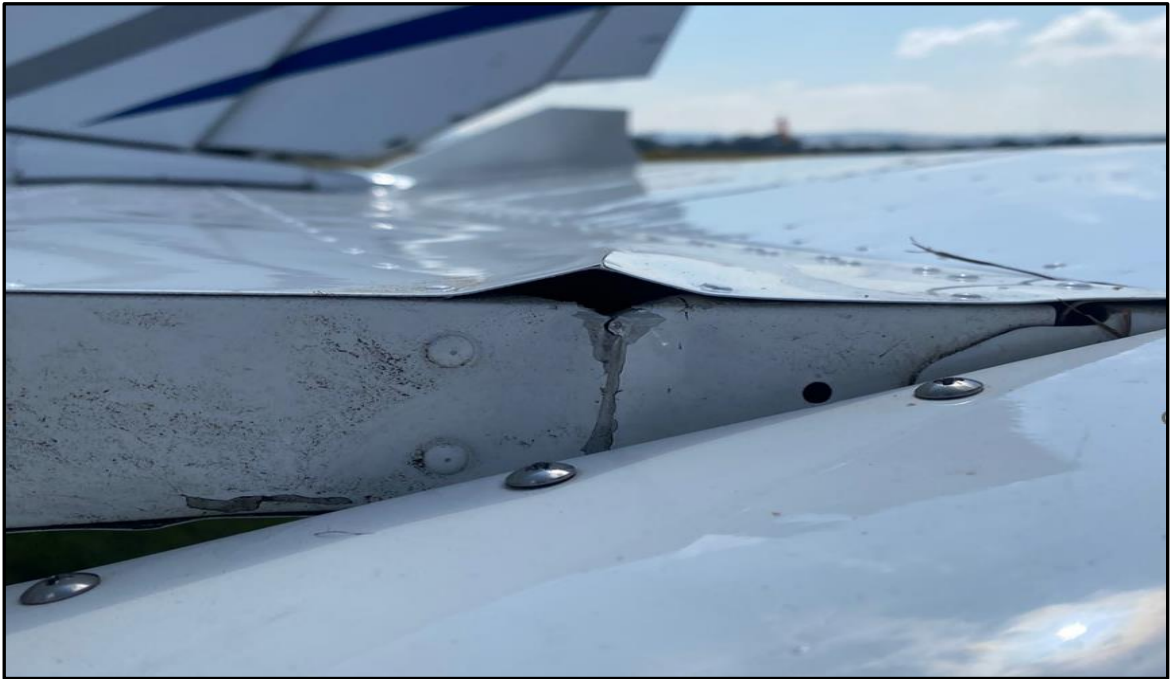
1.12.3 The aircraft elevator was damaged during the accident sequence.

**Figure 8:** The damaged left elevator.

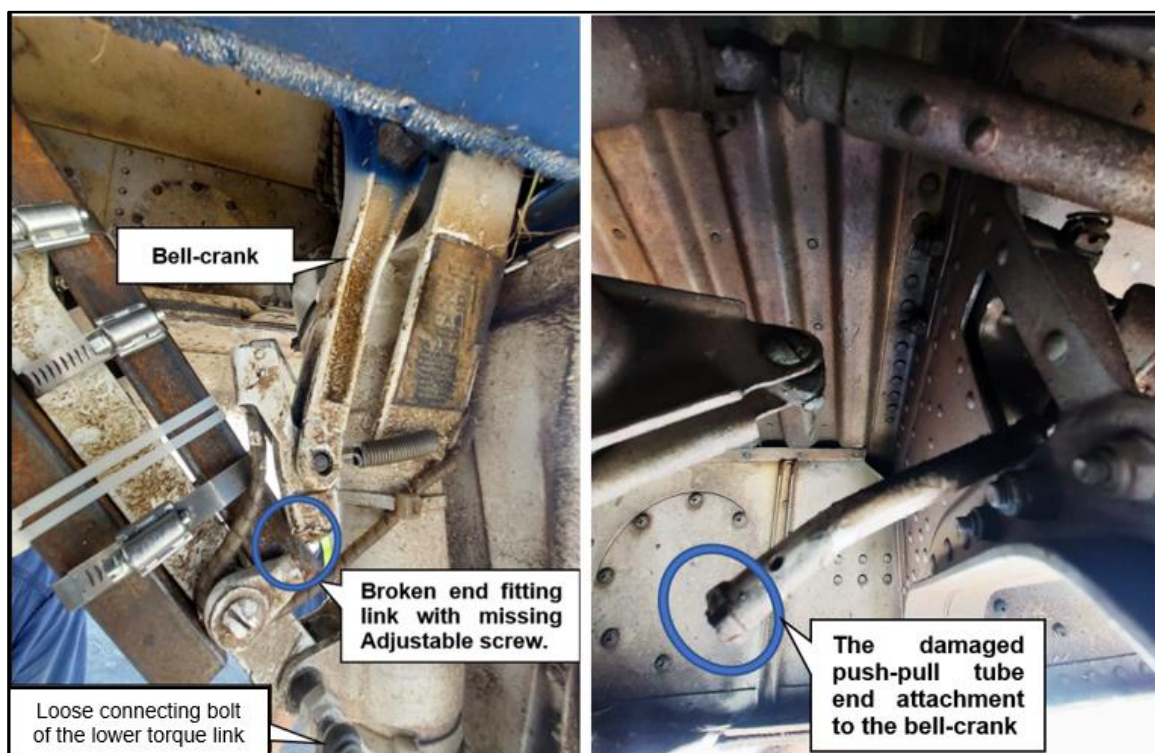
1.16.1 The aircraft was recovered by an AMO in FAWB. During recovery, it was discovered that the left main landing gear retracted uncommanded and the push-pull tube that links the torque tube to the bell crank and the bottom adjustable screw eye-end failed. Further inspection by the AMO revealed that both attachment bolts on each main landing gears were loose and exhibited excessive slackness.

**Figure 9:** The damaged components – bottom end fitting link (left) and bell-crank connecting push-pull tube (right).

- Figure 9 exhibits instantaneous failure which was likely caused by overload forces during an uncommanded landing gear retraction during the slow landing roll. This is also evidence by the peeling off of the paint on the side where compression bending occurred. The eye-end attachment point that connects to the torque tube had broken off.

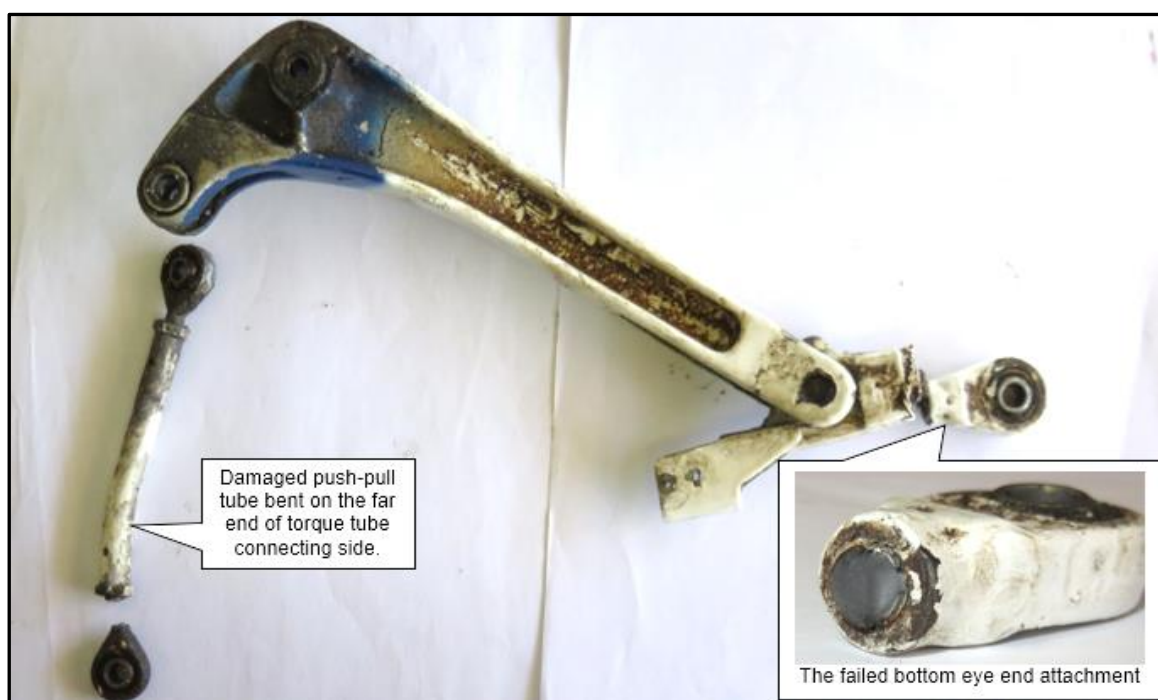
- The damage on the push-pull tube (bent) are likely due to compression force.

**Figure 10:** The damaged components.

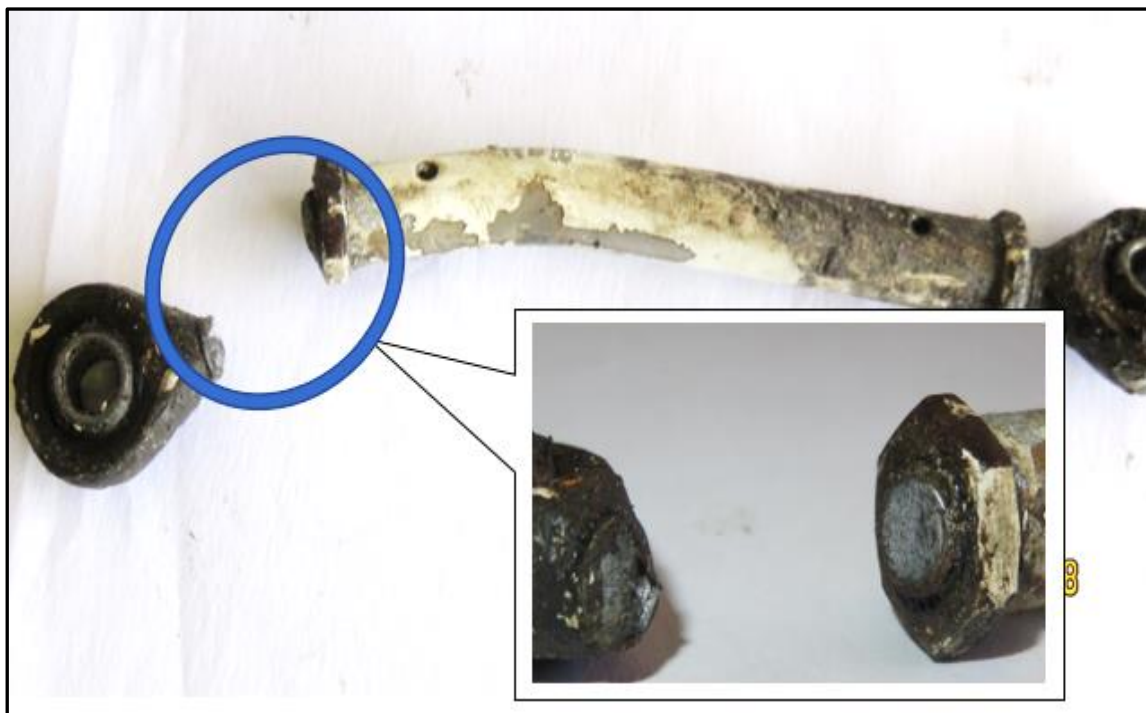
**Figure 11:** Damage on the eye-end push-pull tube.

Figures (11 and 12) show the bottom adjusting screw arm with the failed eye-end attachment. The damage exhibits an instantaneous failure which is likely to have resulted from overload forces that occurred during an uncommanded landing gear retraction.

Figure 11 shows the damage on the bottom adjusting screw below the adjusting nut that remained and still attached to the locking wire.

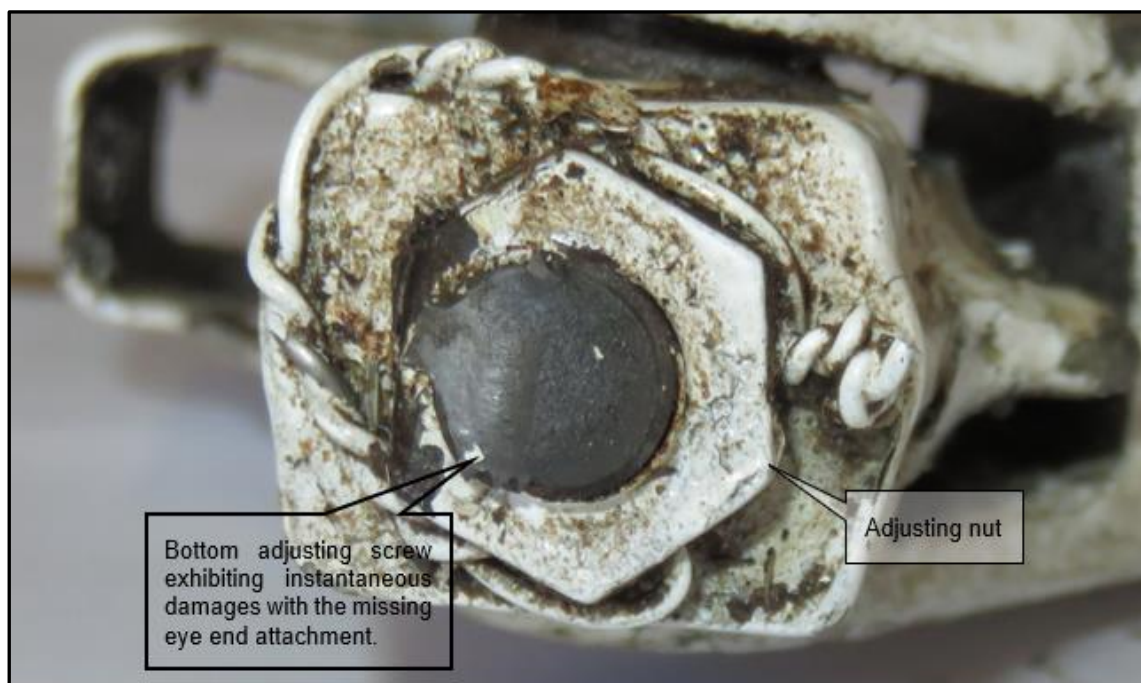
**Figure 12:** The damage on the bottom adjusting screw bolt attachment eye-end.

The failure indicates an instantaneous mode which resulted in the paint peeling off on both the adjusting nut inner part and the locking wire. This was likely caused during the excessive force which resulted from the retracting landing gear that was in 'down and locked' landing gear mode.

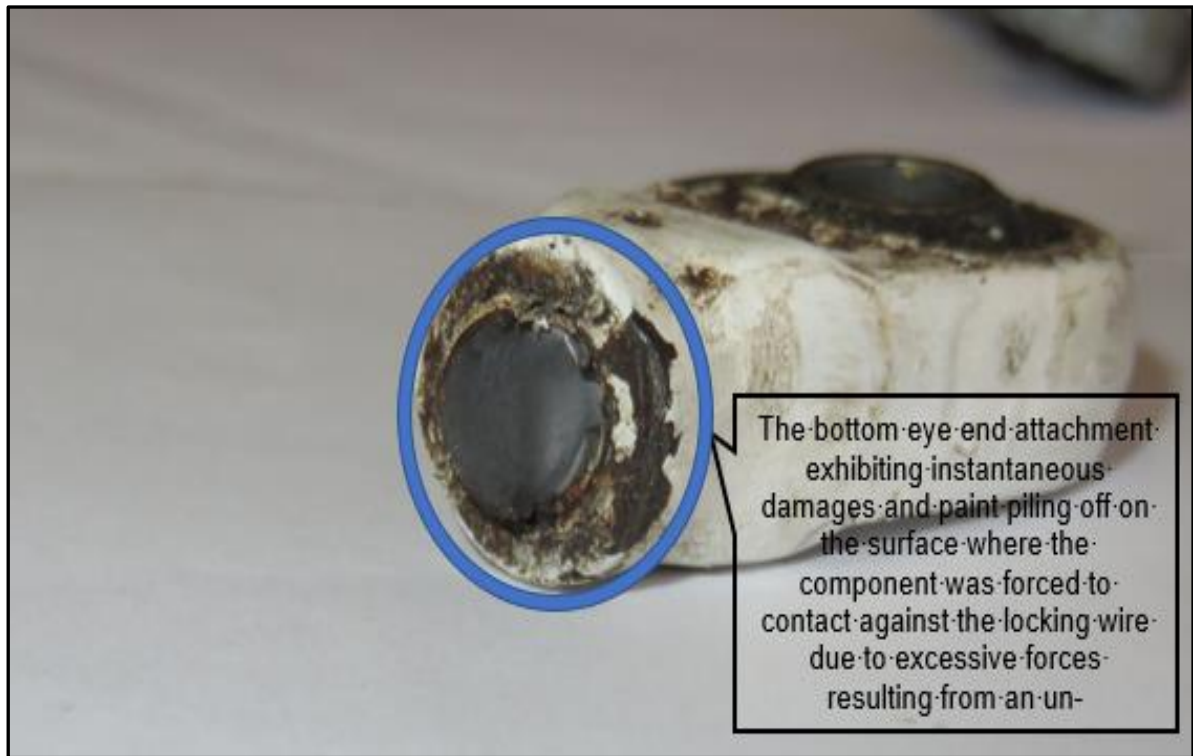
**Figure 13:** The bottom eye-end attachment.
