**LIMITED OCCURRENCE INVESTIGATION REPORT – FINAL**

<b>Reference Number</b>	CA18/2/3/10279						
<b>Classification</b>	Accident	<b>Date</b>	10 March 2023	<b>Time</b>	1010Z		
<b>Type of Operation</b>	Training (Part 141)						
<b>Location</b>							
Place of Departure	Lanseria International Airport (FALA), Gauteng Province		Place of Intended Landing	Lanseria International Airport (FALA), Gauteng Province			
Place of Occurrence	FALA Runway (RWY) 07						
GPS Co-ordinates	Latitude	25°55'53.50" S	Longitude	027°56'9.07" E	Elevation	4281.6 feet (ft)	
<b>Aircraft Information</b>							
Registration	ZS-FOH						
Make; Model; S/N	Piper PA28-140 (Serial number: 28-23935)						
Damage to Aircraft	Substantial		Total Aircraft Hours	9448.81			
<b>Pilot-in-command</b>							
Licence Type	Student Pilot Licence		Gender	Female		Age	19
Licence Valid	Yes	Total Hours	35.6		Total Hours on Type	35.6	
Total Hours past 30 Days	28.3		Total Flying Hours on Type Past 90 Days	28.3

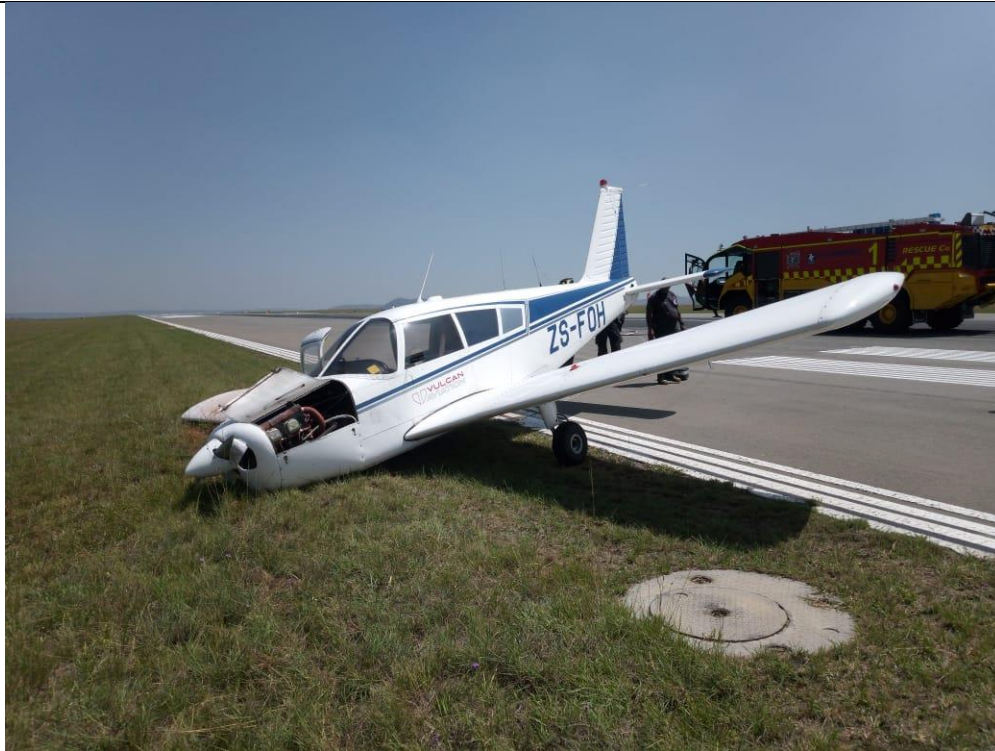
<b>People On-board</b>	1 + 0	<b>Injuries</b>	0	<b>Fatalities</b>	0	<b>Other (on ground)</b>	0
<b>What Happened</b>							
<p>On 10 March 2023, a student pilot (SP) on-board a Piper Cherokee PA28 with registration ZS-FOH was engaged in a training flight from Lanseria International Airport (FALA) in Gauteng province to the general flying area (GFA), with the intention to land back at FALA. The flight was conducted under visual meteorological conditions (VMC) by day and under the provisions of Part 141 of the Civil Aviation Regulations (CAR) 2011 as amended.</p> <p>Runway (RWY) 07 was in use at FALA at the time. The SP stated that she taxied the aircraft to RWY07 holding point whereafter FALA air traffic control (ATC) gave her take-off clearance. After lining up on the runway, she applied power to initiate the take-off roll. When the aircraft reached the take-off speed of approximately 65 miles per hour (mph), the SP pulled back on the yoke and the aircraft lifted off the ground. According to the SP, the aircraft stopped climbing and she could not understand the reason, thereafter, it lost lift and impacted the runway hard with the nose wheel first which separated from the aircraft. As a result, the aircraft veered off to the right of the runway and came to a stop at the edge of it.</p> <p>The SP was not injured during the accident. The aircraft sustained damage to the undercarriage, propeller and the right-side wing.</p>

**Figure 1:** The aircraft as it came to rest on the edge of the runway. (Source: FALA Fire Department)

The aircraft stalled during rotation which resulted in the aircraft impacting the runway.

Application of excessive back pressure during rotation.

1. The school arranged for the SP to undergo remedial action for 1.4 hours to correct her technique on circuits, circuits in controlled airspace, and emergencies in the circuits.

2. The ATO re-emphasised the DFE's concerns with the instructors to ensure that all students' seating positions are checked.
3. The ATO carried out check flights in two folds. Firstly, random students trained by the accident SP's instructor (the instructor who trained the accident SP) were assessed to observe if there was a similar trend related to flight safety. Secondly, random students of the Grade 3 instructors were assessed for overall lapses in flight safety or any trend that could result in a potential hazard. In both cases, no major risks were identified except for minor observations which were resolved through de-briefs and additional flights.

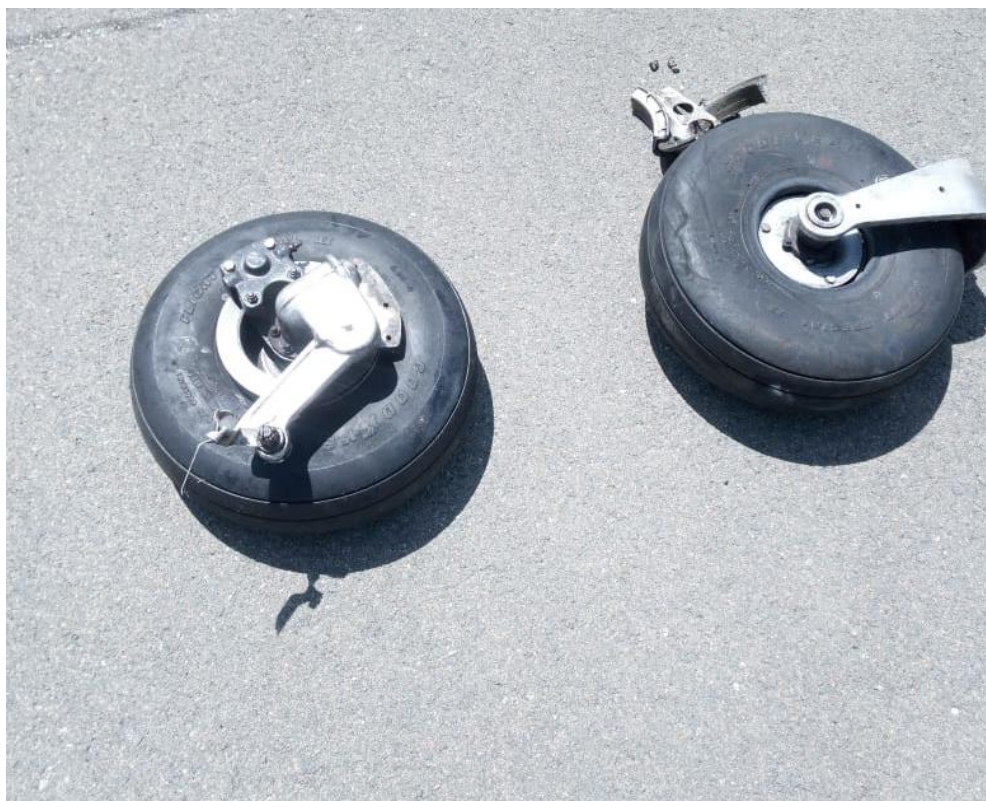
**Figure 2:** The nose and the right main wheels that separated during the accident. (Source: FALA Fire Department)
