LIMITED OCCURRENCE INVESTIGATION REPORT – FINAL

Reference Number	CA18/2/3/10281					
Classification	Accident	Date	29 March 2023	Time	0840Z	
Type of Operation	Non-Type Certified Aircraft (Part 94)					
Location						
Place of Departure	Gariep Dam Aerodrome (FAHV), Northern Cape Province		Place of Intended Landing	Potchefstroom Aerodrome (FAPS), North West Province		
Place of Occurrence	Runway 03 at FAPS, North West Province					
GPS Co-ordinates	Latitude	26°40'22.13" S	Longitude	027°04'54.07" E	Elevation	4 477 ft
Aircraft Information						
Registration	ZU-WDN					
Make; Model; S/N	Van's Aircraft, RV-8 (Serial Number: 83088)					
Damage to Aircraft	Substantial		Total Airframe Hours	51.5		
Pilot-in-command						
Licence Type	Airline Transport Pilot Licence (ATPL)		Gender	Male	Age	40
Licence Valid	Yes	Total Hours on Type	23.0	Total Flying Hours	10 984.0	
Total Hours 90 Days	94.0		Total Hours on Type Past 90 Days		15.0	
People On-board	1 + 1	Injuries	0	Fatalities	0	Other (on ground) 0

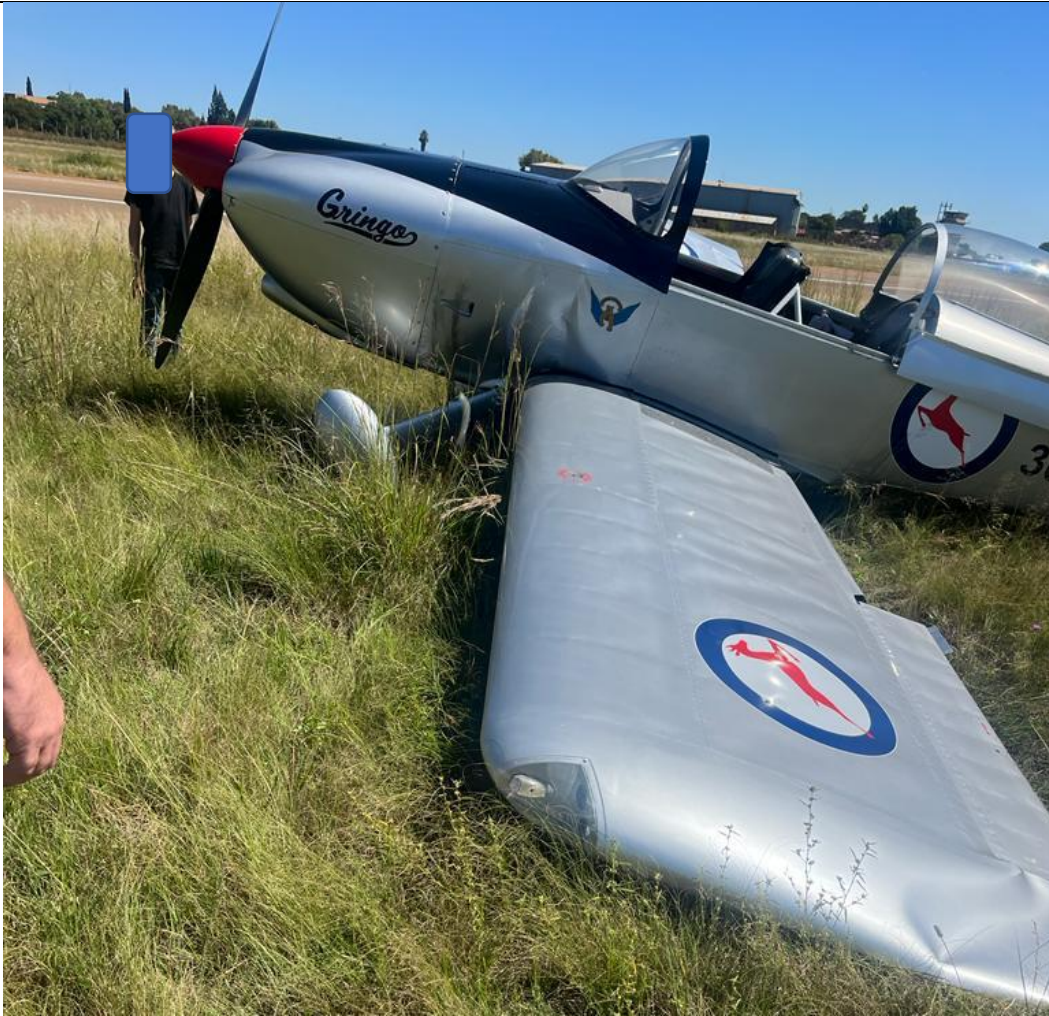
The flight from FAHV to FAPS was uneventful. As the pilot approached for landing, he assessed the wind which was blowing from the north-west (330°) at 12 knots gusting 15 knots. He then opted to land on Runway 03. The pilot stated that after touchdown during ground roll, the aircraft encountered a crosswind from the left which caused it to veer off to the right. He tried to maintain directional control, but the aircraft departed the runway surface approximately 500m from the threshold of Runway 03 and ground looped before it came to rest in the direction of landing. No person was injured during the accident. The aircraft sustained substantial damage.

Figure 2: The aircraft as it came to rest on the right side of Runway 03. (Source: AMO)

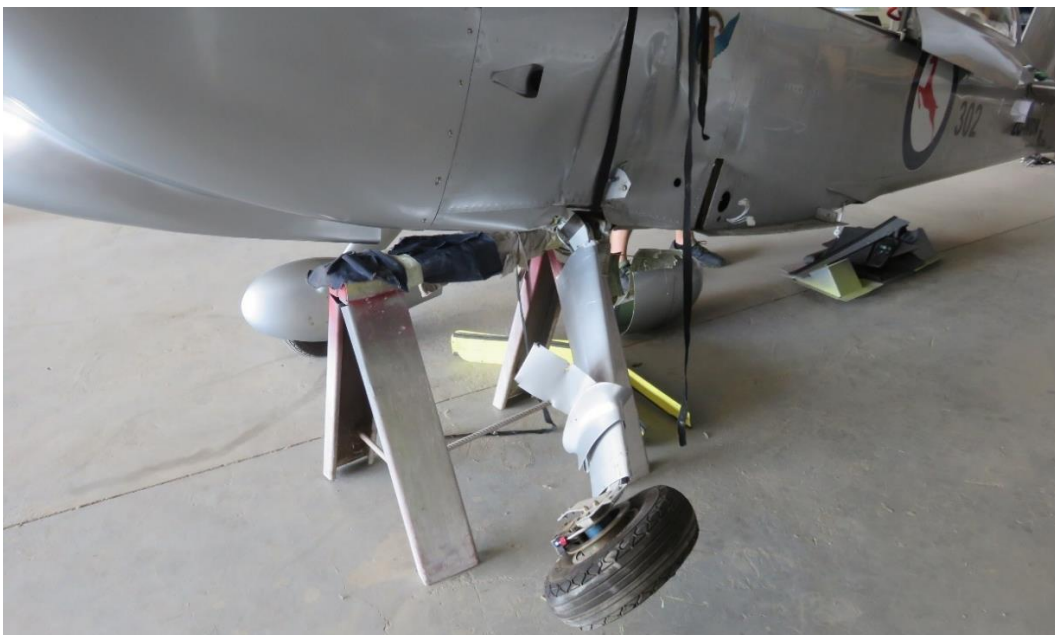
The left main gear collapsed and, as a result, substantial structural damage was caused to the fuselage and the left wing.

Figure 3: The damage caused to the left main gear.

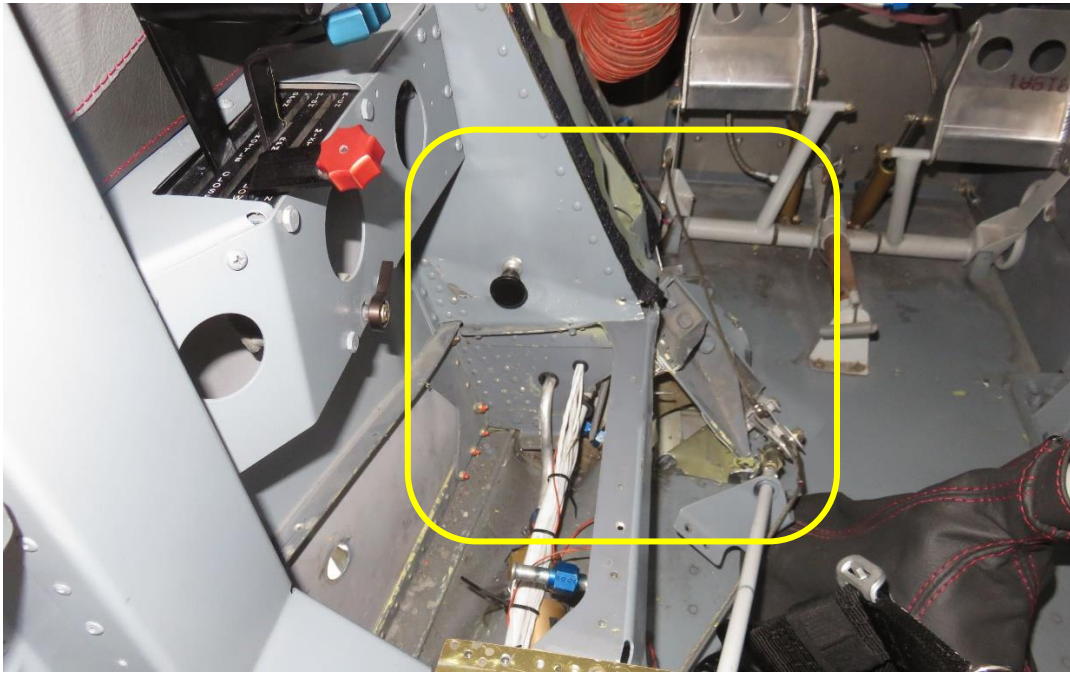
Figure 4: Structural deformation on the fuselage caused by the left main gear strut.

2.5 In addition to the external damage of the aircraft, it was noted that the left wing aft main spar was bent, which would require the wing to be replaced.

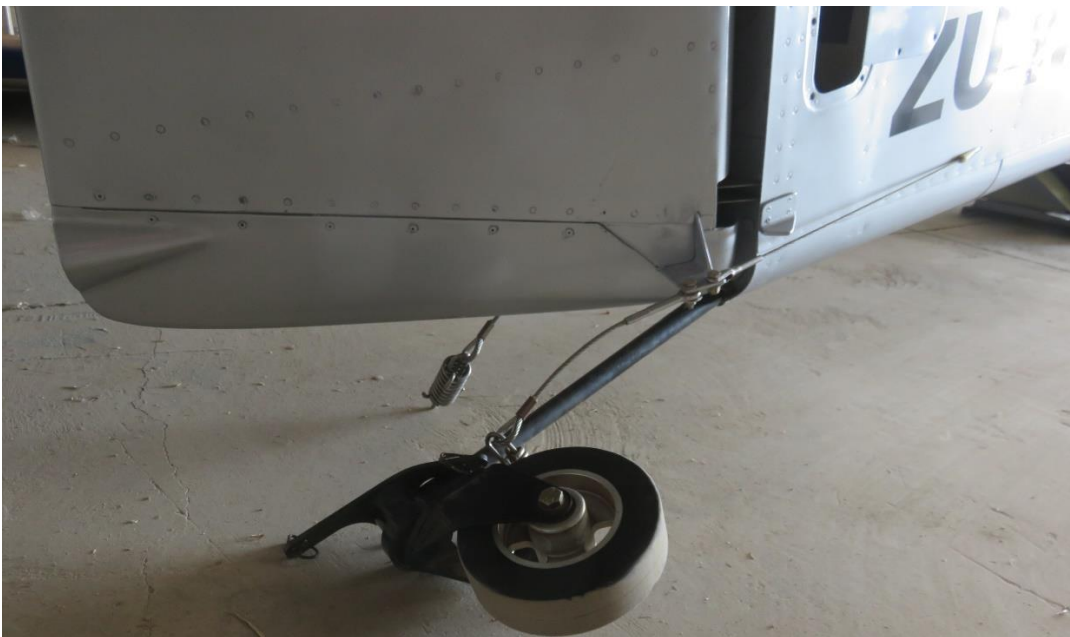
Figure 5: The tail wheel broke off during landing.

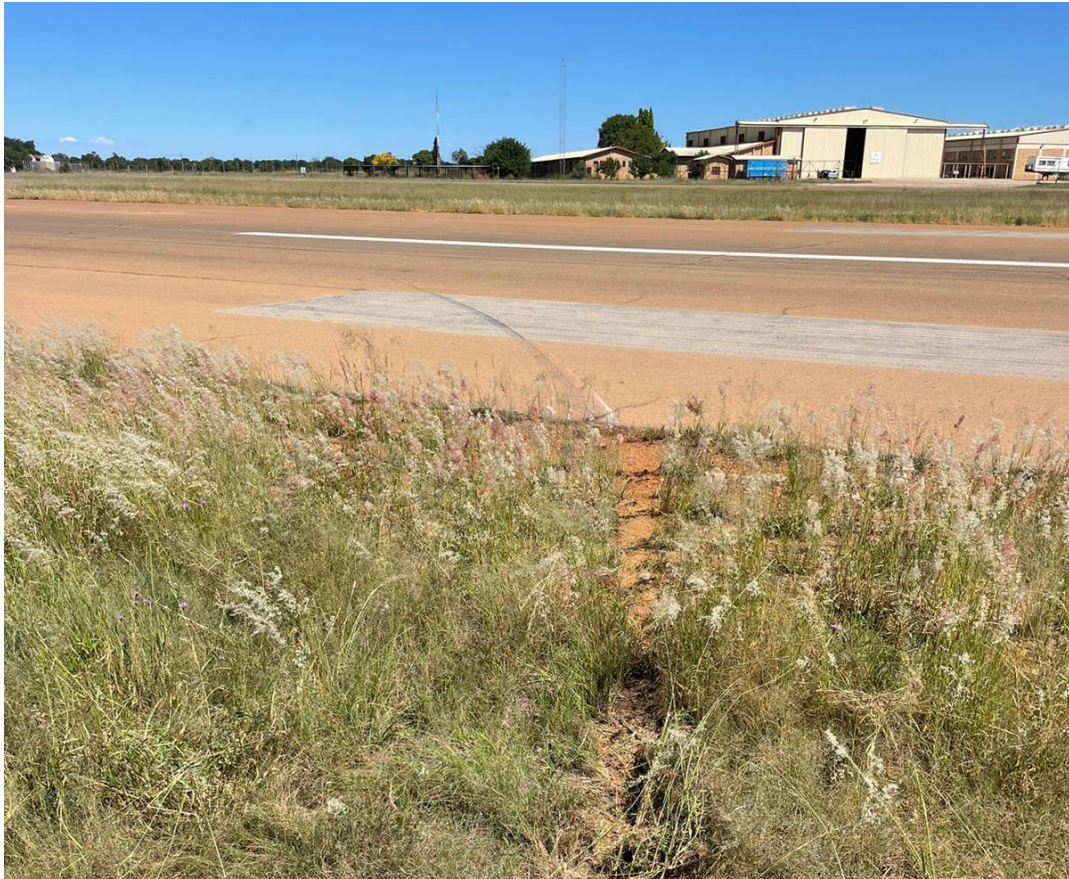
Figure 6: The left main tyre markings on the runway after the aircraft veered off.

4.2 According to the 'local' pilots who are familiar with FAPS, the area between the two sets of hangars usually funnels the wind when blowing from the north-westerly to the south-westerly direction. The hangar to the right in Figure 7 belongs to the SAPS Air Wing. The aircraft veered off the runway, approximately 30m past the taxiway (Figure 6). On the day of the accident, the wind was blowing from the north-west direction.

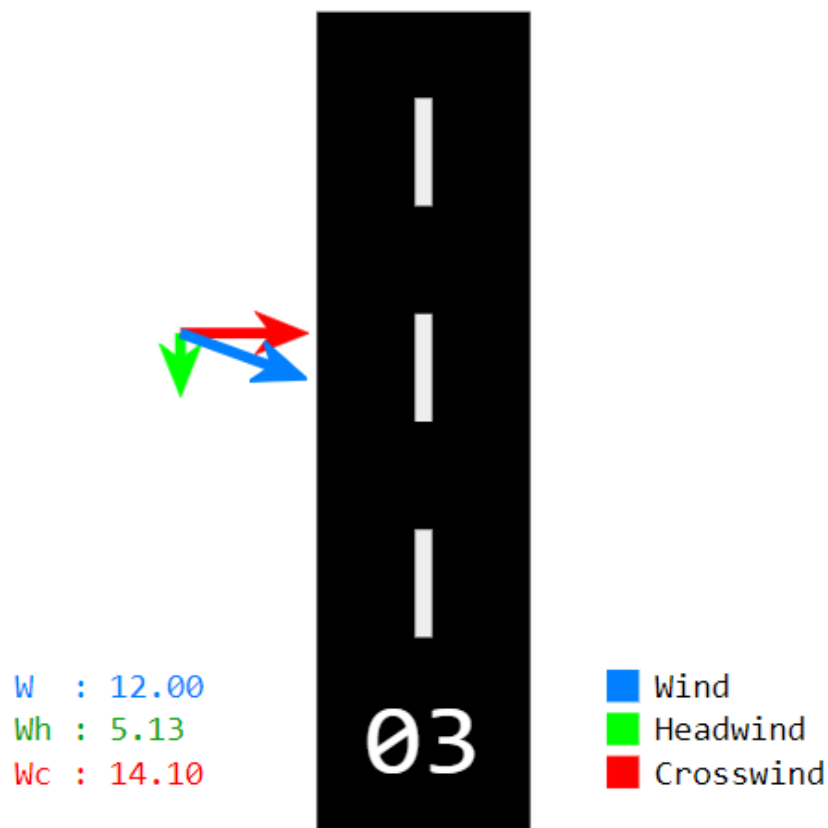
3.4 Crosswind Component (Source: www.e6bx.com/wind-components/)

The pilot opted to land on Runway 03. According to the pilot, the wind was 330° at 12 knots gusting 15 knots with a substantial crosswind component of 14 knots.

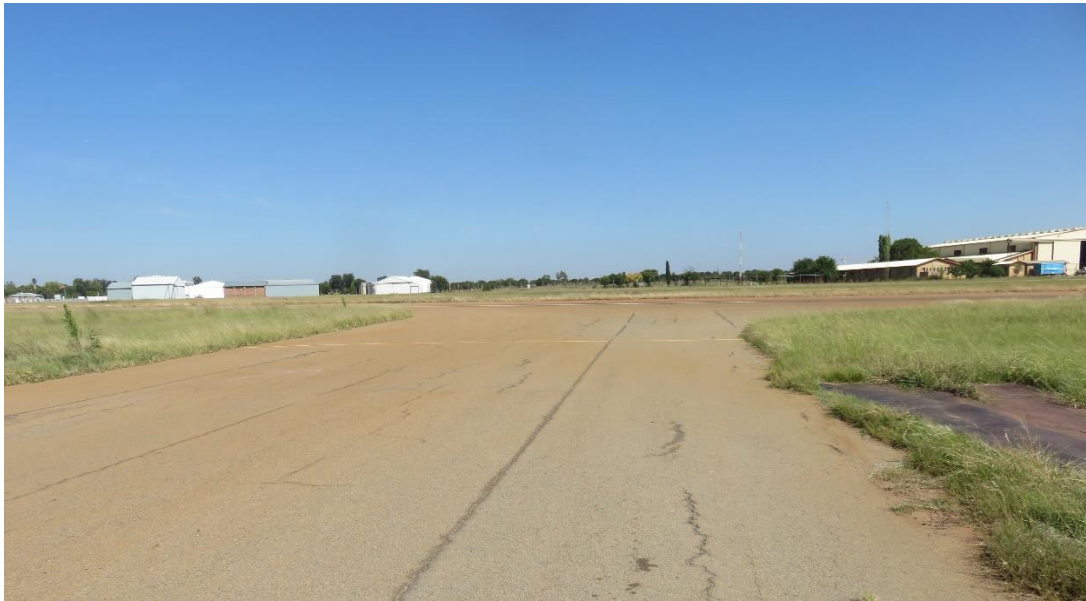
Figure 7: The area on the runway where pilots usually encounter a crosswind from the left.

The pilot overcompensated during landing by applying opposite rudder when he encountered a crosswind from the left, which caused the aircraft to veer off the runway to the right before it ground looped.
