AIRCRAFT ACCIDENT REPORT AND EXECUTIVE SUMMARY

Reference:		CA18/2/3/10282		
Aircraft Registration	ZU-DPK	Date of Accident	7 April 2023		Time of Accident	1445Z		
Type of Aircraft	TL-2000 Sting		Type of Operation		Private (Part 94)			
Pilot-in-command Licence Type	Commercial (A)		Age	55		Licence Valid	Yes	
Pilot-in-command Flying Experience	Total Flying Hours		1 900		Total Hours on Type		7.5	
Last Point of Departure	Potchefstroom Aerodrome (FAPS), North West Province							
Next Point of Intended Landing	Potchefstroom Aerodrome (FAPS), North West Province							
Damage to Aircraft	Substantial							
Location of the accident site with reference to easily defined geographical points (GPS readings if possible)								
Left side of Runway 03 at FAPS at GPS co-ordinates determined to be 26°40'13.16" South, 27°04'44.66" East at an elevation of 4 520 feet (ft)								
Meteorological Information	Surface Wind: 240°/01kt; Temperature: 28°C; Dew Point: 8°C; Visibility: 9999m

Reference Number : CA18/2/3/10282
Occurrence Category : Accident (Category 1)
Type of Operation : Private (Part 94)
Aircraft Registration : ZU-DPK
Aircraft Make and Model : TL Ultralight, TL-2000 Sting
Nationality : South

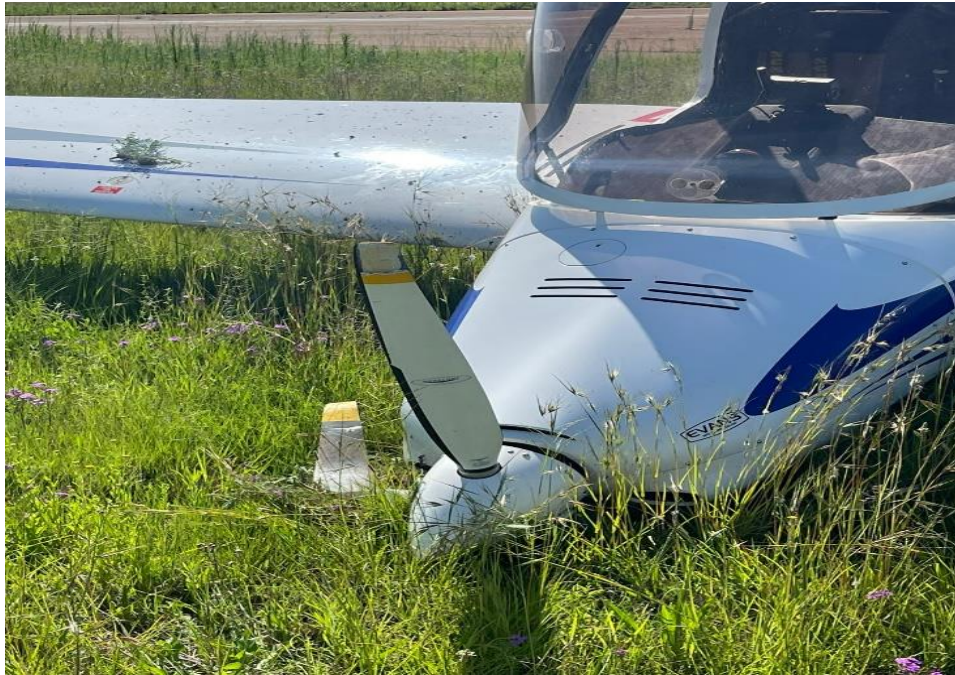
1.3.1. The aircraft sustained substantial damage.

Figure 1: The aircraft post-accident. (Source: Pilot)

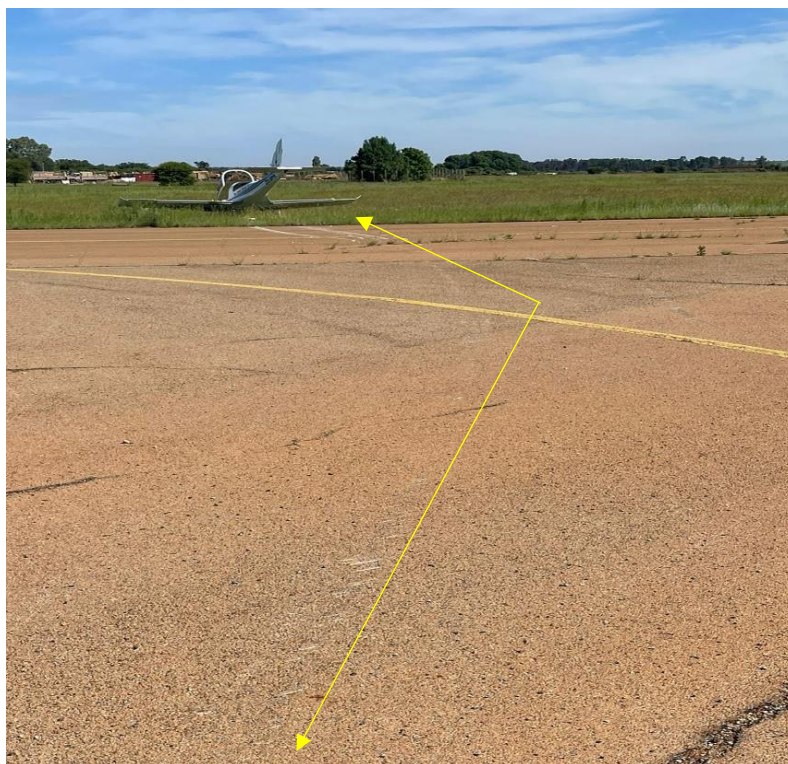
Figure 3: The aircraft on the left side of the runway. (Source: Pilot)

1.12.1. The pilot completed a circuit and approached Runway 03 at 012° magnetic heading. After touchdown, the nose gear strut bent to the right before it broke off and the aircraft skidded on the bottom engine cowling as it veered off to the left of the runway and onto the grass where it came to a stop.

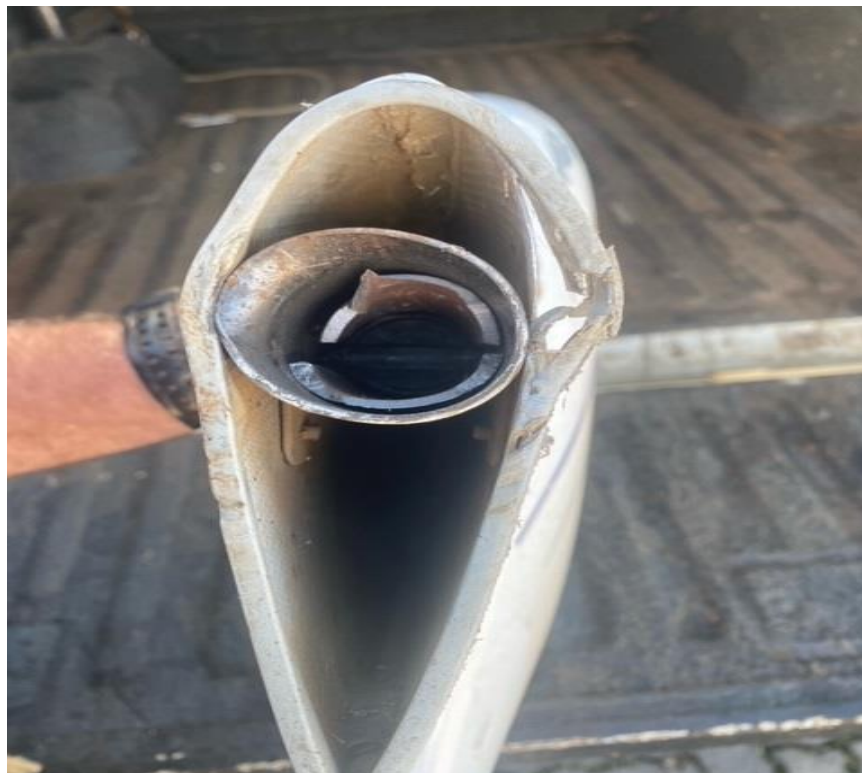
Figure 5: The nose gear strut. (Source: Pilot)

1.16.1 Post-accident examination of the nose gear wheel assembly, the fork and strut were performed by the SACAA approved person (AP) at the aircraft maintenance organisation (AMO) facility; nothing abnormal was noted during this examination. The broken nose gear strut was taken to a metallurgist for visual inspection, and no evidence of fatigue-induced or inherent failures were noted.

- 3.4.1. The pilot seemed to have landed the aircraft with the nose wheel not aligned to the direction of travel which caused the nose gear strut to bend due to overload; this contributed to loss of directional control to the left of the runway before the nose wheel broke off.
