LIMITED OCCURRENCE INVESTIGATION REPORT – FINAL

Reference Number	CA18/2/3/10283						
Classification	Accident	Date	12 April 2023		Time	0630Z	
Type of Operation	Training (Part 141)						
Location							
Place of Departure	Ballito Airfield, KwaZulu-Natal Province		Place of Intended Landing	Ballito Airfield, KwaZulu-Natal Province			
Place of Occurrence	On Runway 08 at Ballito Airfield, KwaZulu-Natal Province						
GPS Co-ordinates	Latitude	29° 29'20.05"S	Longitude	31°10'40.98."E	Elevation	235 ft	
Aircraft Information							
Registration	ZU-DJR						
Make; Model; S/N	Solo Wings; Windlass Aquilla Trike (Serial Number: WA 1010)						
Damage to Aircraft	Substantial		Total Aircraft Hours	186.6			
Pilot-in-command							
Licence Type	National Pilot Licence (NPL)		Gender	Male		Age	66
Licence Valid	No	Total Hours	149		Total Hours on Type	128.7	
Total Hours 30 Days	6.8		Total Flying on Type Past 90 Days	6.8			
People On-board	1+0	Injuries	0	Fatalities	0	Other (on ground)	0

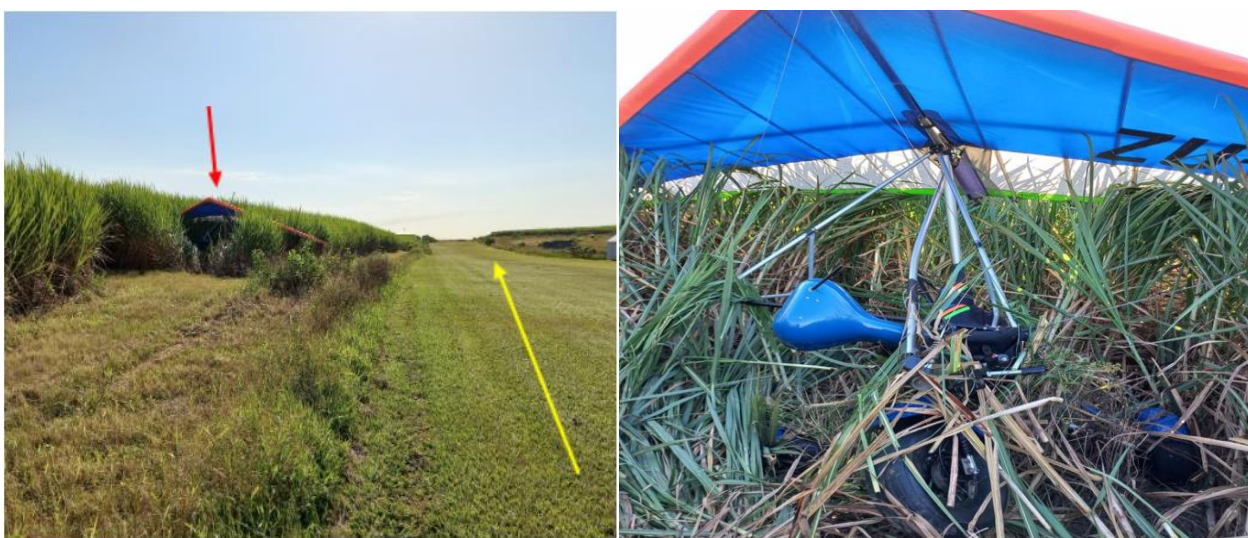
The pilot decided to conduct a go-around but the microlight veered further to the left and, as a result, the left wing clipped the sugar cane and the microlight spun 180° before it came to a stop in the sugar cane field.

Figures 1 and 2: The red arrow shows the Windlass Aquilla Trike at the accident site and the yellow arrow shows the direction of landing (Source: Operator).

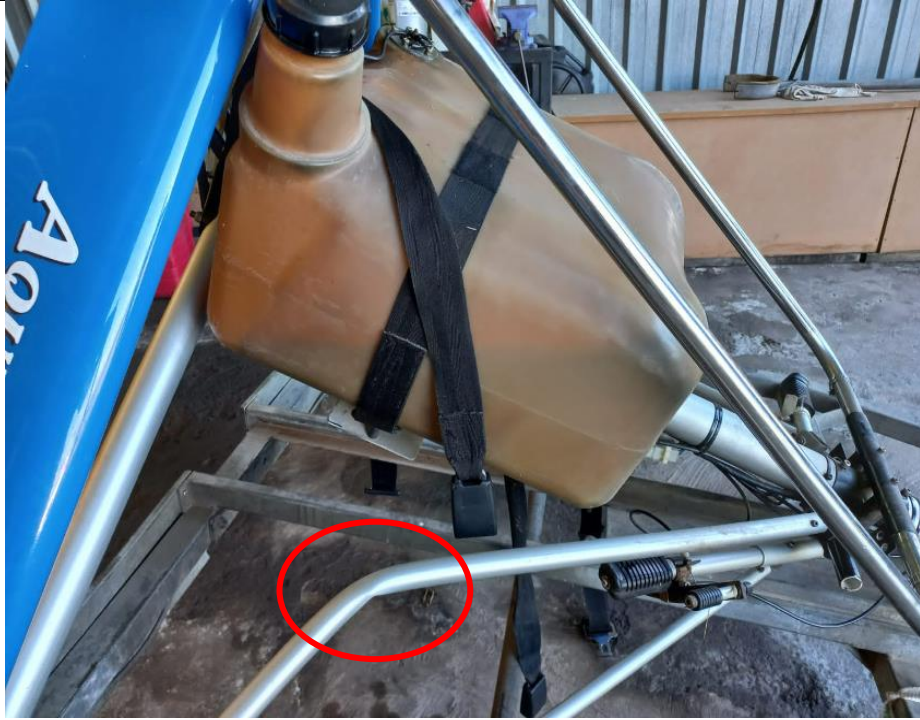
- The microlight had visible damage to the nose landing gear and the right main landing gear. The bowsprit and the drag link on the right undercarriage broke during the accident, and the two propeller blades were damaged.

Figure 3: The bent right bowsprit. (Source: Operator)

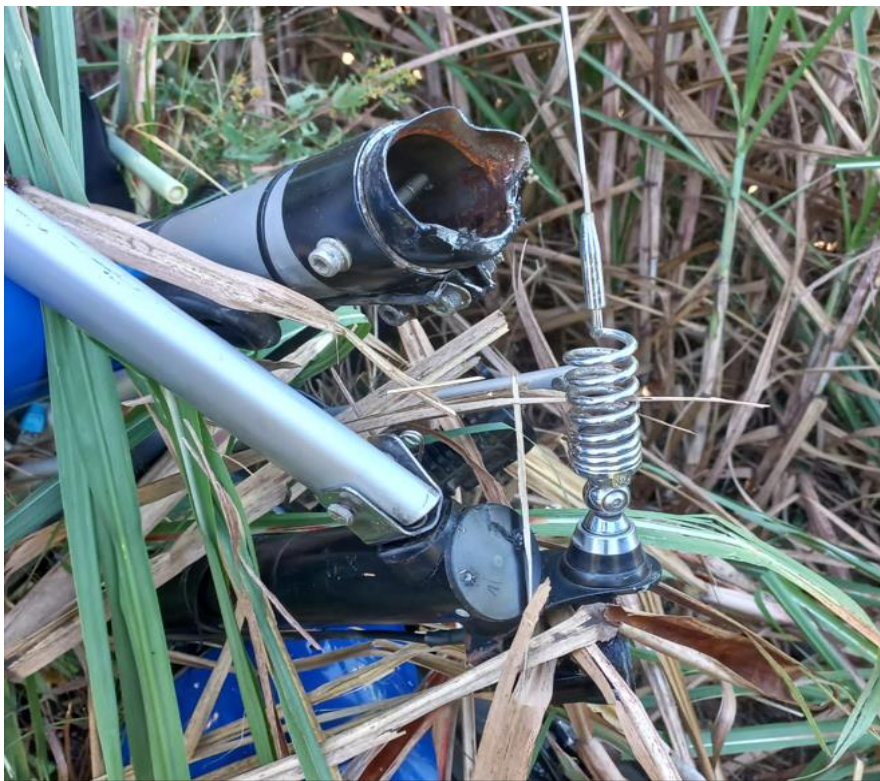
Figure 4: The broken bowsprit. (Source: Operator)

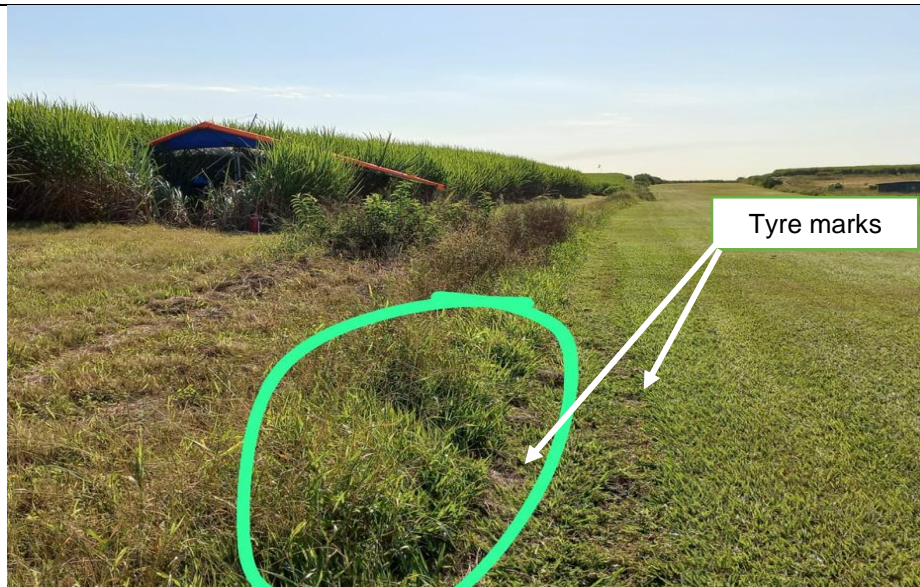
What Happened							
<p>On Wednesday morning, 12 April 2023 at approximately 0400Z, a pilot on-board a Windlass Aquilla Trike with registration ZU-DJR took off on a training flight from Runway 08 at Ballito Airfield in KwaZulu-Natal province with the intention to perform circuit-and-landing exercises at the same airfield in preparation for the renewal of his National Pilot Licence (NPL). Visual meteorological conditions (VMC) by day prevailed at the time of the flight, and the pilot had filed a flight plan. The flight was conducted under the provisions of Part 141 of the Civil Aviation Regulations (CAR) 2011 as amended.</p> <p>On the morning of 12 April 2023, the pilot's instructor stated that 12 dual circuit training exercises were completed with the pilot which took 0.8 hours (48 minutes) prior to the accident flight. Later, the pilot conducted 10 solo circuits which lasted approximately 0.7 hours (42 minutes), followed by a 30-minute rest. Thereafter, the pilot conducted three uneventful circuit-and-landing exercises whilst flying solo. During the fourth circuit, the approach was unstable when the pilot landed the microlight on the grass-covered Runway 08. The microlight was travelling at a speed of 45 miles per hour (mph) (39 knots [kts]) when the pilot lost directional control and the microlight landed to the left of the runway's centreline. The left main wheel rolled over tall grass on the side of the runway edge, which</p>

was approximately 30 centimetres (cm) in height. This caused the drag on the left side of the microlight.

Figure 5: The circle shows the long grass. (Source: Operator)

- On the day of the accident, the grass was dry. The runway surface condition was suitable for use, however, the terrain along the runway edge was unsuitable.

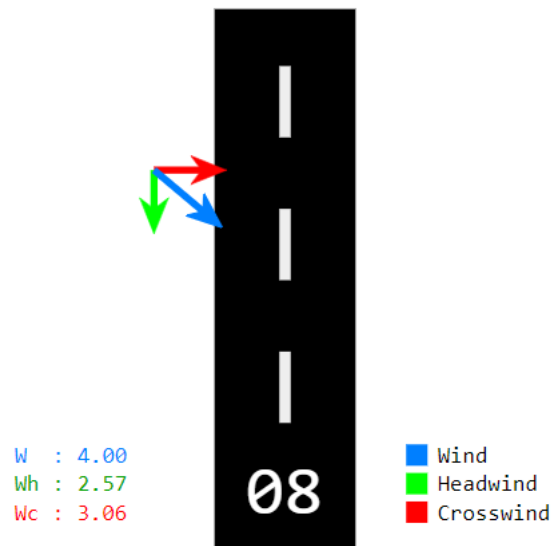
Wind Direction	030°	Wind Speed	04 kt	Visibility	9999 m
Temperature	22°C	Cloud Cover	Nil	Cloud Base	Nil
Dew Point	unknown	QNH	unknown

Figure 7: The crosswind component as per the weather report. (Source: <https://e6bx.com>)
