LIMITED OCCURRENCE INVESTIGATION REPORT – FINAL

Reference Number	CA18/2/3/10284					
Classification	Accident	Date	13 April 2023	Time	0900Z	
Type of Operation	General Aviation and Operating Flight Rules – Game Capture Operation (Part 91)					
Location						
Place of Departure	Zoutpan Farm, Baltimore District, Limpopo Province		Place of Intended Landing	Zoutpan Farm, Baltimore District, Limpopo Province		
Place of Occurrence	Bushy terrain on Zoutpan Farm, Baltimore District, Limpopo Province					
GPS Co-ordinates	Latitude	23°10'18.53" S	Longitude	028°24'39.27" E	Elevation	3 100 ft
Aircraft Information						
Registration	ZT-RWJ					
Make; Model; S/N	Schweizer 269C (Serial Number: S1507)					
Damage to Aircraft	Substantial		Total Airframe Hours	2 390.7		
Pilot-in-command						
Licence Type	Commercial Pilot Licence (CPL)			Gender	Male	Age 35
Licence Valid	Yes	Total Hours on Type	969.0	Total Flying Hours	4 344.0	
Total Hours 90 Days	84.0		Total Hours on Type Past 90 Days	84.0

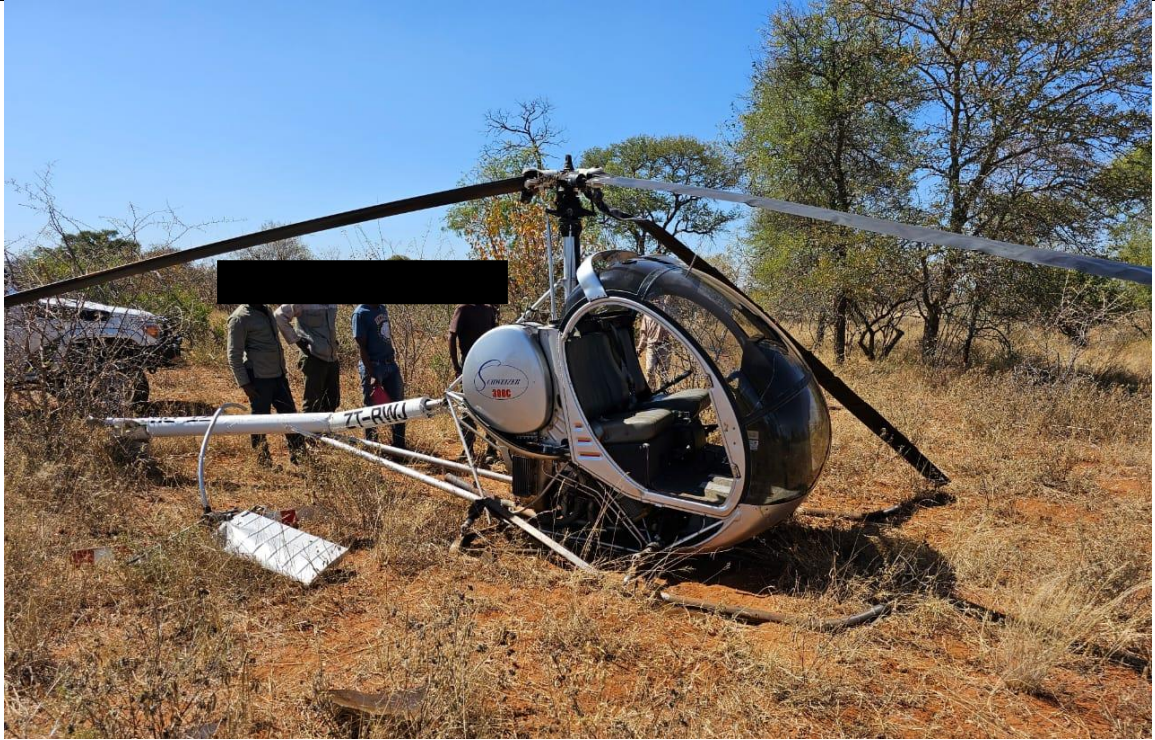
Figure 2: The helicopter as it came to rest. (Source: Pilot)

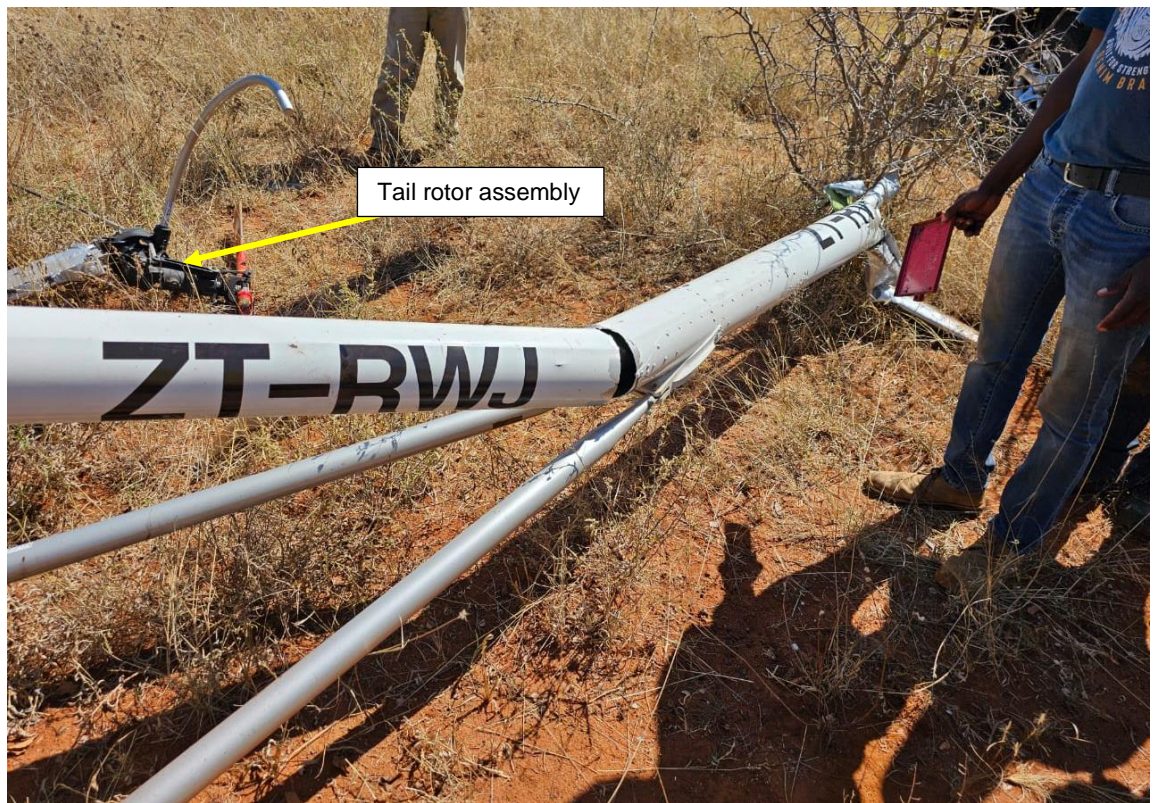
The helicopter touched down hard and as a result, the skid gear collapsed (flattened outwards) and the tail rotor drive assembly broke off and separated from the tail boom (see Figure 3).

Figure 3: The damaged tail boom and the tail rotor drive assembly. (Source: Pilot)

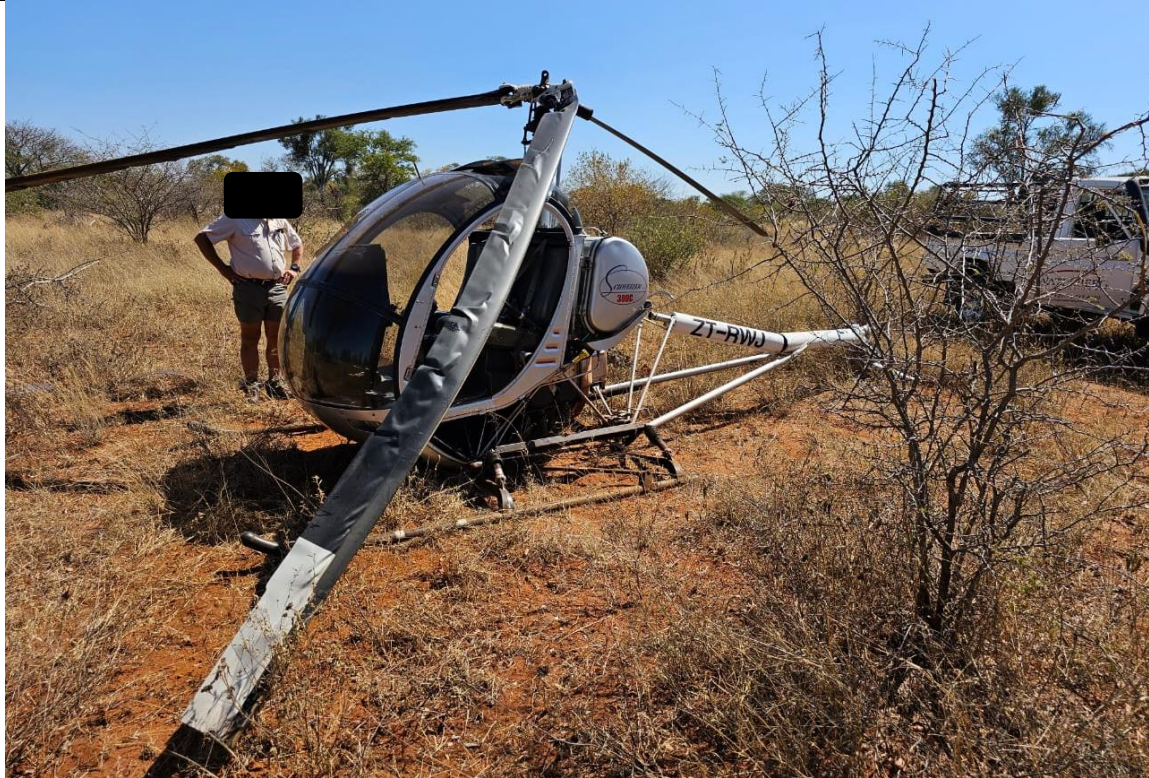
Figure 4: The damaged main rotor blades. (Source: Pilot)

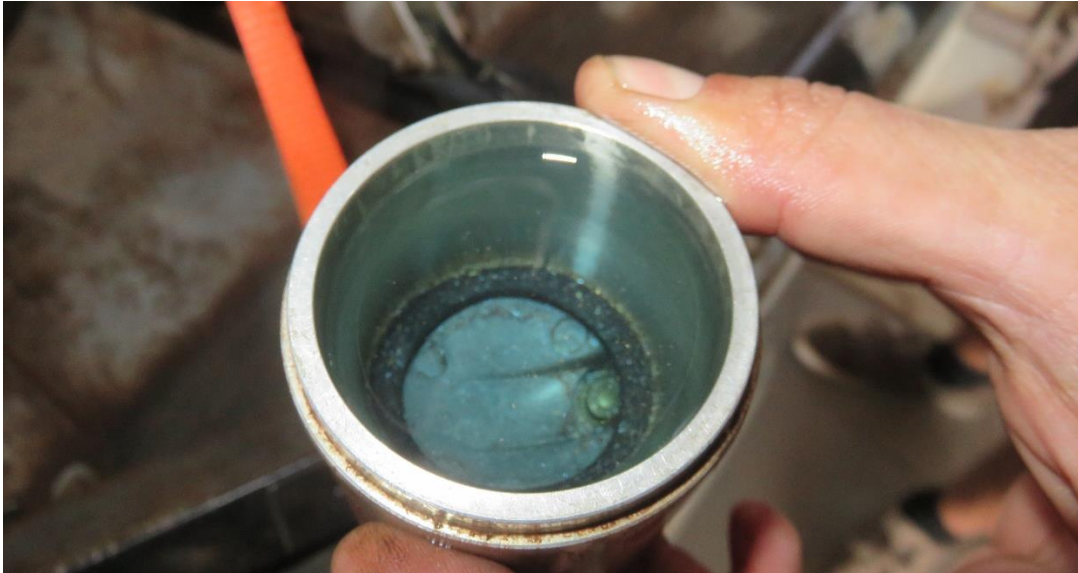
- 4.1 On-site investigation was not conducted; however, a follow-up inspection was carried out on 19 April 2023 following the recovery of the helicopter to an approved aircraft maintenance organisation (AMO). It was noted that there was no damage to the engine/components or anomaly on the helicopter fuel, induction or electrical system. The gascolator, which was undamaged was removed and inspected; the fuel inside of the gascolator was of the correct grade (Avgas 100LL) and was free of contamination. The screen type filter within the unit was clean. The gascolator was replaced, and an engine ground run with the engine in the airframe

Figure 5: Gascolator with fuel in it.

4.2 With the evidence presented during the post-recovery investigation, no evidence could be found to support the pilot's recollection that the engine stopped in operation during flight, which necessitated a forced landing.
