LIMITED OCCURRENCE INVESTIGATION REPORT – FINAL
--

Reference Number	CA18/2/3/10285						
Classification	Accident	Date	15 April 2023	Time	1417Z		
Type of Operation	Private (Part 94)						
Location							
Place of Departure	Parys Aerodrome (FAPY), Free State Province		Place of Intended Landing	Parys Aerodrome (FAPY), Free State Province			
Place of Occurrence	Open field near Parys Aerodrome (FAPY), Free State Province						
GPS Co-ordinates	Latitude	26° 53' 51.8" S	Longitude	027° 30' 01.91" E	Elevation	4646 ft	
Aircraft Information							
Registration	ZU-WAS						
Make; Model; S/N	PZL "Warszawa-Okecie" PZL-104 Wilga 35 (Serial Number: KA86229)						
Damage to Aircraft	Substantial		Total Aircraft Hours	1275.12			
Pilot-in-command							
Licence Type	Private Pilot Licence (PPL)		Gender	Male	Age	32	
Licence Valid	Yes	Total Hours	2202.48		Total Hours on Type	17.30	
Total Hours 30 Days	39.42		Total Flying on Type Past 90 Days	8.12			
People On-board	1+0	Injuries	0	Fatalities	0	Other (on ground)	0

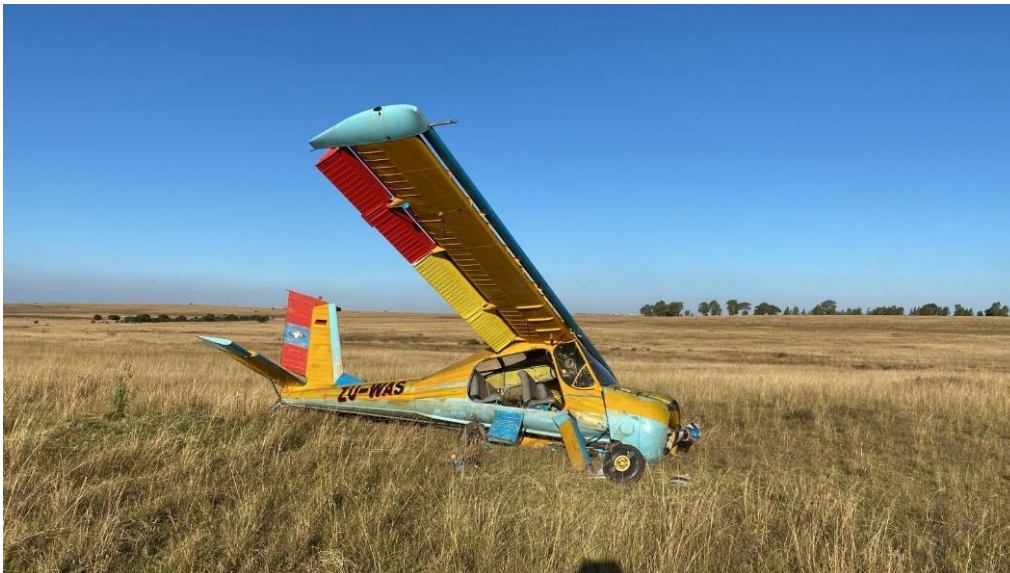
Figure 2: The aircraft at the accident site. (Source: Operator)

5. The Certificate of Registration (C of R) was issued to the present owner on 9 April 2019.
6. The pilot stated that shortly after take-off, the engine had a partial power loss, and the RPM reduced from 2000 to 1000. Thereafter, the aircraft could not maintain altitude. The pilot elected to execute a precautionary landing on an open field ahead of his flight path. During the landing roll, the left main wheel rolled over a ditch and bent, and thus, the left wing impacted the ground, and the propeller struck the ground before the aircraft stopped.

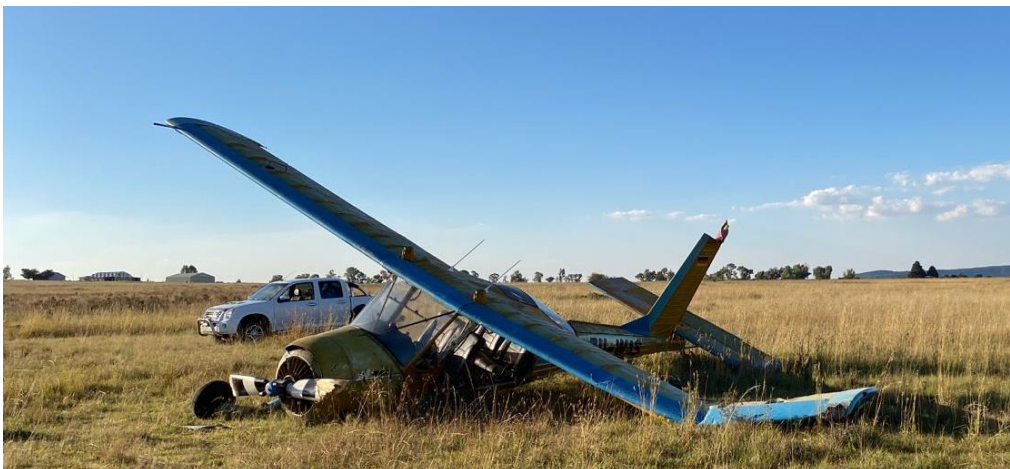
What Happened							
<p>On 15 April 2023, a pilot on-board a PZL "Warszawa-Okecie" aircraft with registration ZU-WAS took off on a private flight from Parys Aerodrome (FAPY) in the Free State province with the intention to land at the same aerodrome. The flight was conducted under visual meteorological conditions (VMC) by day and under the provisions of Part 94 of the Civil Aviation Regulations (CAR) 2011 as amended.</p> <p>The pilot reported that he conducted a pre-flight inspection and found no anomalies. He then taxied the aircraft to Runway 24 for take-off. The aircraft took off at 1415Z, turned left and climbed. Shortly thereafter, the engine experienced a partial power loss and the revolutions per minute (RPM) dropped from 2000 to 1000. As a result, the aircraft could not maintain height. The pilot elected to execute a precautionary landing on an open field ahead of the flight path. During the landing roll, the left main gear rolled over a ditch which caused it to bend; the left wing impacted the ground, and the propeller struck the ground before the aircraft came to a stop. The pilot switched off the master switch and disembarked from the aircraft unassisted.</p> <p>The aircraft sustained damage to the left wing, both main gears, propeller blades, engine cowling and elevator.</p>

Figure 3: The left view showing the damaged wing. (Source: Operator)
