LIMITED OCCURRENCE INVESTIGATION REPORT – FINAL

Reference Number	CA18/2/3/10286							
Classification	Accident		Date	30 September 2022		Time	0736Z	
Type of Operation	Remotely Piloted Aircraft System Surveillance (Part 101) Areal Mapping							
Location								
Place of Departure	Cooke Randfontein Surface Operations (RSO) Mine Dump, Randfontein, Gauteng Province			Place of Intended Landing	Cooke Randfontein Surface Operations (RSO) Mine Dump, Randfontein, Gauteng Province			
Place of Occurrence	Cooke Randfontein Surface Operations (RSO) Mine Dump 38, Randfontein							
GPS Co-ordinates	Latitude	26°08'04.26" S		Longitude	027°42'36.90" E		Elevation	3145 ft
Aircraft Information								
Registration	ZT-UKH							
Make; Model; S/N	DJI; Phantom 4 (Serial Number: P40016)							
Damage to Aircraft	Substantial			Total Aircraft Hours	323.32			
Pilot-in-command								
Licence Type	Remote Pilot Licence (RPL)		Gender	Male		Age	26	
Licence Valid	Yes	Total Hours		13.26	Total Hours on Type		13.26

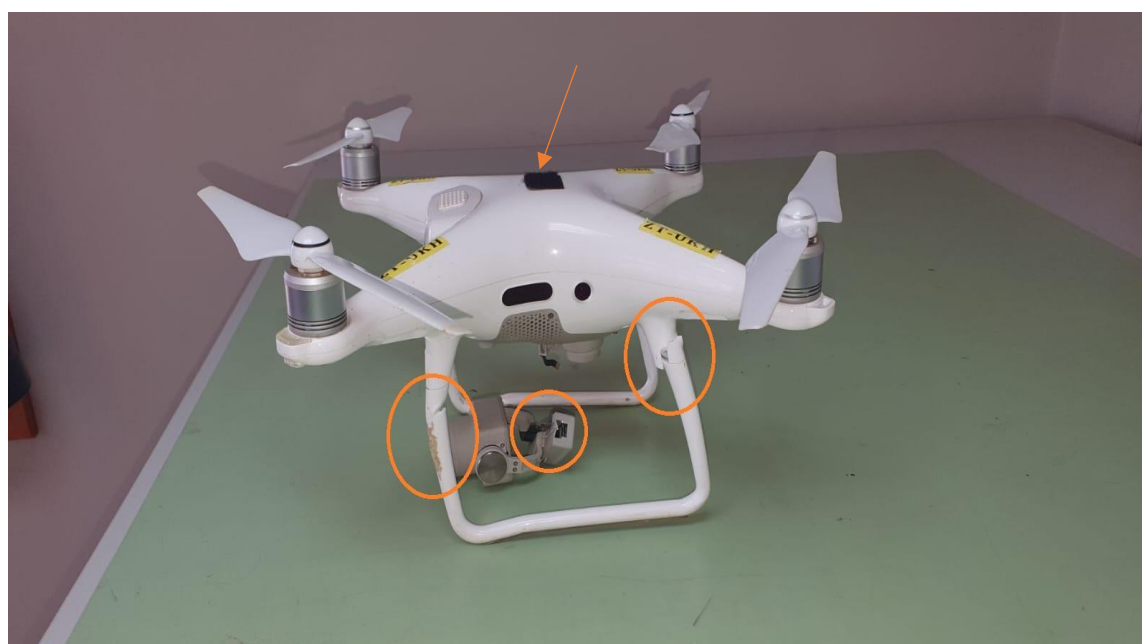
The pilot drove to the last known position of the RPA and located it on the ground, approximately 0.3 nautical miles south-west of the launch site with substantial damage to the landing skids and camera. There were no injuries to persons reported on the ground.

Figure 2: Damage to the aircraft (circled in orange). The orange arrow shows the Trackimo tracking module attachment point. (Source: Operator)

Secondary GPS device on the RPA interfered with or reduced GPS signal strength.

Positioning of GPS tracking device.

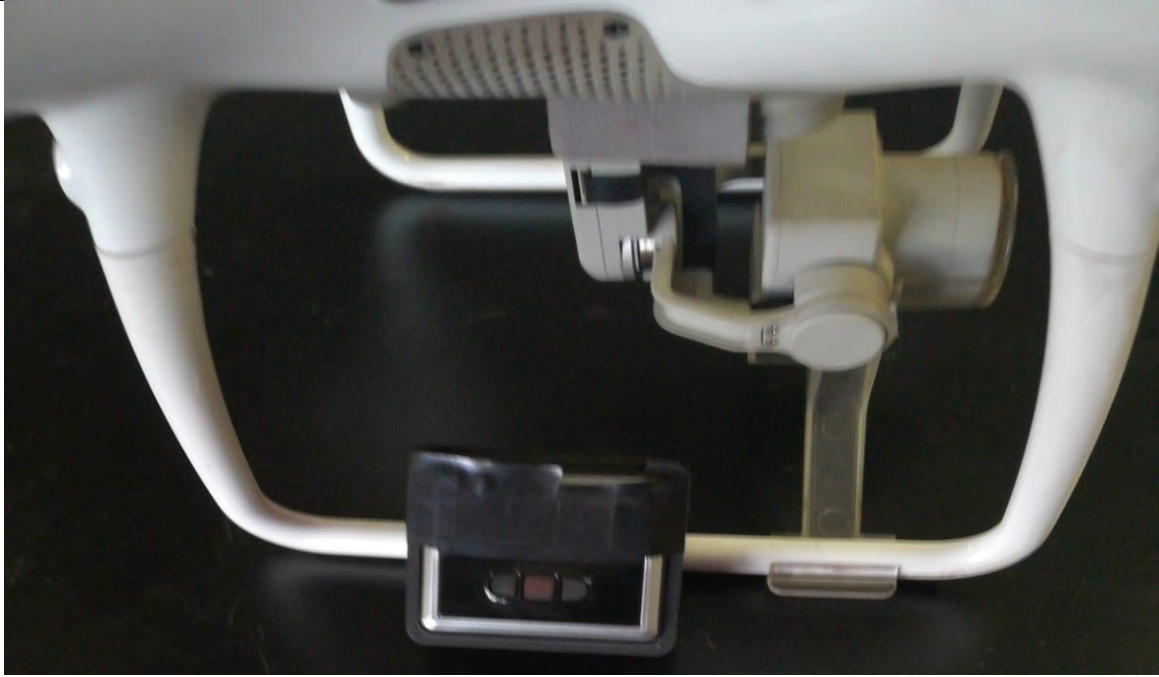
Figure 3: The new position of the Trackimo tracking module in a 3D printed holder attached to the skid.
(Source: Operator)

- 1. The aircraft stopped mid-air during a mapping (surveillance) flight.*
- 2. The pilot-in-command (PIC) attempted to initiate 'ATTI' (attitude) mode and RTL to no avail.*
- 3. The aircraft was located approximately 0.3 nm south-west of the launch site, crashed.*
- 4. The tracking module was placed in a 3D printed holder and attached on the skids to limit Global Positioning System (GPS) signal interference (Figure 3).*

The operator relocated the Trackimo module to reduce GPS signal interference.

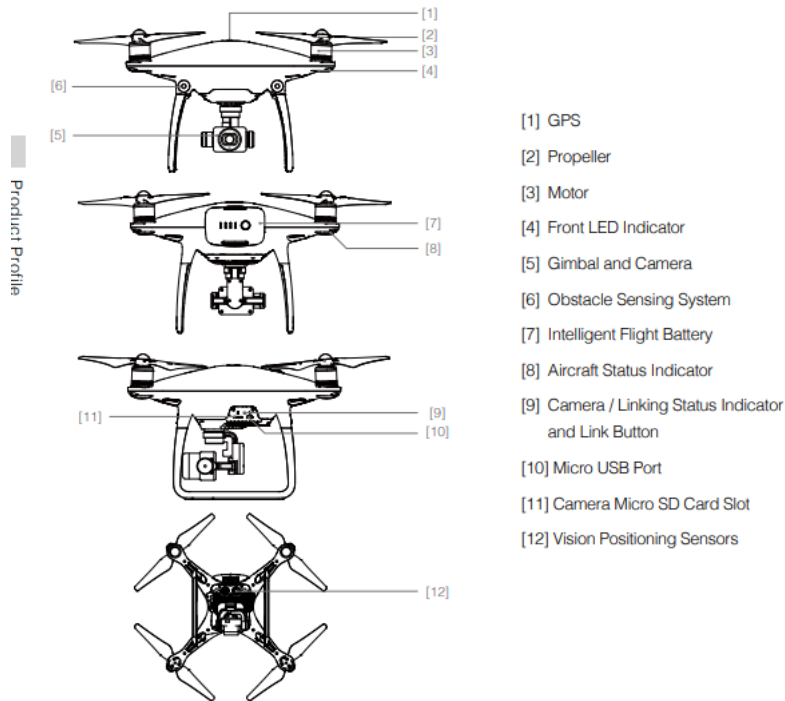
Illustration 1: The position of the GPS sensor (1). (Source: Aircraft User Manual)
