HELICOPTER ACCIDENT REPORT AND EXECUTIVE SUMMARY

Reference:		CA18/2/3/10288	
Aircraft Registration	ZS-HKC	Date of Accident		19 April 2023		Time of Accident	1145Z
Type of Aircraft	Guimbal Cabri G2			Type of Operation		Training (Part 141)	
Pilot-in-command Licence Type		Commercial Pilot Licence		Age	25	Licence Valid	Yes
Pilot-in-command Flying Experience		Total Flying Hours		432.9		Hours on Type	209.9
Last Point of Departure		Mossel Bay Aerodrome (FAMO), Western Cape Province					
Next Point of Intended Landing		Mossel Bay Aerodrome (FAMO), Western Cape Province					
Damage to Helicopter		Substantial					
Location of the accident site with reference to easily defined geographical points (GPS readings if possible)							
Open field (farmland) approximately 1.6nm west of FAMO (GPS co-ordinates: 34°09'21.10" South 022°01'36.80" East)							
Meteorological Information		Surface wind; 260°/3kt, temperature; 21°C, dew point; 16°C, CAVOK					
Number of People On-board	2 + 0	Number of People Injured	1	Number of People Killed	0	Other (On Ground)	0

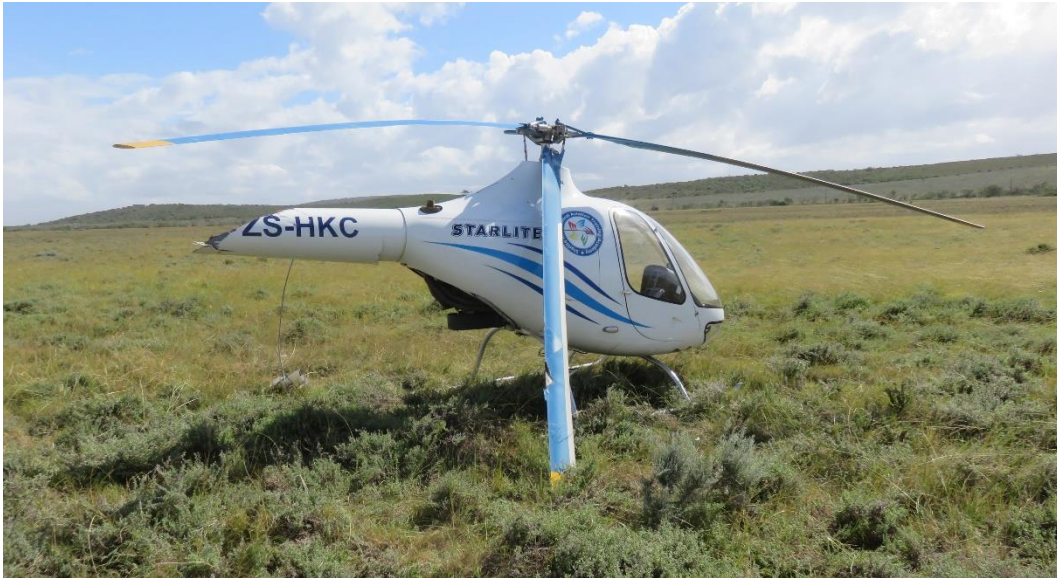
1.3.1 The helicopter's main rotor blades severed the tail boom.

Figure 2: The helicopter as it came to rest.

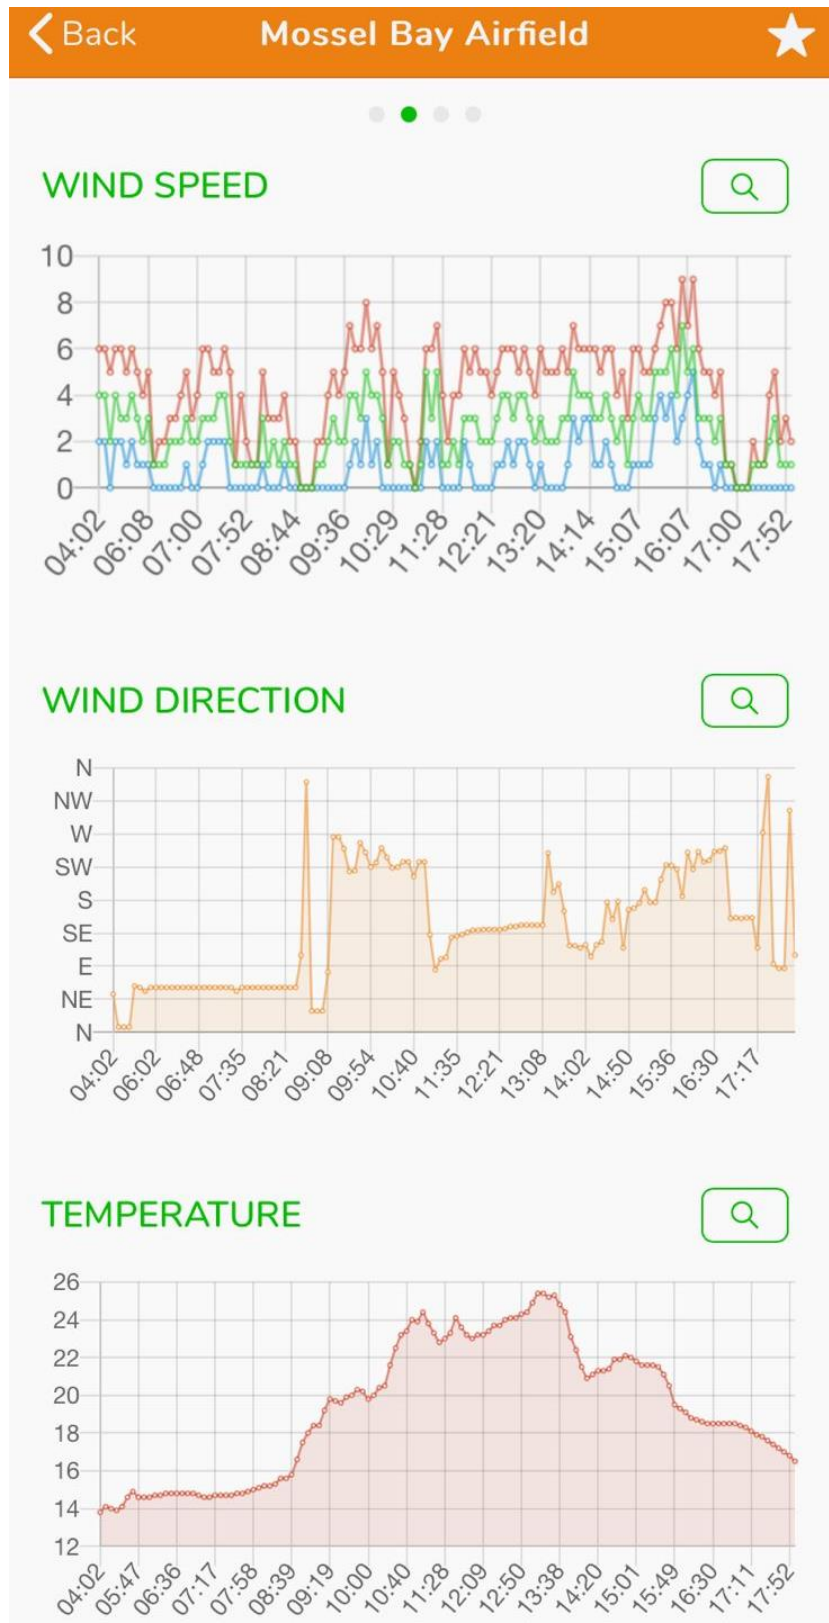
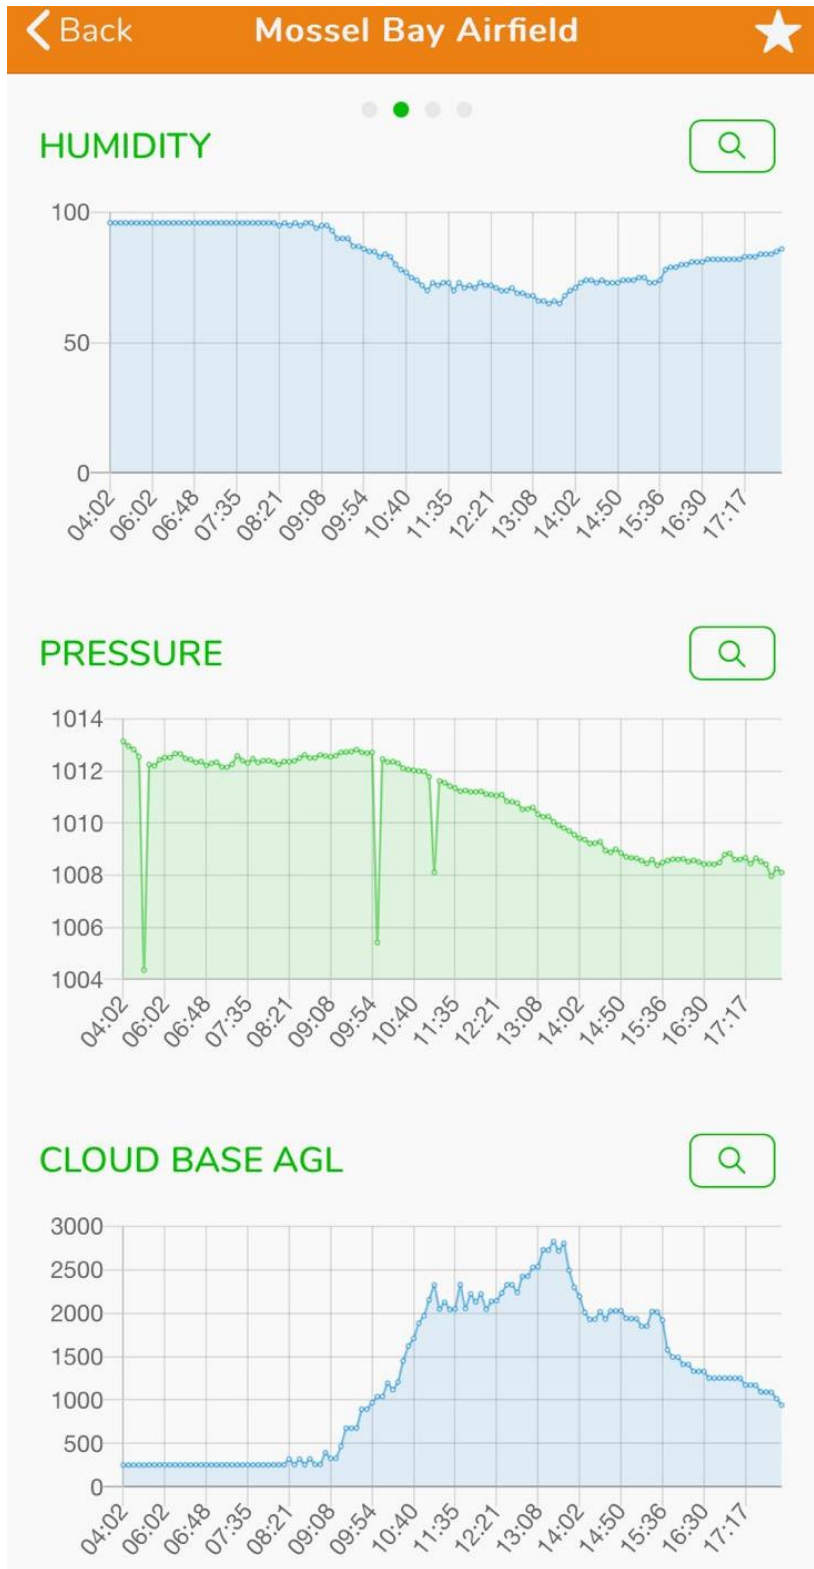
1.7.5 The weather conditions at the time of the accident as per diagrams 1 and 2 indicate the following conditions:

Wind Direction	215°	Wind Speed	3kt	Visibility	9999m
Temperature	23°C	Humidity	75%	Cloud Base	2 300ft
Dew Point	16°C	QNH	1011hPa

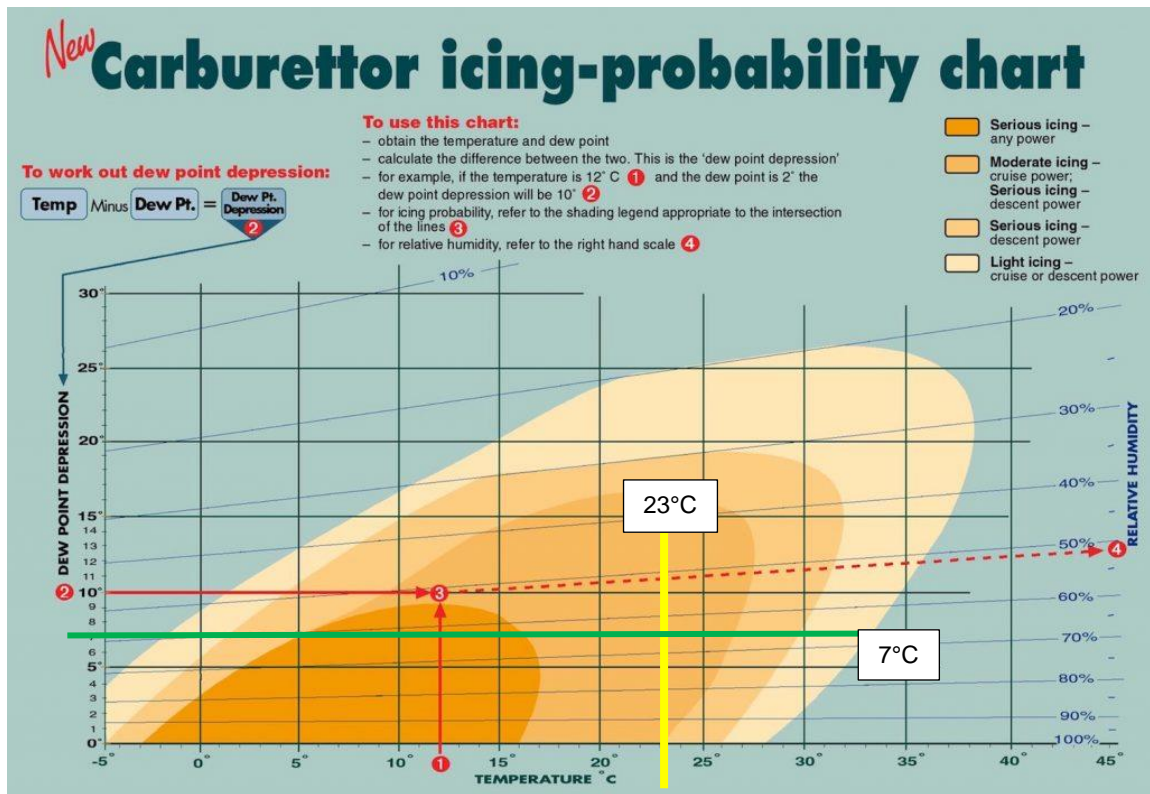
1.7.6 The carburettor icing-probability chart (Figure 4) indicates moderate icing during cruise flight and serious icing during descent power. It should be noted that carburettor icing is not restricted to cold weather. It can occur in warm days if the humidity is high enough, especially at low power settings.

Figure 4: The icing probability is where the yellow and green lines cross.

Carburettor icing was considered as the most plausible possibility that could have caused engine stoppage. In this case, the conditions were conducive to carburettor icing according

to the icing chart on page 13 of this report, which indicated the probability of serious icing was likely as they were low on power and in descent trajectory. The helicopter was fitted with an automatic carburettor heating system, which was selected to auto. The operation of the device was found to function within the prescribed limits when it was tested post-recovery. However, the possibility of ice forming in the carburettor venturi before the automatic carburettor heating system detected and activated could not be confirmed.

The humidity at the time of the flight was approximately 75%, this information was obtained from the graph on page 12 of the report. The conditions for serious carburettor icing were highly favourable at the time of the flight as indicated in the carburettor icing probability chart.

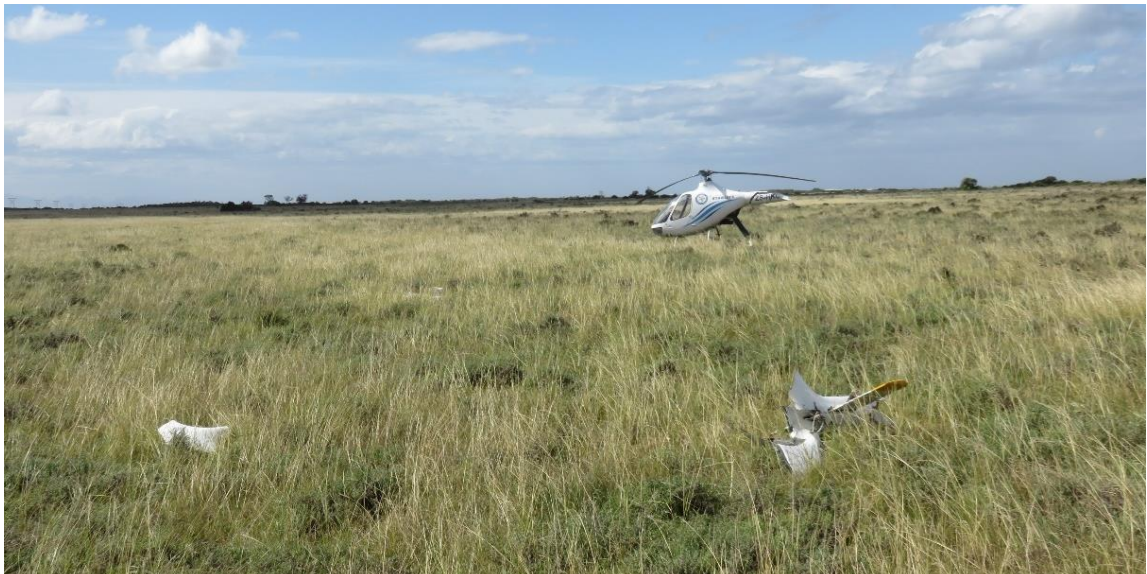
Figure 5: Fragments of the fenestron shroud in the foreground.

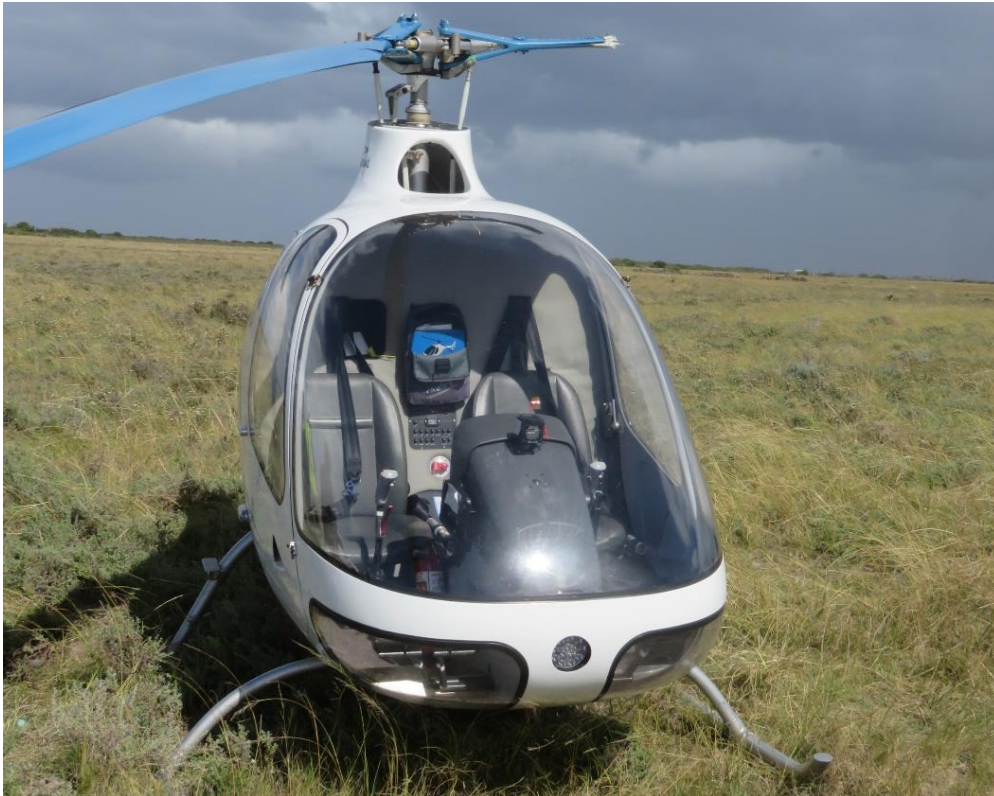
Figure 6: The front view of the helicopter with the blue blade severed near the hub assembly.

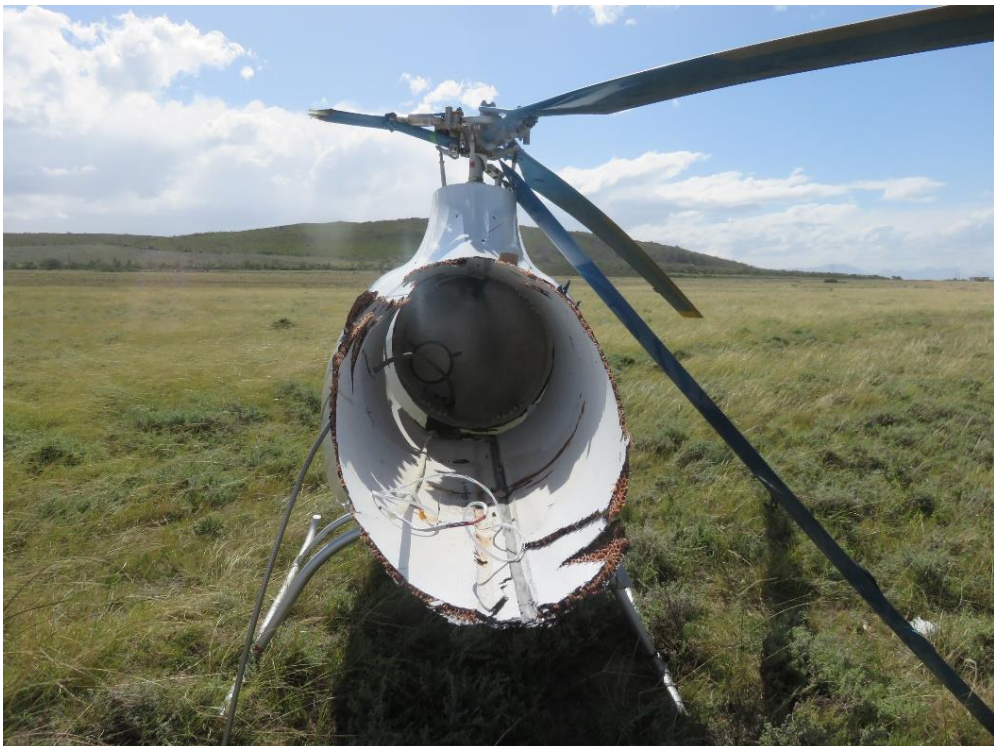
Figure 7: View of the aft position of the helicopter with the tail boom severed.

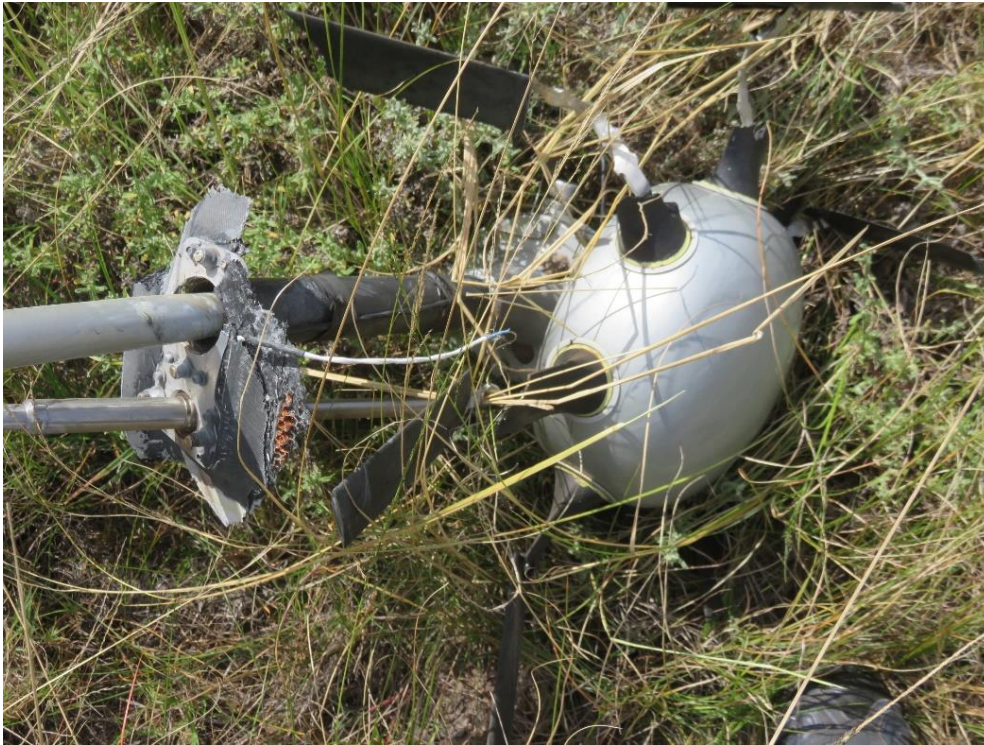
Figure 8: Substantially damaged fenestron and tail rotor drive shaft assembly.

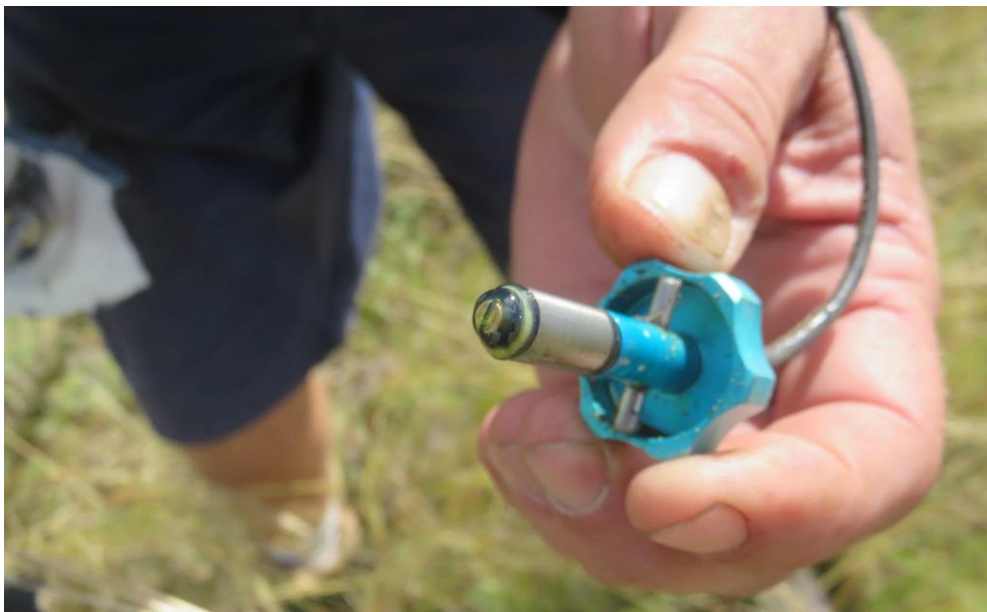
1.12.1 The helicopter touched down hard on its skid gear on an open terrain in a north-westerly direction (320°) approximately 1.6 nautical miles (nm) west of FAMO, whereafter it bounced and rotated to the right about 90° before it came to rest in an upright position on its skid gear facing north-east (050°). Following the hard landing, the main rotor blades flapped down and severed the tail boom as the helicopter rotated to the right, evidenced by the debris which was located to the west (left side of where the main wreckage came to rest). *The main rotor blades on this helicopter type rotate clockwise when viewed from above; this further supports the wreckage distribution.* The magnetic chip detector on the tail rotor gearbox was removed on site and inspected, it was found to be free of any metal particles (see Figure 9).

Figure 9: The magnetic chip detector on the tail rotor gearbox was clean.

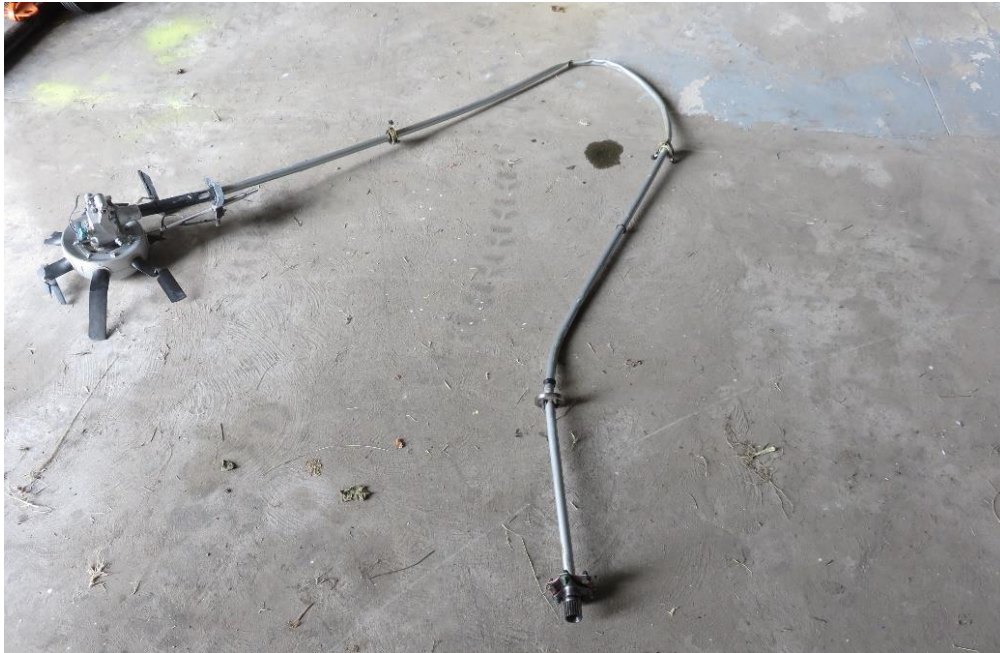
Figure 10: The entire tail rotor drive shaft assembly.

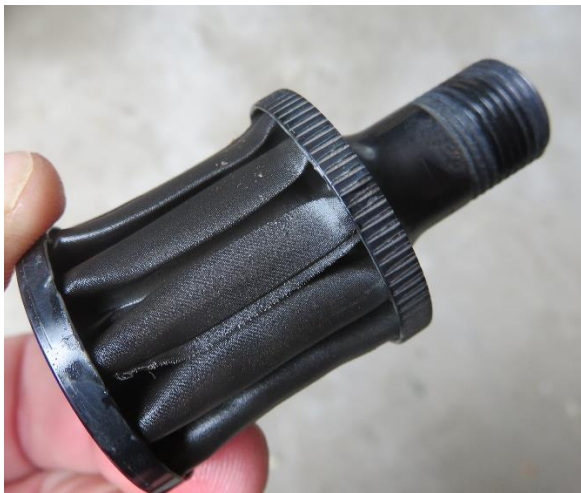
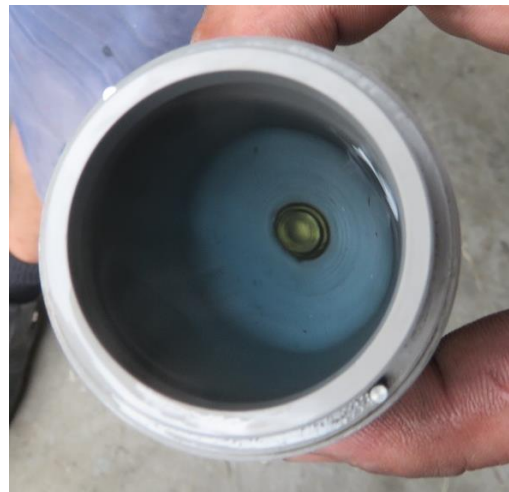
Figure 11: A picture of the fuel filter (a) and the gascolator, (b) with some fuel inside, which was clean.

- 3.2.9 The helicopter was operated within the prescribed weight and balance limitations during this flight.
- 3.2.10 Approximately 60 litres of fuel was in the fuel tank at the time of the accident, as well as sufficient engine oil. The gascolator was removed and the filter was inspected and was found clean. No evidence of fuel contamination was found.

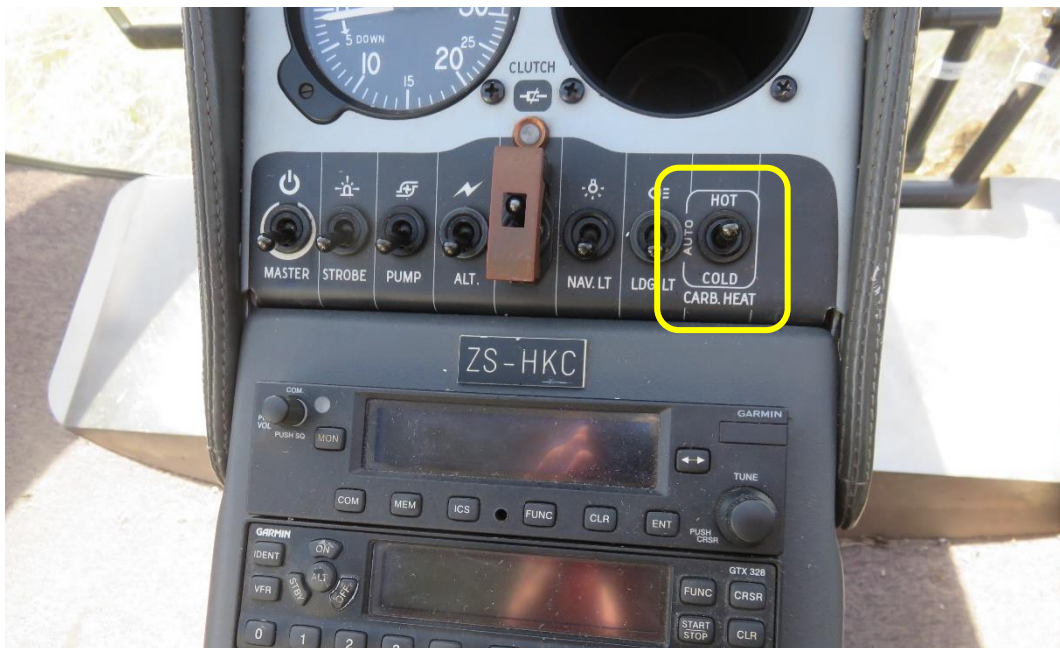
Figure 12: Instrument panel with the carb heat switch in the yellow window.

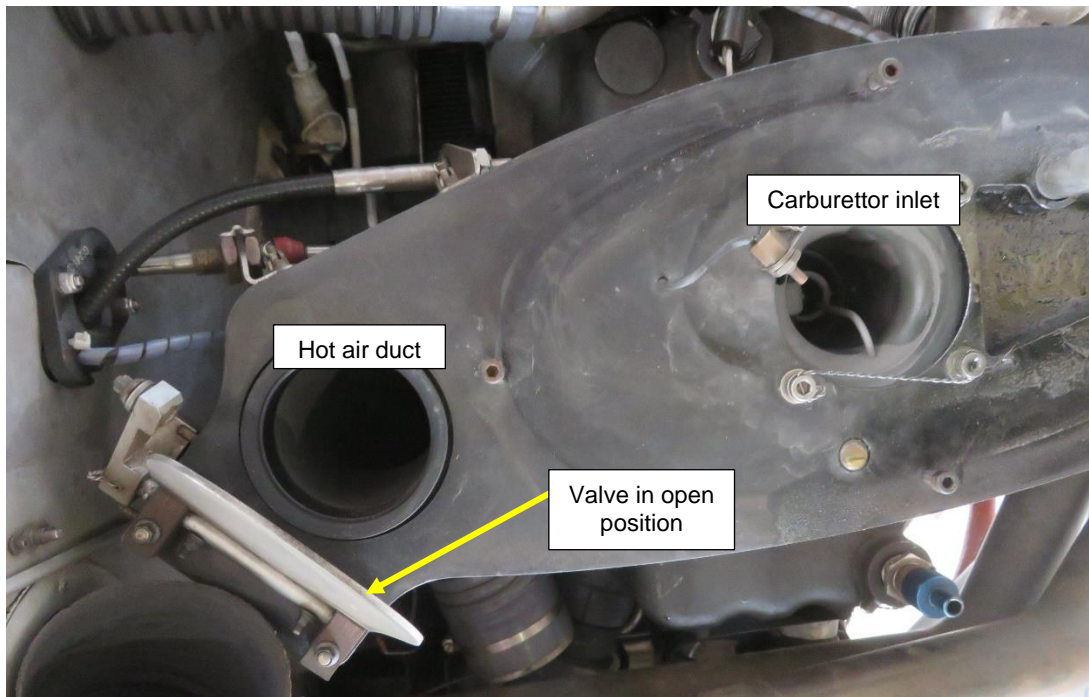
Figure 14: With the air induction box removed, the valve is in the open position.

- 3.2.11 The air induction box was removed, and the air filter was found to be clean. The automatic carburettor icing unit was activated, and the valve opened from the fully closed to the fully open position within 7 seconds.

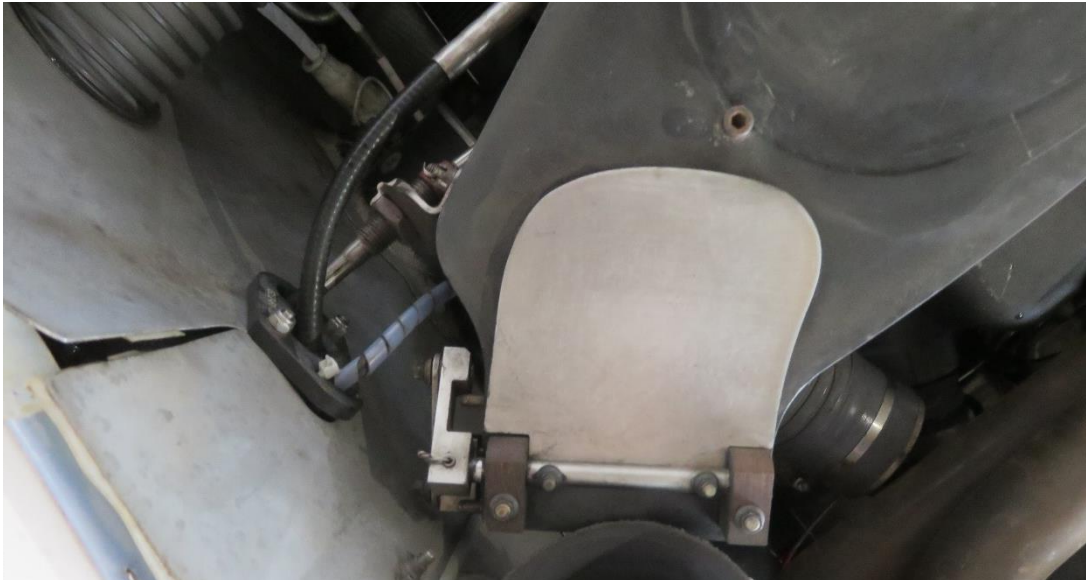
Figure 15: The valve in the close position.
