**LIMITED OCCURRENCE INVESTIGATION REPORT – FINAL**

<b>Reference Number</b>	CA18/2/3/10290						
<b>Classification</b>	Accident	<b>Date</b>	23 April 2023			<b>Time</b>	1247Z
<b>Type of Operation</b>	Training (Part 141)						
<b>Location</b>							
<b>Place of Departure</b>	Lanseria International Airport (FALA), Gauteng province		<b>Place of Intended Landing</b>	Lanseria International Airport (FALA), Gauteng province			
<b>Place of Occurrence</b>	Lanseria International Airport (FALA), Gauteng province						
<b>GPS Co-ordinates</b>	<b>Latitude</b>	25° 56' 19" S	<b>Longitude</b>	27° 55' 34" E	<b>Elevation</b>	4 455ft	
<b>Aircraft Information</b>							
<b>Registration</b>	ZS-KVW						
<b>Make; Model; S/N</b>	Cessna; 172P Skyhawk (Serial Number: 172-74779)						
<b>Damage to Aircraft</b>	Substantial			<b>Total Aircraft Hours</b>	12 433.3		
<b>Pilot-in-command</b>							
<b>Licence Type</b>	Commercial Pilot Licence (CPL) Aeroplane		<b>Gender</b>	Male	<b>Age</b>	37

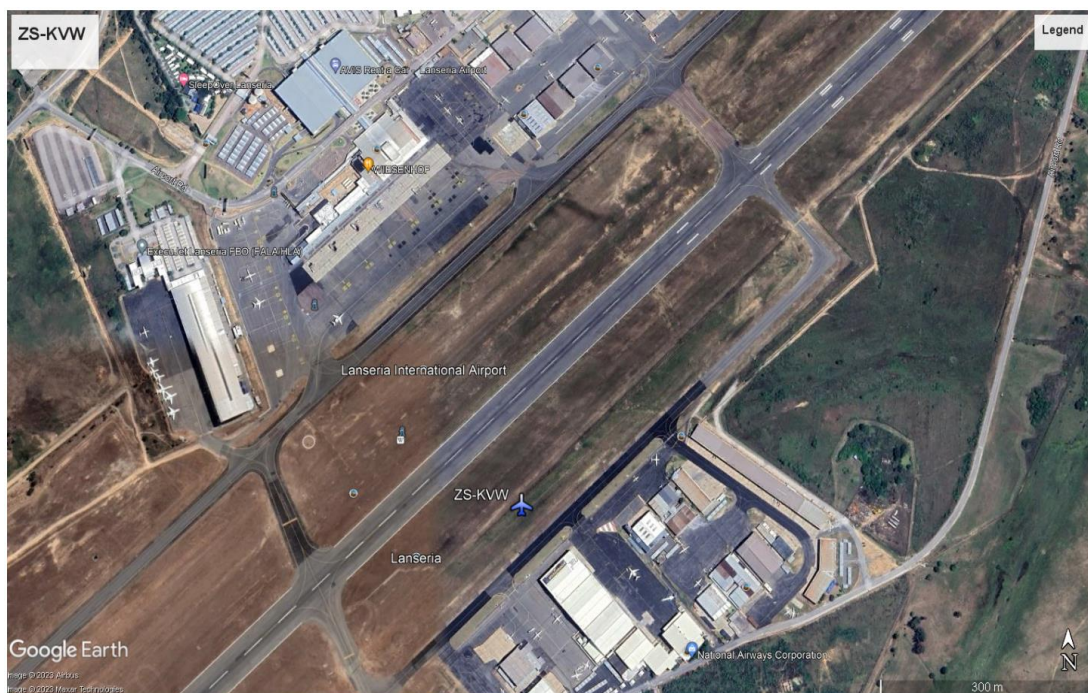
**Figure 1:** The view of the accident site at FALA. (Source: Google Earth)

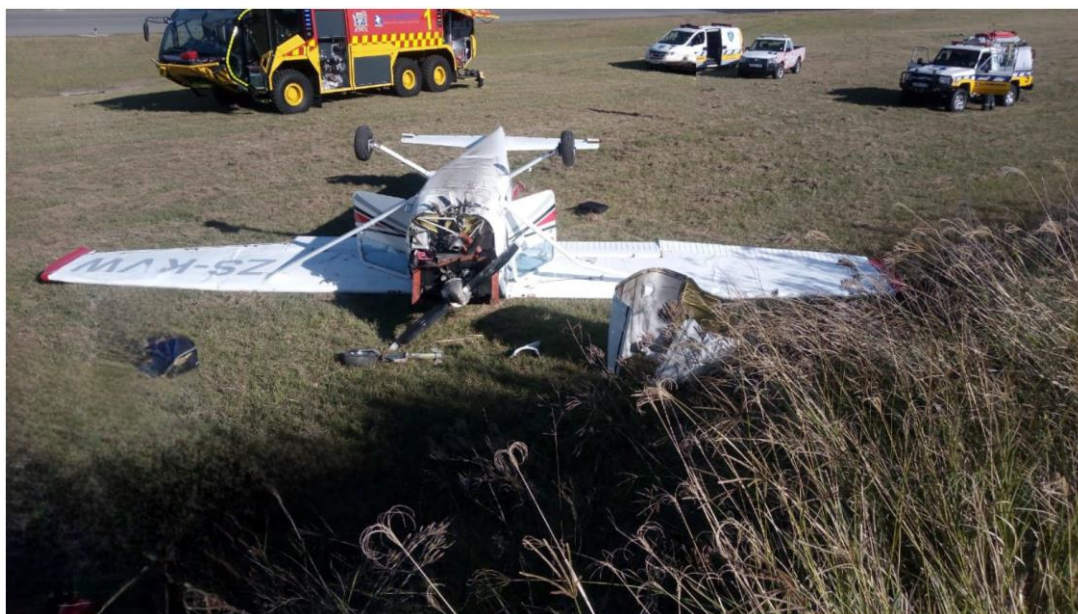
*go-around would not have been a safe undertaking*). The flight instructor stated that he applied full back pressure on the control column to ease pressure off the nose wheel. The aircraft veered off to the left of the runway and, as Runway 25 had a down slope (lower lying ground) next to it, the aircraft nosed over and came to rest in an inverted position.

The crash alarm was activated by FALA tower, and the Aircraft Rescue and Firefighting (ARFF) team and the Emergency Medical Services (EMS) personnel responded swiftly to the scene. The aircraft had damage to the engine fire wall, engine mountings, nose gear assembly (which broke off), propeller, right- and left-wing leading edges, vertical stabiliser and rudder. The crew sustained minor injuries during the accident sequence.

**Figure 2:** The aircraft's resting position after the accident. (Source: Pilot)
