LIMITED OCCURRENCE INVESTIGATION REPORT – FINAL

Reference Number	CA18/2/3/10291					
Classification	Accident	Date	23 April 2023	Time	1450Z	
Type of Operation	General Aviation and Operating Flight Rules (Part 91)					
Location						
Place of Departure	Wonderboom Aerodrome (FAWB), Gauteng Province		Place of Intended Landing	Wonderboom Aerodrome (FAWB), Gauteng Province		
Place of Occurrence	Runway 29 at Wonderboom Aerodrome (FAWB), Gauteng Province					
GPS Co-ordinates	Latitude	25°39'7.79" S	Longitude	028°13'16.20" E	Elevation	4 095 ft
Aircraft Information						
Registration	ZS-KJU					
Make; Model; S/N	Rockwell Commander, 112TCA (Serial Number: 13183)					
Damage to Aircraft	Substantial		Total Airframe Hours	2 395.34		
Pilot-in-command						
Licence Type	Private Pilot Licence (PPL)			Gender	Male	Age 54
Licence Valid	Yes	Total Hours on Type	63.04	Total Flying Hours	144.1	
Total Hours 90 Days	3.0		Total Hours on Type Past 90 Days	3.0		
People On-board	1 + 0	Injuries	0	Fatalities	0	Other (on ground) 0

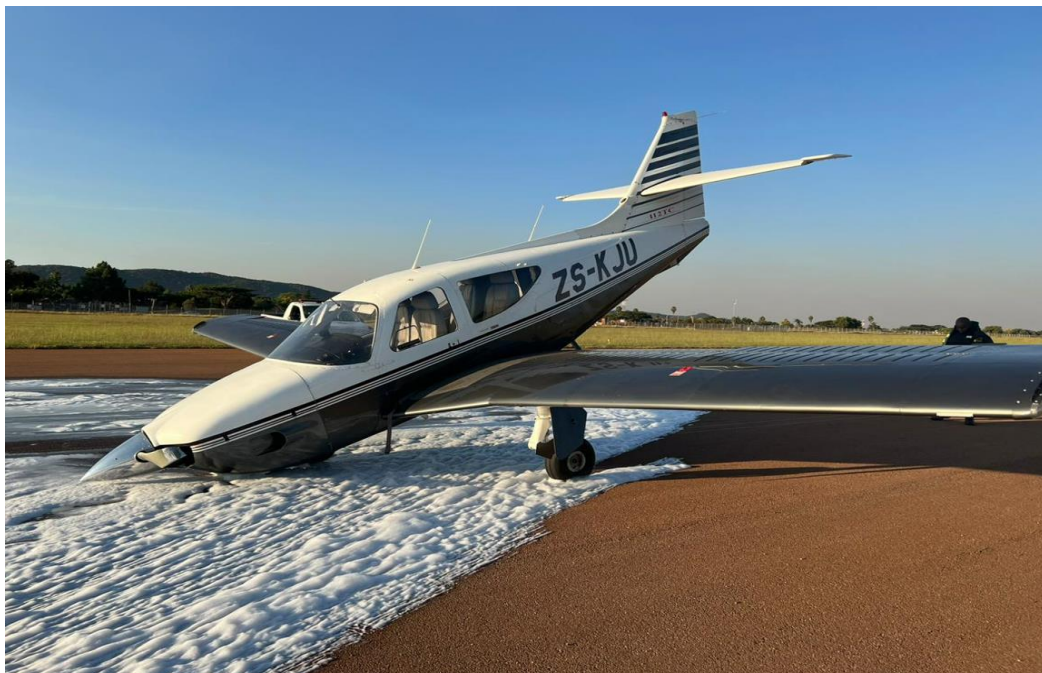
The pilot called the FAWB ATC and requested a low-level fly past for the ATC to verify and confirm the position of the landing gears. The ATC told the pilot that all three gears appeared to be down. The pilot then flew a circuit and, after touchdown on Runway 29, approximately beyond 100 metres (m) during the landing roll as the aircraft slowed down, the nose landing gear collapsed. The propeller blades contacted the runway surface and the aircraft skidded on the lower engine cowling for approximately 80m before it stopped in the middle of the runway. The pilot turned off the fuel selector and master and got out of the aircraft unassisted and unharmed. The Aircraft Rescue and Firefighting (ARFF) team responded swiftly to the scene; they administered foam to the aircraft to suppress sparks and to prevent any aircraft metal igniting due to friction with the runway surface. The aircraft sustained substantial damage.

Figure 1: The resting position of the aircraft on Runway 29. (Source: Pilot)

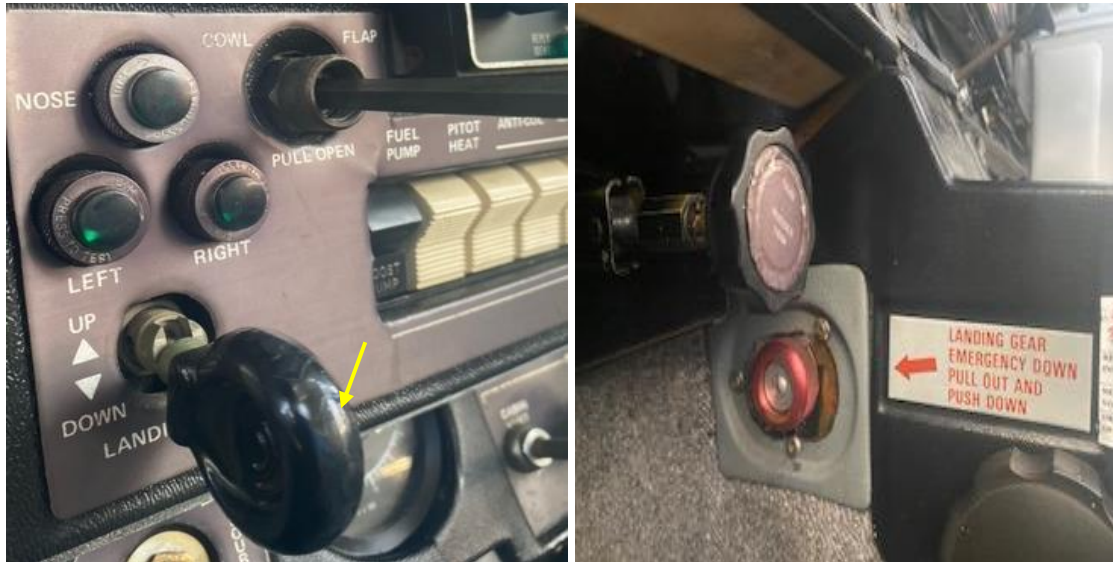
Figures 2 and 3: The gear selector switch/position indicator lights (left). The gear emergency extension (right).

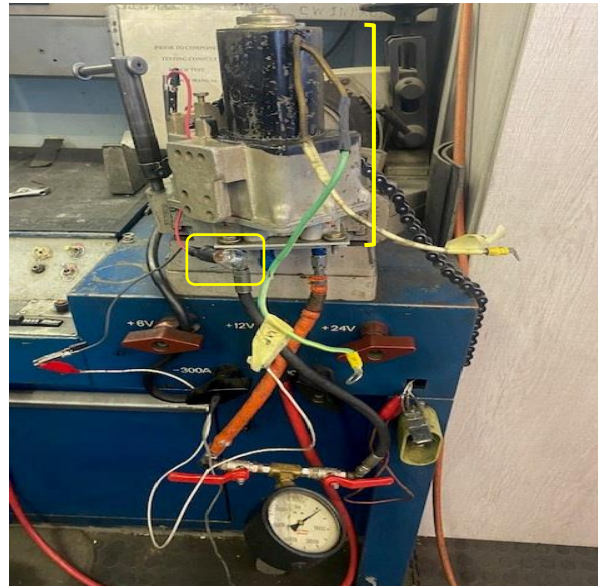
The power pack was removed from the aircraft and taken to Rand Aerodrome (FAGM) for examination and testing. The AME who performed the task had a Category “W” rating. The power pack was placed on a test bench and it contained adequate hydraulic fluid. Gauges were fitted to test the hydraulic pump and the applicable voltage (12 volts) was applied to the motor with no indication of the gear movement.

Figure 4: The power pack indicating no sign of gear movement when tested (globe not lit as shown in the yellow window).

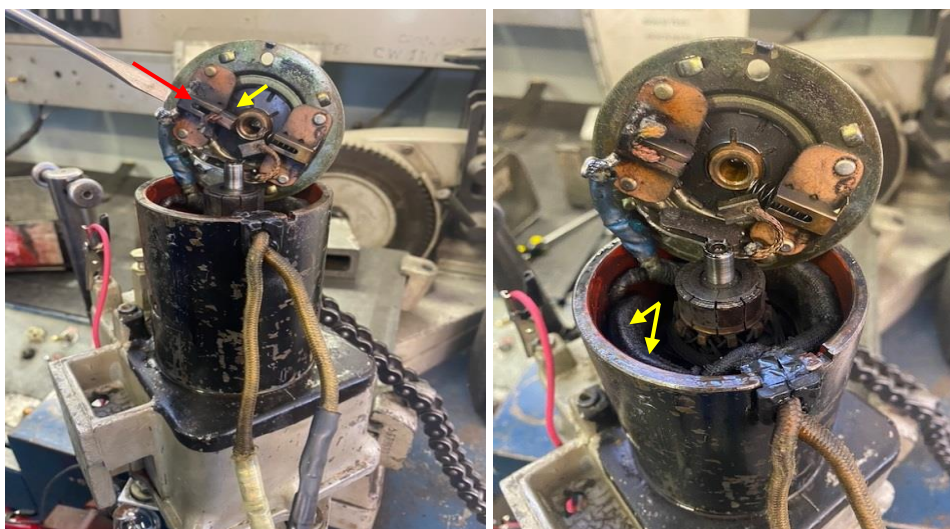
The landing gear power pack motor cover was opened, and the electrical carbon brush which transmits electrical current was found disconnected and the spring was destroyed due to excessive heat. Signs of hydraulic weep were observed inside the motor which indicated hydraulic fluid push up into the electrical parts that appeared to have contributed to the failure of the landing gear power pack.

Figures 5 and 6: The landing gear power pack motor showing heat damage (left picture). Wetness on the wiring is caused by hydraulic fluid weep (right picture).
