UAS LIMITED OCCURRENCE INVESTIGATION REPORT – FINAL

Reference Number	CA18/2/3/10292						
Classification	Accident	Date	24 April 2023		Time	2045Z	
Type of Operation	Remotely Piloted Aircraft Systems – Surveillance (Part 101)						
Location							
Place of Departure	Syferfontein Mine, Mpumalanga Province		Place of Intended Landing	Syferfontein Mine, Mpumalanga Province			
Place of Occurrence	Syferfontein Mine in Mpumalanga Province						
GPS Co-ordinates	Latitude	26° 24' 36.86" S	Longitude	29° 12' 13.35" E	Elevation	5253 ft	
Aircraft Information							
Registration	ZT-UZY		Class	3A			
Make; Model; S/N	Da-Jiang Innovations (DJI); Mavic 2 Enterprise (Serial Number: MAV0014)						
Damage to Aircraft	Substantial		Total UAS Hours	3743.1			
Pilot-in-command							
Licence Type	Remote Pilot Licence (RPL)		Gender	Male		Age	28
Licence Valid	Yes	Total Hours	332.4		Total Hours on Type	332.4	
Total Hours Past 90 Days	153.5		Total Flying Past 90 Days on Type	153.5			
Injuries	0	Injuries (On Ground)	0	Fatalities (On Ground)	0

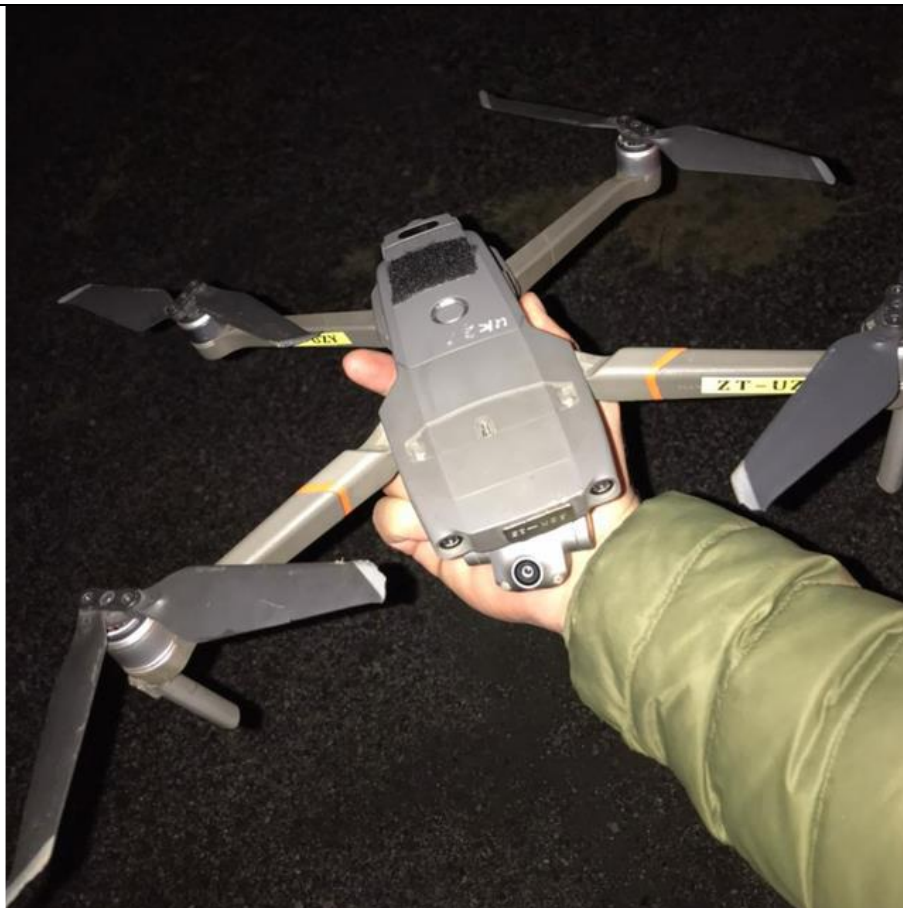
People Controlling	1						
What Happened							
<p>On 24 April 2023, an Unmanned Aircraft System (UAS) with registration ZT-UZY was engaged in a surveillance flight at Syferfontein Mine in Secunda, Mpumalanga province. The flight was conducted under visual line of sight (VLOS) rules by night and under the provisions of Part 101 of the Civil Aviation Regulations (CAR) 2011 as amended.</p> <p>The pilot stated that he launched the UAS and, shortly after, an error message of the left gimbal reflected on the remote pilot station before it failed. As the UAS was in the pilot's line of sight, he noticed that the gimbal had tilted to the left which also skewed the camera view on the remote pilot station. The UAS impacted a perimeter fence at a height of 2 metres (m). The GPS tracking device separated from the UAS upon impact and the pilot could not track it as it was night time. At approximately 0830Z the following day, the UAS was located next to the perimeter fence, it had sustained scratches on some of the propeller blades.</p> <p>The UAS was substantially damaged. There was no injury to persons or damage to property that was reported.</p>

Figure 1: A picture of the UAS after recovery from the accident site. (Source: Operator)

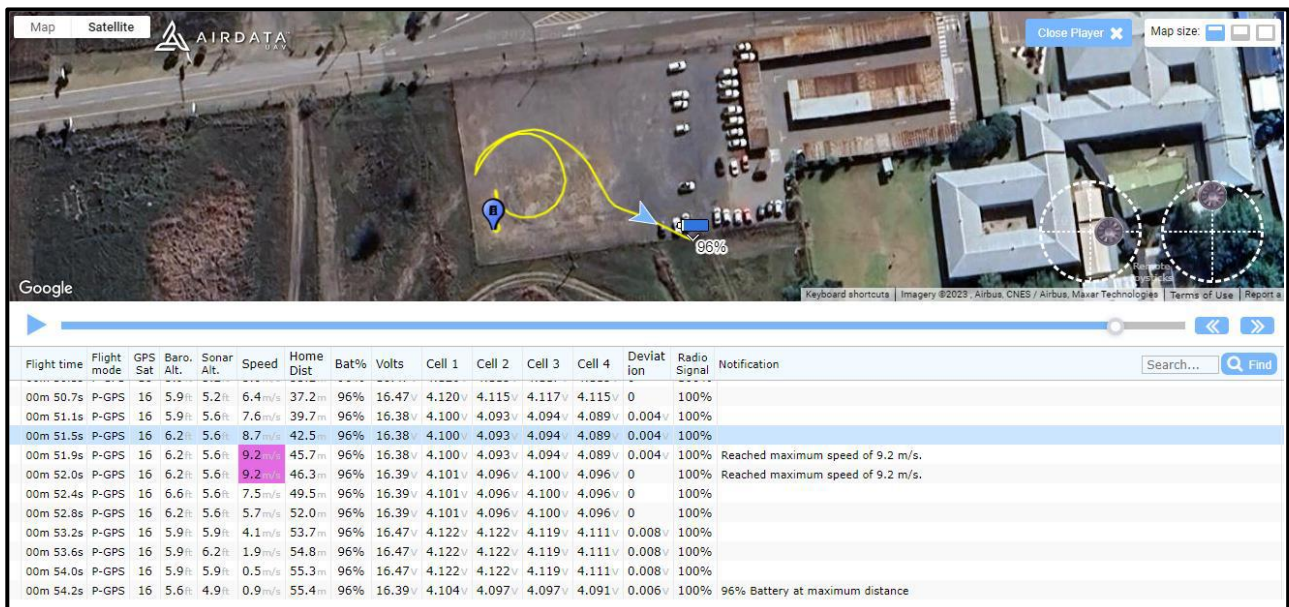
7. Post-accident Log Analysis Report (Source: Manufacturer)
 - 20:45 UTC: The pilot armed the aircraft and ascended to 6 ft AGL.
 - 20:45 UTC: The pilot tried to engage a point of interest and lost orientation of the aircraft.

- 20:45 UTC: The pilot gave full pitch inputs and flew into a fence 20 metres from the home location.

Figure 3: Flight path of the UAS. (Source: Manufacturer)

The pilot lost control of the UAS whilst attempting to engage a point of interest manoeuvre.
