UAS LIMITED OCCURRENCE INVESTIGATION REPORT – FINAL
--

Reference Number	CA18/2/3/10293						
Classification	Accident	Date	24 April 2023		Time	1615Z	
Type of Operation	Remotely Piloted Aircraft Systems – Surveillance (Part 101)						
Location							
Place of Departure	Dumbe, KwaZulu-Natal Province		Place of Intended Landing	Dumbe, KwaZulu-Natal Province			
Place of Occurrence	6 nautical miles north-east of Dumbe, KwaZulu-Natal Province						
GPS Co-ordinates	Latitude	27° 21' 02.00" S	Longitude	030° 53' 42.00" E	Elevation	5009 ft	
Aircraft Information							
Registration	ZT-XSH		Class	3A			
Make; Model; S/N	DJI Mavic 2 Enterprise (Serial Number: Mav0055)						
Damage to Aircraft	Minor		Total UAS Hours	1358.48			
Pilot-in-command							
Licence Type	Remote Pilot Licence (RPL)		Gender	Male		Age	33
Licence Valid	Yes	Total Hours	115.0		Total Hours on Type	115.0	
Total Hours 30 Days	100		Total Flying on Type Past 90 Days	100			
People Controlling	1	Injuries	0	Fatalities	0	Injuries (On ground)	0

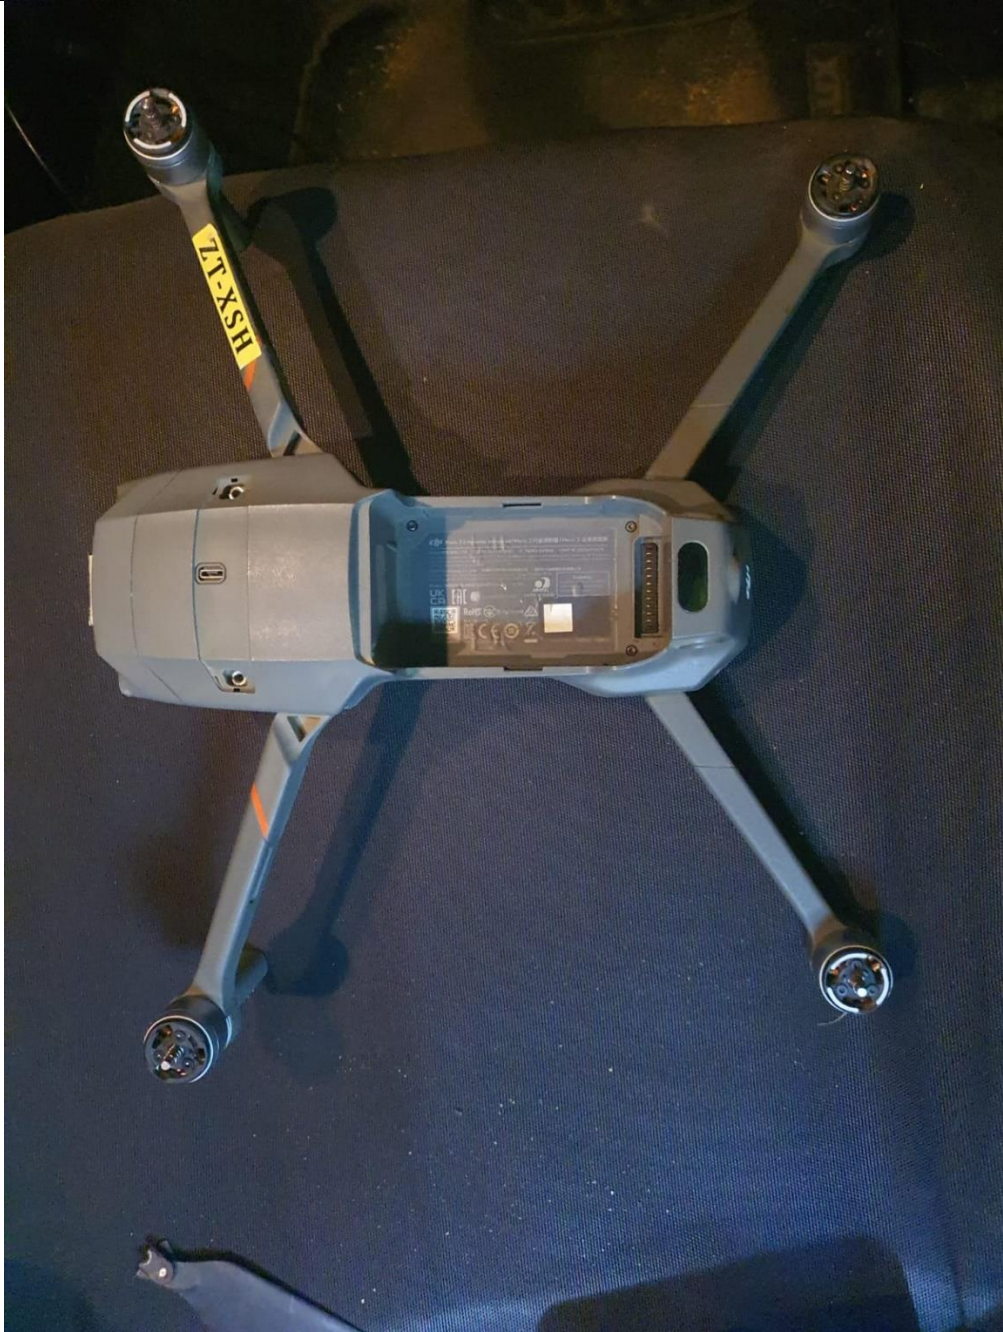
Figure 2: The aircraft after recovery. (Source: Operator)

4. The pilot accidentally knocked the throttle whilst landing the UAS and it crashed on the cone which was placed on one of the corners of the launch pad. The propeller blade was damaged as a result.
Probable Cause
The UAS propeller blade struck a cone during landing.
Contributing Factor(s)
None.
Safety Action(s)
None.
Safety Message and/or Safety Recommendation(s)
None.
About this Report
<i>The decision to conduct a limited investigation is based on factors including whether the cause is known and the evidence supporting the cause is clear, the level of safety benefit likely to be obtained from an investigation and that will determine the scope of an investigation. For this occurrence, a limited investigation has been conducted, and the Accident and Incident Investigations Division (AIID) has relied on the information submitted by the affected person/s and organisation/s to compile this limited report. The report has been compiled using information supplied in the initial notification, as well as from follow-up desk top enquiries to bring awareness of potential safety issues to the industry in respect of this occurrence, as well as possible safety action/s that the industry might want to consider in preventing a recurrence of a similar occurrence.</i>

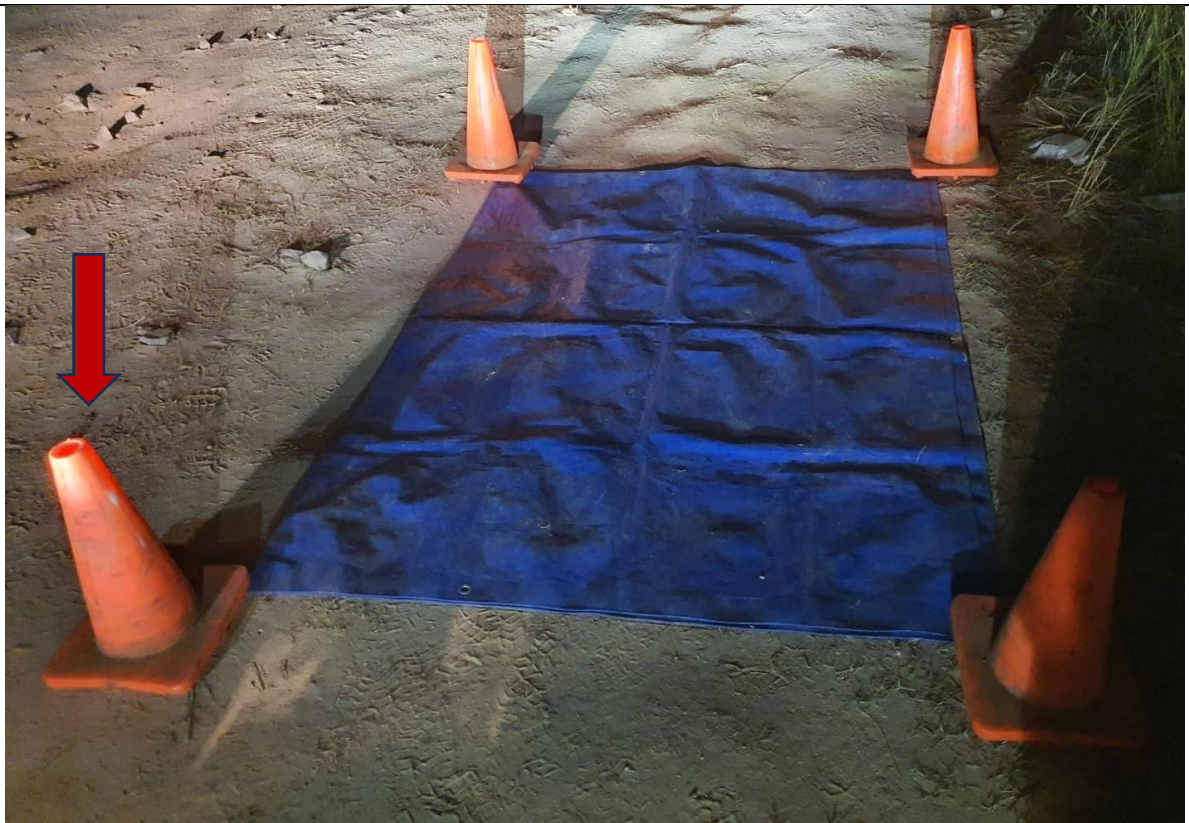
Figure 3: The red arrow points to the cone that the UAS struck. (Source: Operator)
