LIMITED OCCURRENCE INVESTIGATION REPORT – FINAL

| Reference Number | CA18/2/3/10295 | | | | | | |
| Registration | ZT-WSI | | | | | | |
| Make; Model; S/N | DJI Matrice 210 (Serial Number: 17TDGWR13U7SX) | | | | | | |

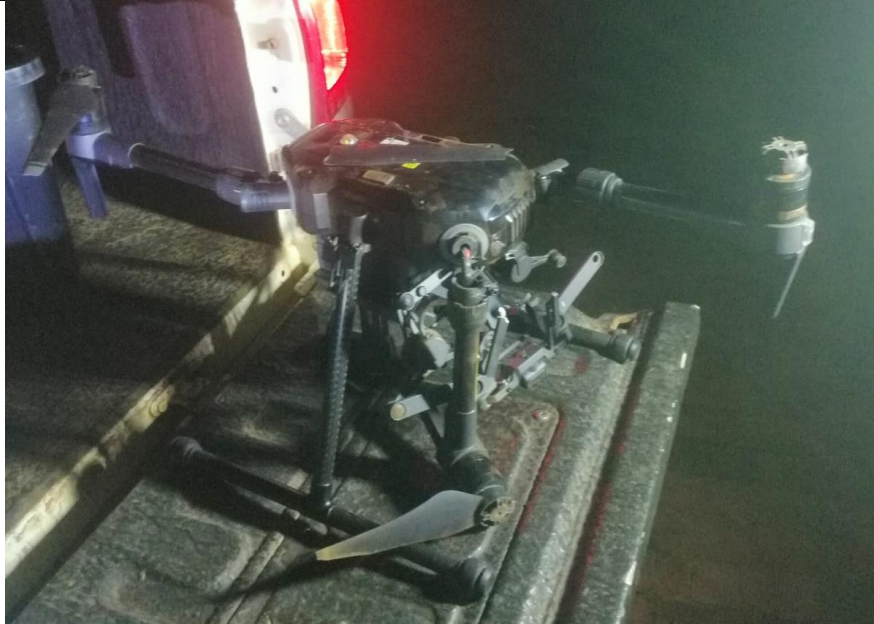
| <p>On 2 March 2023, a DJI Matrice 210 remotely piloted aircraft (RPA) with registration ZT-WSI was launched for surveillance purposes at Mabalingwe Game Reserve in Bela-Bela, Limpopo province. The operation was conducted under beyond visual line of sight (BVLOS) rules by night and under the provisions of Part 101 of the Civil Aviation Regulations (CAR) 2011 as amended.</p> <p>The pilot stated that he conducted a pre-flight inspection and no anomalies were found. The RPA's battery level (serial number: TB5514A/B) was at 99% at the time of launch, and it (RPA) climbed to 50 metres (m) above ground level (AGL) to commence the mission. The flight from waypoint 1 to 19 was uneventful. However, from waypoint 20, the pilot identified tall trees and activated the return-to-home function, but the RPA did not return to home. After 10 seconds, the RPA lost Command and Control (C2) connection with the pilot's controller unit. Therefore, the pilot set out to search for it from its last known location. He found it crashed on the ground under the lightning conductor. (It appeared that the RPA collided with the lightning conductor.)</p> <p>The RPA sustained damage to the propellers, camera and camera holder.</p> | | | | | | | |

Figure 1: The ZT-WSI after recovery. (Source: Operator)

The RPA collided with a lightning conductor and lost C2 connection link, which resulted in loss of control and the subsequent crash.

The operator reviewed all the waypoint routes to ensure that controlled flight into terrain (CFIT) is not repeated. Additional training was also offered to both pilots.

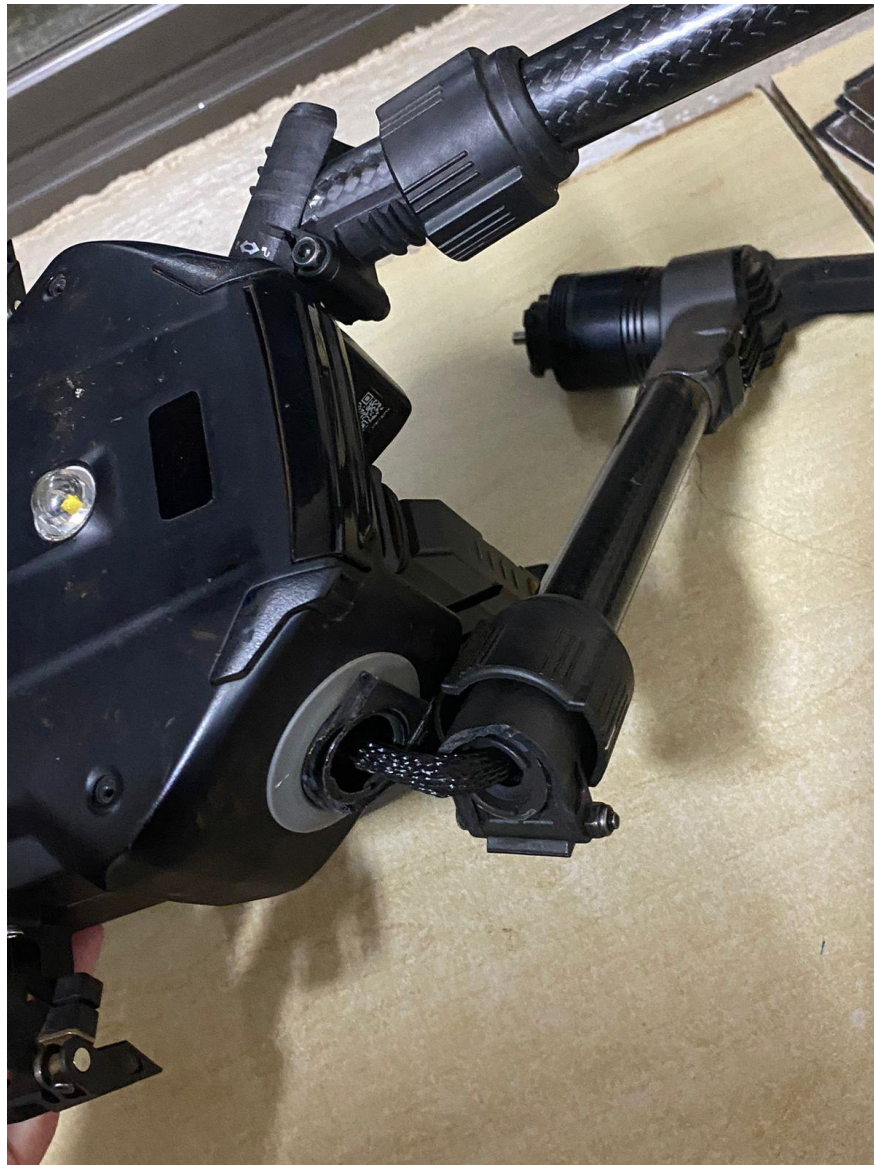
Figure 2: The damaged arm of the RPA.

6. The RPA was damaged beyond economical repair.
