RPAS/UAS LIMITED OCCURRENCE INVESTIGATION REPORT – FINAL

Reference Number	CA18/2/3/10296						
Classification	Accident	Date	26 April 2023		Time	2050Z	
Type of Operation	Remotely Piloted Aircraft System – Surveillance (Part 101)						
Location							
Place of Departure	Sibanye Stillwater Mines, Rustenburg, North West, Province		Place of Intended Landing	Sibanye Stillwater Mines, Rustenburg, North West, Province			
Place of Occurrence	Sibanye Stillwater Mines in Hexriver dumping area, Rustenburg, North West Province						
GPS Co-ordinates	Latitude	25°40'31.78"S	Longitude	27°17'20.87"E	Elevation	3738ft ft	
Aircraft Information							
Registration	ZT-YJG		Class	Class 3A			
Make; Model; S/N	Arace; Sirin (Serial Number: SIR117)						
Damage to Aircraft	Destroyed		Total UAS Hours	420.11			
Pilot-in-command							
Licence Type	Remote Pilot Licence (RPL)		Gender	Female		Age	34
Licence Valid	Yes	Total Hours	974.49		Total Hours on Type	175.5	
Total Hours 30 Days	0		Total Flying on Type Past 90 Days	77.46

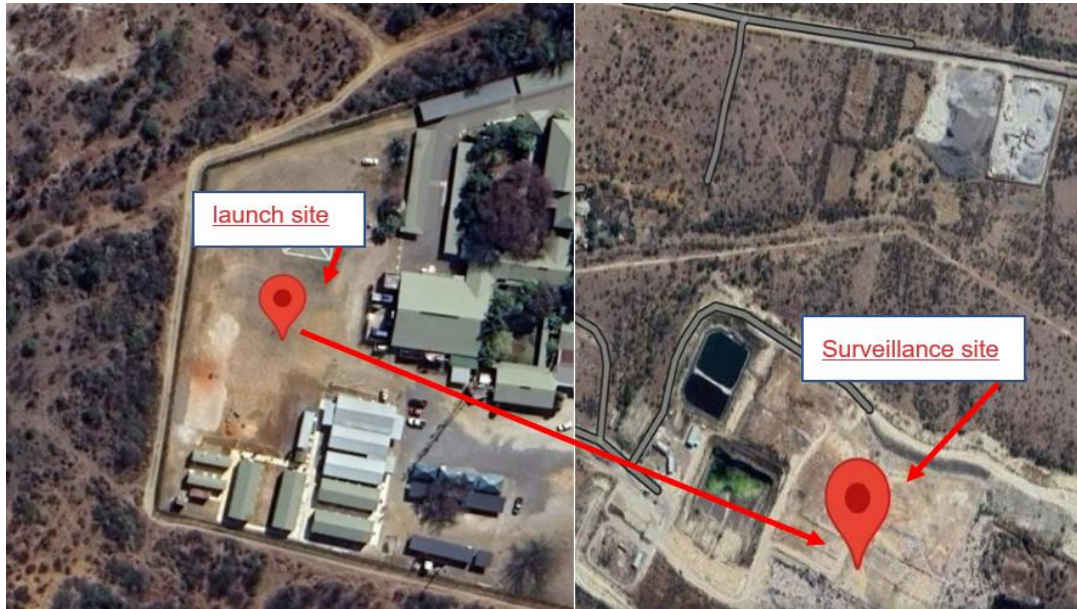
Figure 1: A view of the UAS flight path and the accident site. (Source: Google Earth).

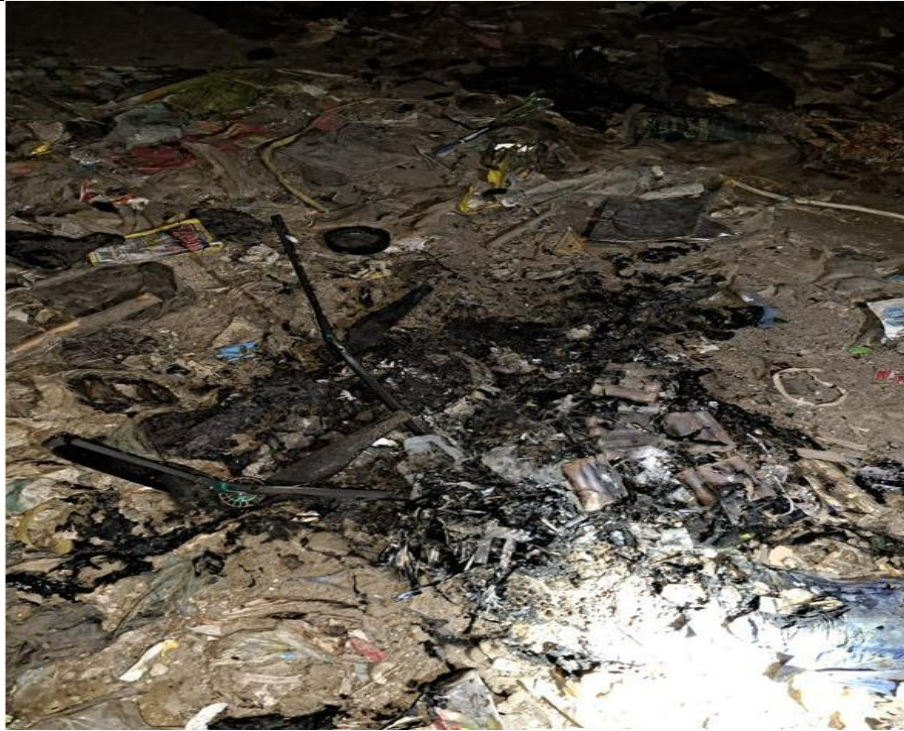
The pilot reported that whilst attempting to engage the UAS back to GPS mode, the UAS entered a dive and the airspeed drastically increased before it disconnected from the remote pilot station. A post-impact fire ensued which destroyed the UAS. It is likely that the fire was caused by an explosion from the UAS's battery after impact. No damage to property or injury to personnel on the ground was reported. The pilot and her team tracked the UAS from the last recorded location; they found it crashed on the ground and destroyed by fire. During the investigation, it was discovered that the flight log burnt in the fire.

Figure 2: The burnt UAS at the accident site. (Source: Operator)
