LIMITED OCCURRENCE INVESTIGATION REPORT – FINAL

Reference Number	CA18/2/3/10297						
Classification	Accident	Date	29 April 2023		Time	2000Z	
Type of Operation	Remotely Piloted Aircraft System – Surveillance (Part 101)						
Location							
Place of Departure	Vrede, Free State Province		Place of Intended Landing	Vrede, Free State Province			
Place of Occurrence	Vrede, Free State Province						
GPS Co-ordinates	Latitude	27° 27' 9.66" S	Longitude	029° 9' 2.93" E	Elevation	5560 ft	
Aircraft Information							
Registration	ZT-XVM						
Make; Model; S/N	Arace Sirin (Serial Number: SR0053)						
Damage to Aircraft	Substantial			Total Aircraft Hours	679.22		
Pilot-in-command							
Licence Type	Remote Pilot Licence (RPL)		Gender	Male		Age	30
Licence Valid	Yes	Total Hours	208.1		Total Hours on Type	208.1	
Total Hours Past 90 Days	88.2		Total Flying Past 90 Days on Type	88.2			
People Controlling	1	Injuries	0	Fatalities	0	Other (on ground)	0
What Happened

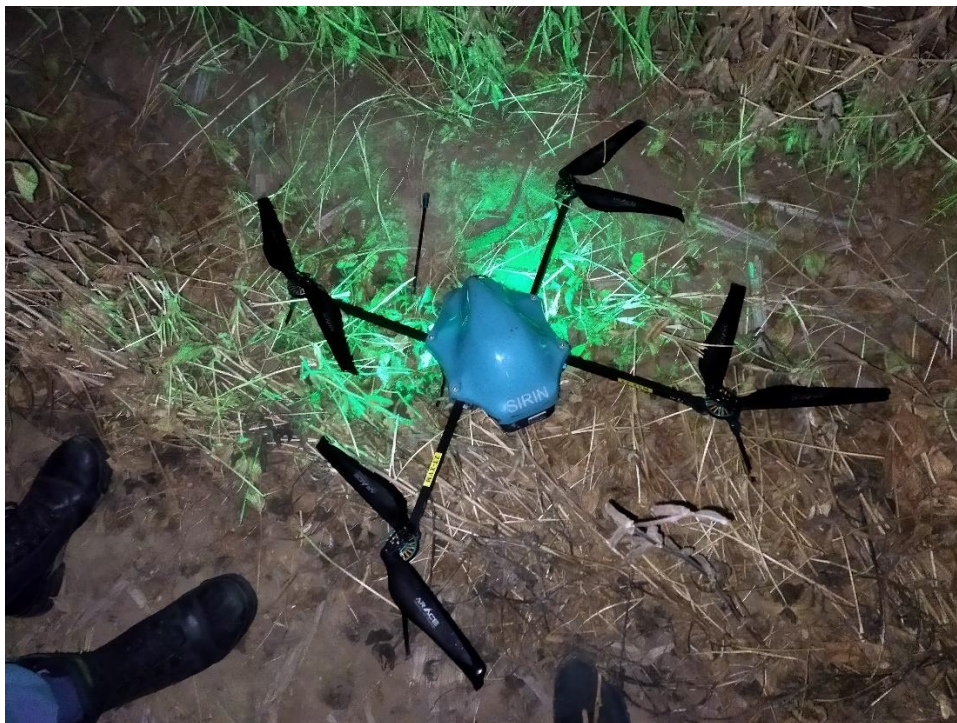
with substantial damage to the propellers, one motor arm and the landing gear. No injuries were reported on the ground.

Figure 1: The Arace Sirin post-accident. (Source: Operator)

The RPA lost forward thrust and disconnected from the controller unit and crashed. The cause for loss of thrust could not be determined as the RPA's memory card was full prior to the flight.

The operator will be using memory cards with a higher storage capacity.
