LIMITED OCCURRENCE INVESTIGATION REPORT – FINAL
--

Reference Number	CA18/2/3/10298						
Classification	Serious Incident	Date	30 April 2023		Time	0050Z	
Type of Operation	Remotely Piloted Aircraft Systems – Surveillance (Part 101)						
Location							
Place of Departure	Vryheid, KwaZulu-Natal Province		Place of Intended Landing	Vryheid, KwaZulu-Natal Province			
Place of Occurrence	Vryheid, KwaZulu-Natal Province						
GPS Co-ordinates	Latitude	27°48'3.78" S	Longitude	30°44'33.75" E	Elevation	3789 ft	
Aircraft Information							
Registration	ZT-XNI						
Make; Model; S/N	Arace Industrial Solutions; Sirin (Serial Number: SRI0032)						
Damage to Aircraft	Substantial		Total Aircraft Hours	656			
Pilot-in-command							
Licence Type	Remote Pilot Licence (RPL)		Gender	Female		Age	28
Licence Valid	Yes	Total Hours	499.85		Total Hours on Type	499.85	
Total Hours Past 30 Days	148.24		Total Flying Hours on Type Past 90 Days	148.24			
People Controlling	1	Injuries	0	Fatalities	0	Other (on ground)	0

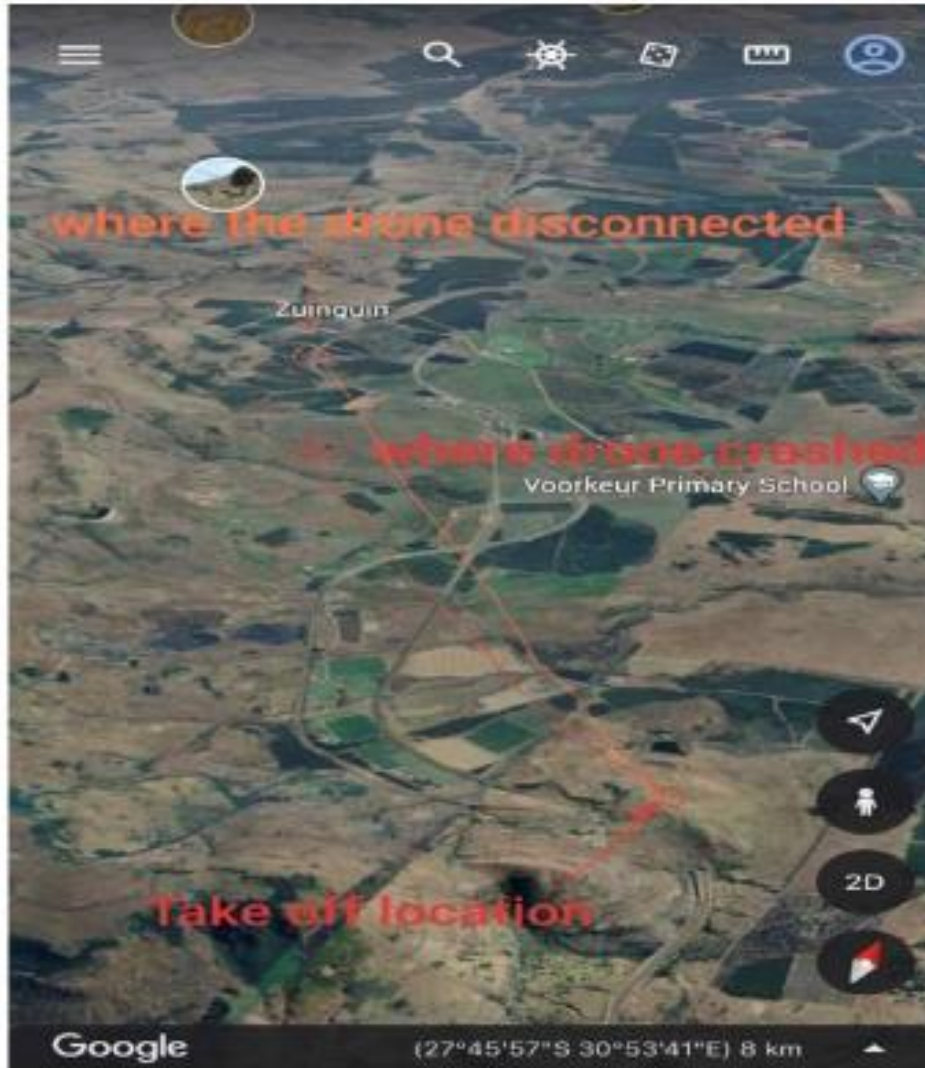
The accident occurred during the night at Global Positioning System (GPS) co-ordinates determined to be 27°48'3.78" South, 30°44'33.75" East at an elevation of 3789 feet (ft).

Figure 1: The crash site. (Source: Pilot)

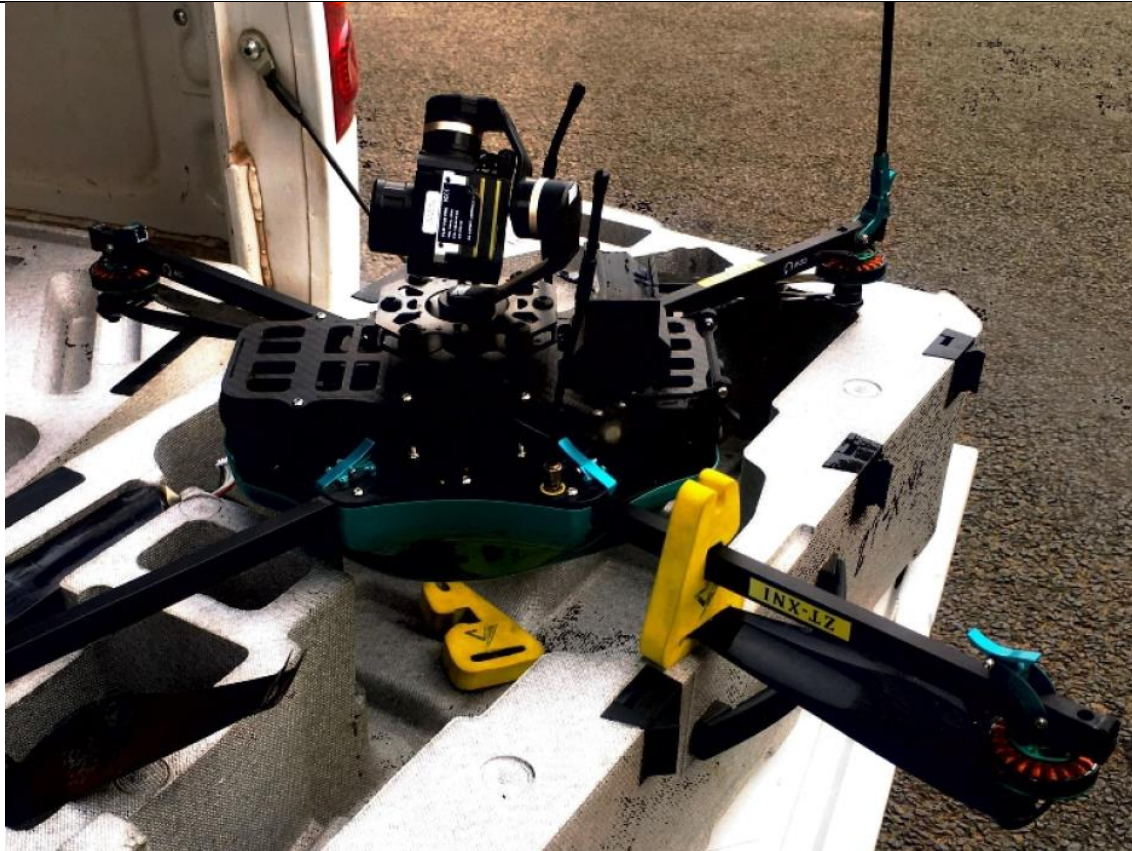
found it crashed with substantial damage to the propeller blades and landing gear. No person was injured on the ground.

Figure 2: The RPA post-accident. (Source: Pilot)

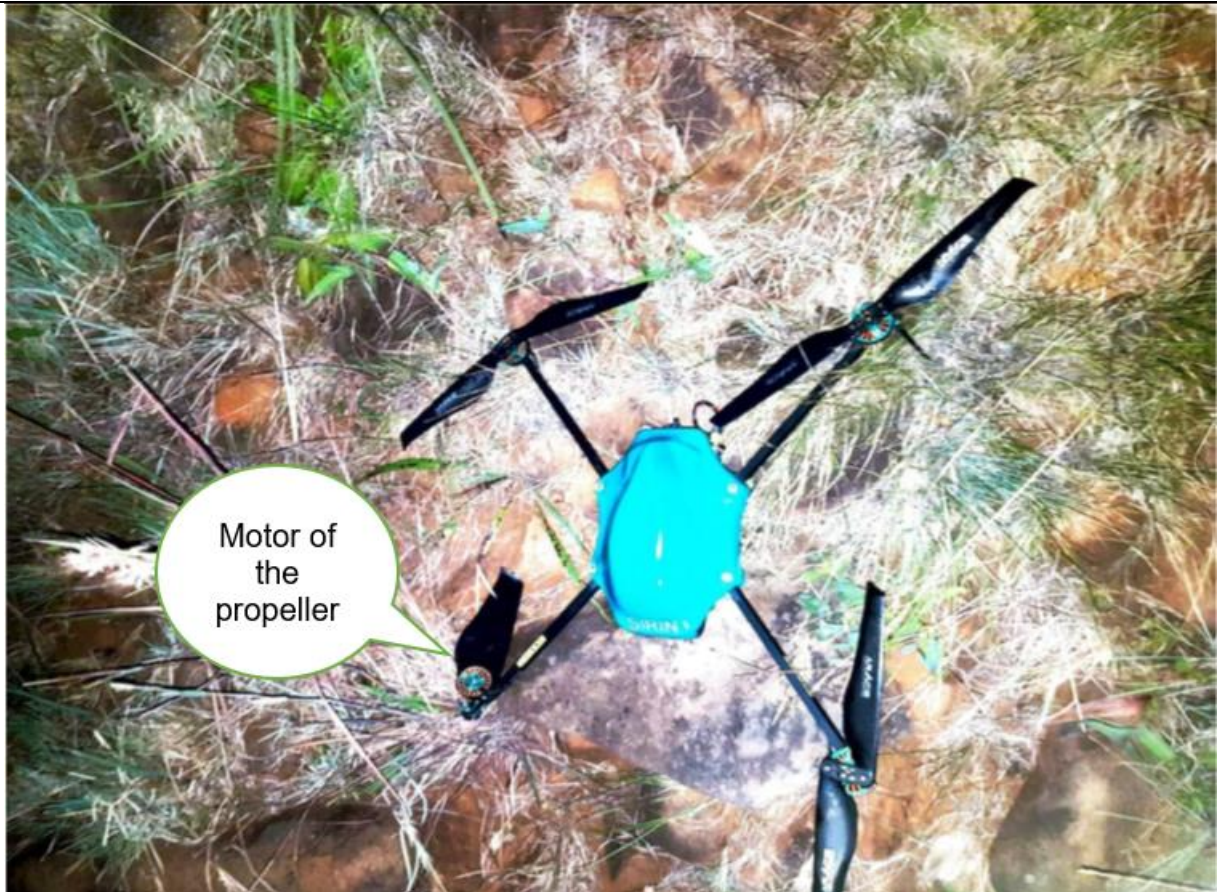
Figure 3: The RPA post-accident. (Source: Pilot)

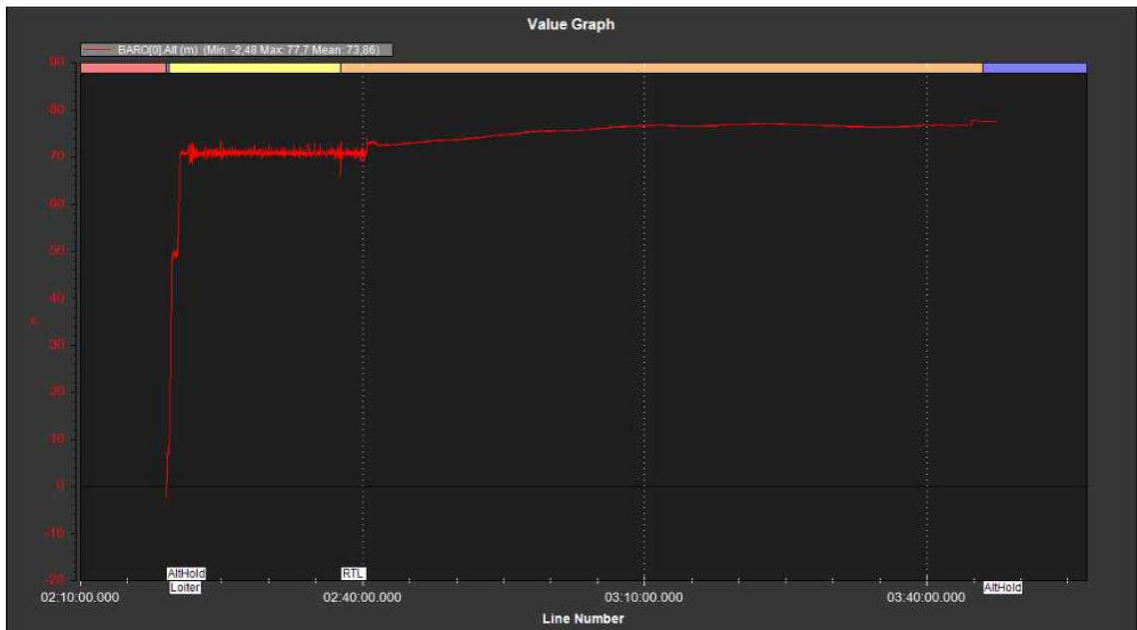
At 00:38 UTC: 19 minutes into the flight, the aircraft lost communication, about 7km out and switched to return-to-launch (RTL) mode.

At 00:39 UTC: The aircraft crashed into a mountain.

Figure 4: The data indicates that the aircraft did not descend or land.

A possible loss of command-and-control link caused the RPA to lose communication with the pilot's controller unit.

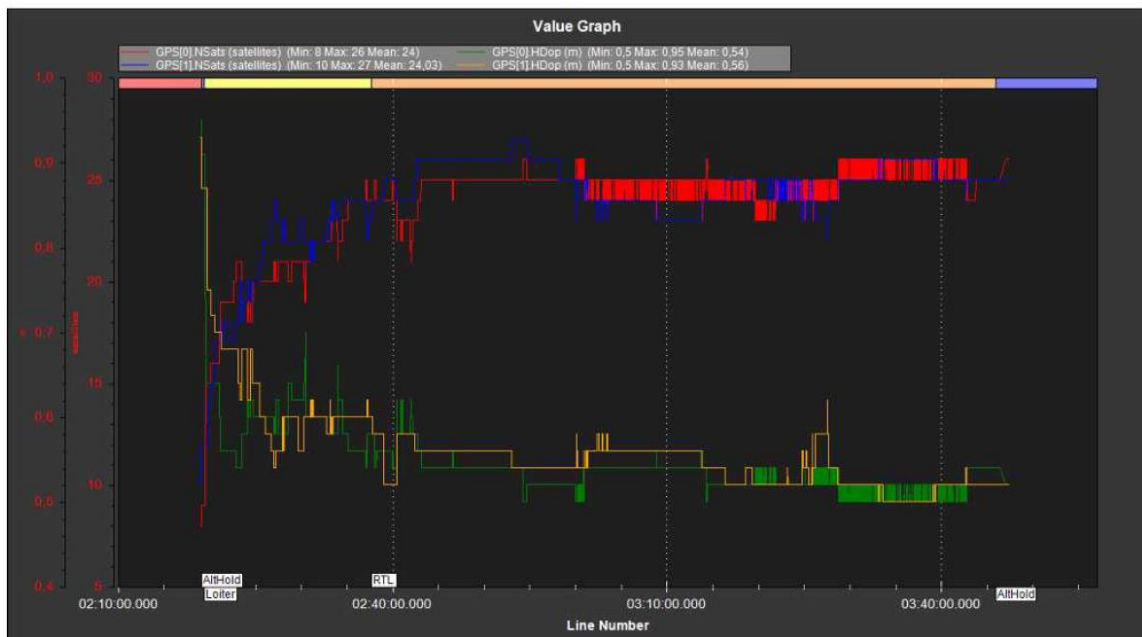
Figure 5: The GPS was in normal range.
