**LIMITED OCCURRENCE INVESTIGATION REPORT – FINAL**

<b>Reference Number</b>	CA/18/2/3/10300						
<b>Classification</b>	Accident	<b>Date</b>	02 February 2023	<b>Time</b>	0632Z		
<b>Type of Operation</b>	Remotely Piloted Aircraft System – Agricultural Operations (Part 101)						
<b>Location</b>							
<b>Place of Departure</b>	Pongola Farm, KwaZulu-Natal Province		<b>Place of Intended Landing</b>	Pongola Farm, KwaZulu-Natal Province			
<b>Place of Occurrence</b>	3 nautical miles (nm) east of Pongola CBD, KwaZulu-Natal Province						
<b>GPS Co-ordinates</b>	Latitude	27° 23' 20.32" S	Longitude	031° 39' 30.21" E	Elevation	771.2 ft	
<b>Aircraft Information</b>							
Registration	ZT-XSR						
Make; Model; S/N	DJI, Agras T30 (Serial Number: 527BJ8600100E8)						
Damage to Aircraft	Substantial		Total Aircraft Hours	472.17			
<b>Pilot-in-command</b>							
Licence Type	Remote Pilot Licence (RPL)		Gender	Male	Age	29	
Licence Valid	Yes	Total Hours	532.4	Total Hours on Type	431.46

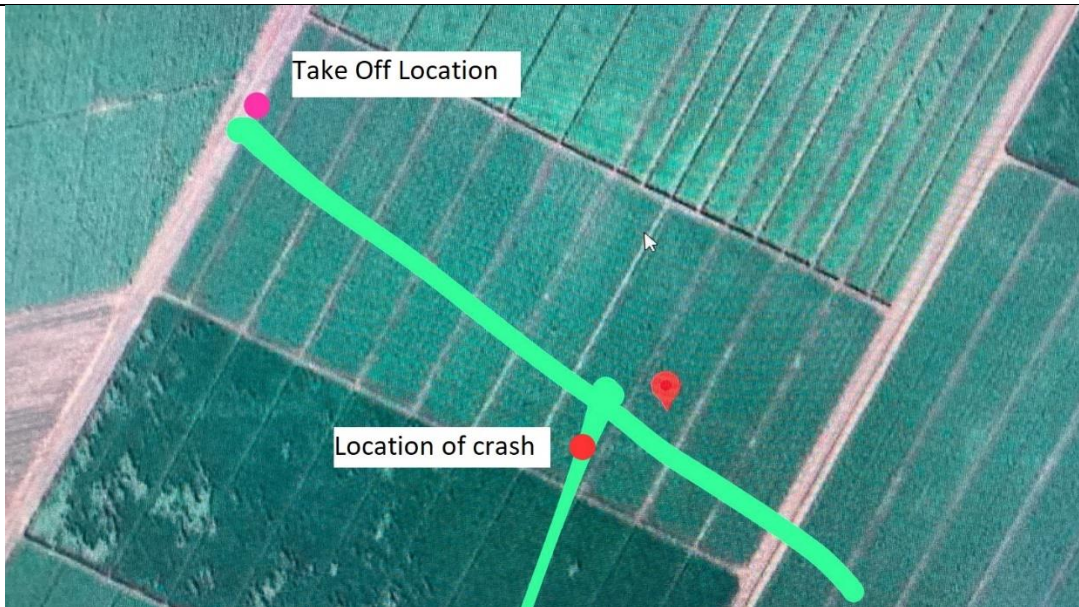
**Figure 1:** Aerial view of the path flown by the RPA. (Source: Operator)

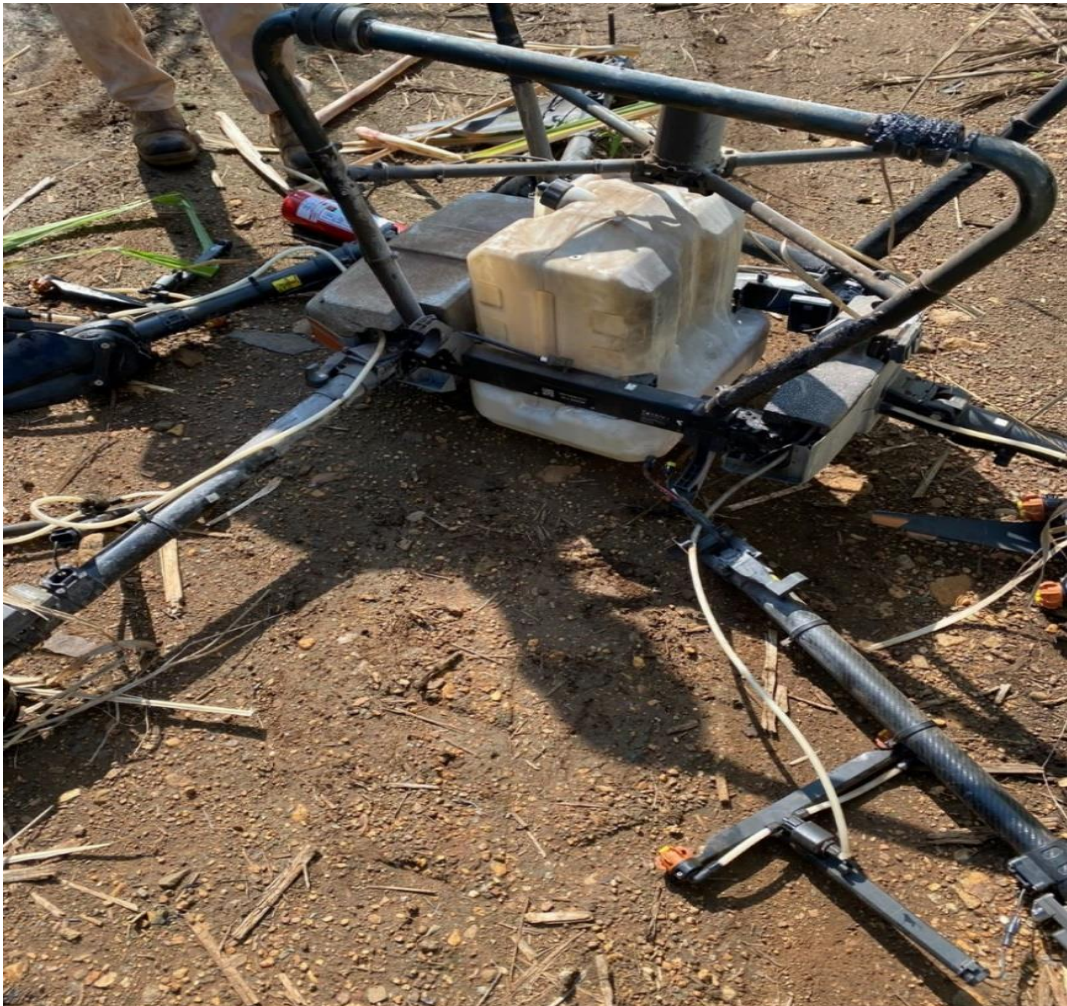
**Figure 2:** The RPA at the accident site (inverted orientation). (Source: Operator)

Post-accident inspection revealed substantial damage to the RPA's landing gear, arms and rotors, attributed to contact with live wire, which led to the fire erupting and the subsequent fall to the ground.
