LIMITED OCCURRENCE INVESTIGATION REPORT – FINAL

Reference Number	CA18/2/3/10301						
Classification	Accident	Date	4 May 2023	Time	2213Z		
Type of Operation	Remotely Piloted Aircraft System – Surveillance (Part 101)						
Location							
Place of Departure	Mondi Mill Bay, KwaZulu-Natal Province		Place of Intended Landing	Mondi Mill Bay, KwaZulu-Natal Province			
Place of Occurrence	Mondi Mill Bay, KwaZulu-Natal, approximately 100 metres from the launch station						
GPS Co-ordinates	Latitude	28° 46'05.21" S	Longitude	031° 59' 28.87" E	Elevation	93ft	
Aircraft Information							
Registration	ZT-XSD						
Make; Model; S/N	DJI; Mavic 2 Enterprise (Serial Number: Mav0073)						
Damage to Aircraft	Substantial		Total Aircraft Hours	150.34			
Pilot-in-command							
Licence Type	Remote Pilot Licence (RPL)		Gender	Male		Age	41
Licence Valid	Yes	Total Hours	1284.45		Total Hours on Type	1284.45	
Total Hours 30 Days	32.8		Total Flying on Type Past 90 Days		57.36

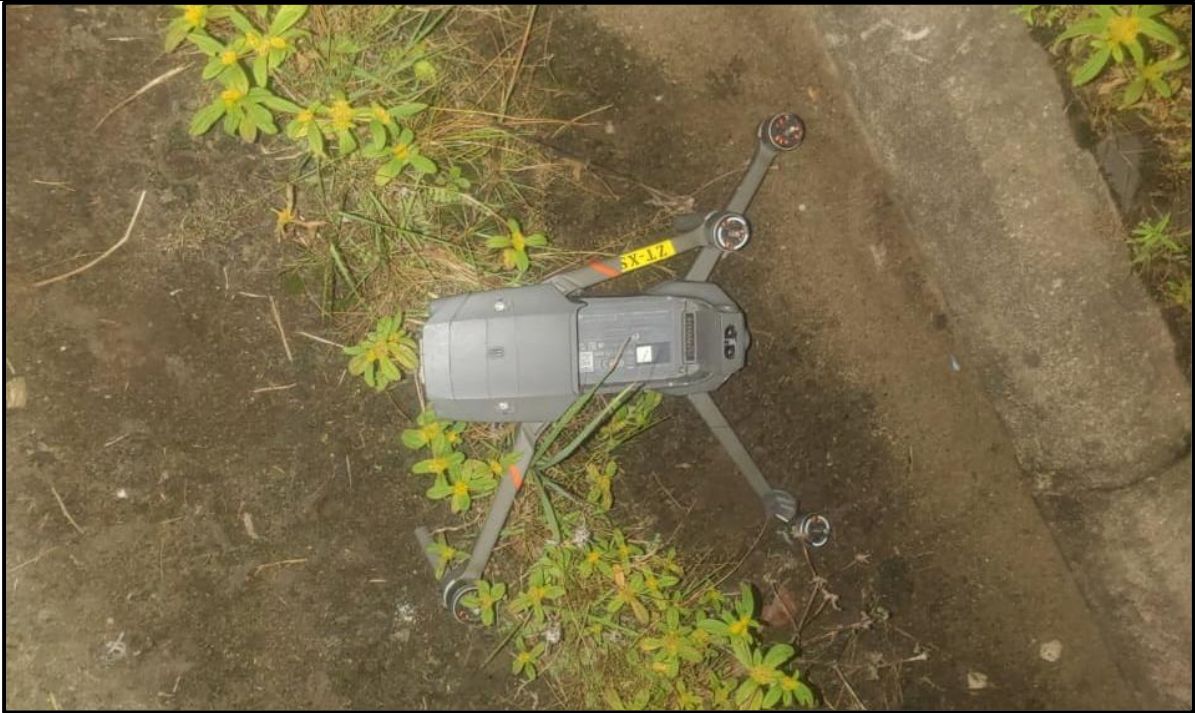
Figure 1: The RPA at the accident site. (Source: Google)

According to the operator's post-accident analysis, the RPA experienced an electronic speed control (ESC) unit malfunction which affected one of the motors, and caused it to spiral down before it impacted the ground.

The electronic speed control unit on the RPA malfunctioned during operation and affected the motor; this caused the RPA to spiral down and eventually crash on the ground. The cause of the ESC unit malfunction could not be determined.
