LIMITED OCCURRENCE INVESTIGATION REPORT – FINAL

Reference Number	CA18/2/3/10302						
Classification	Accident	Date	05 May 2023		Time	0815Z	
Type of Operation	Private (Part 94)						
Location							
Place of Departure	Wag-n-Bietjie Game Safaris, 22nm south-east of FAKM, Northern Cape Province		Place of Intended Landing		Graaf-Reinet (FAGR) Aerodrome, Eastern Cape Province		
Place of Occurrence	Runway 31, Wag-n-Bietjie Game Safari, 22nm south-east of FAKM, Northern Cape Province						
GPS Co-ordinates	Latitude	29°03'08.9" S	Longitude	025°04'36.8" E	Elevation	3324 ft	
Aircraft Information							
Registration	ZU-EWU						
Make; Model; S/N	Rans; S-6 Coyote II (Serial Number: 02061726)						
Damage to Aircraft	Substantial		Total Aircraft Hours	580.3			
Pilot-in-command							
Licence Type	National Pilot Licence (NPL) A		Gender	Male		Age	73
Licence Valid	Yes	Total Hours	2000		Total Hours on Type	390.3	
Total Hours 30 Days	3.24		Total Flying on Type Past 90 Days		22.0

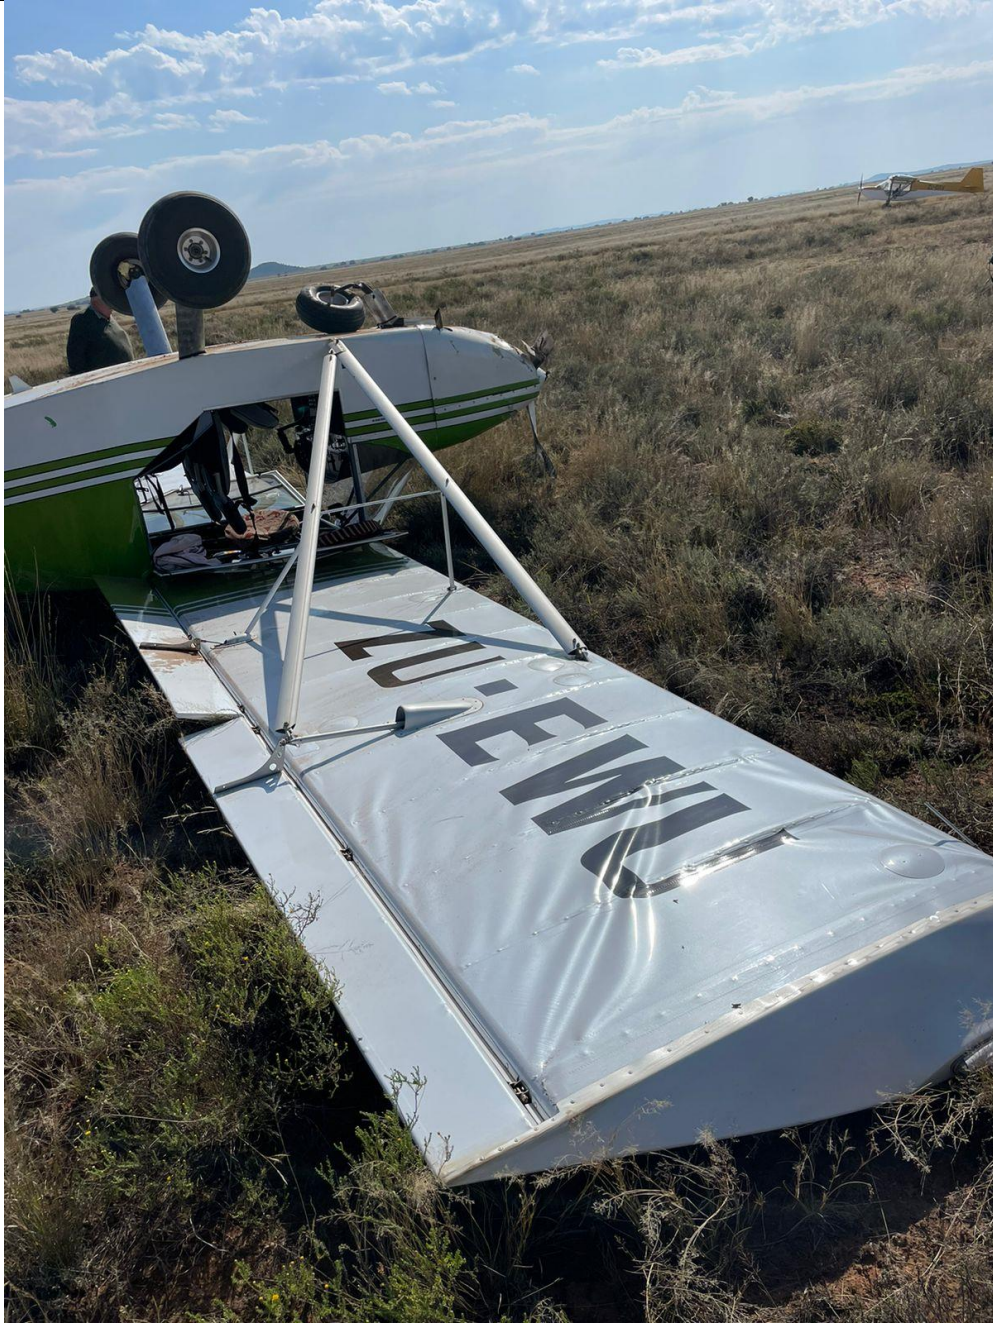
People On-board	1 + 1	Injuries	0	Fatalities	0	Other (on ground)	0
What Happened							
<p>On Friday morning, 5 May 2023, a pilot and a passenger on-board a Rans S6S Coyote II aircraft with registration ZU-EWU took off on a private flight from Wag-n-Bietjie Game Safaris, located 22 nautical miles (nm) south-east of Kimberly (FAKM) in the Northern Cape province to Graaf-Reinet (FAGR) Aerodrome in the Eastern Cape province. The flight was conducted under visual meteorological conditions (VMC) by day and under the provisions of Part 94 of the Civil Aviation Regulations (CAR) 2011 as amended.</p> <p>In preparation for the flight, the pilot reported that he conducted the pre-flight checks on the aircraft, and no anomalies were noted. The pilot selected one notch of flaps for take-off upon reaching the threshold of Runway (RWY) 31. During the ground roll, the aircraft drifted off to the left of the runway. According to the pilot, the aircraft's airspeed was slow to 'come alive'. After rotation, the pilot was unable to correct or recover the aircraft from drifting due to the crosswind that was gusting at the time. The left wing stalled, and the nose wheel ran into one of the animal burrows on the left side of RWY31. This caused the aircraft to nose over before it came to rest in an inverted attitude on the field of grass. The aircraft sustained substantial damage to the nose gear strut, propeller, vertical stabiliser, and fuselage. The pilot and the passenger disembarked from the aircraft uninjured.</p>

Figure 2: The aircraft at the accident site. (Source: Pilot)

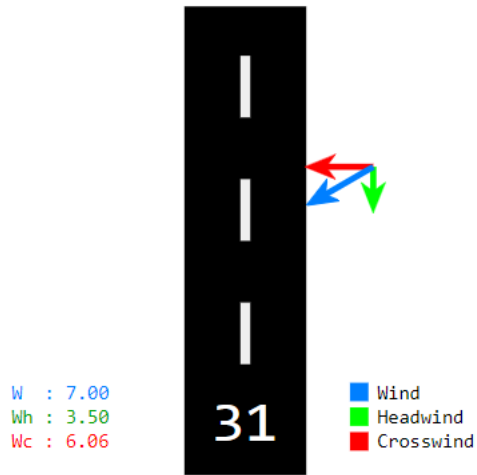
Figure 3: Crosswind component calculation. (Source: E6BX.com)

- The aircraft was maintained by an approved person (AP) with an AP certificate that was issued by the Regulator (SACAA) on 1 August 2021 with an expiry date of 31 July 2022.
- The aircraft drifted to the left of RWY31 during the take-off run due to the crosswind from the right which was at 6 knots. The nose wheel ran into an animal burrow, which caused the aircraft to nose over before it came to rest in an inverted attitude. The pilot and the passenger were not injured. The aircraft sustained substantial damage to the nose gear strut, propeller, fuselage and vertical stabiliser during the accident sequence.
- The aircraft's maximum demonstrated crosswind component is 17.2786 kt (20 miles per hour).

An easterly crosswind.

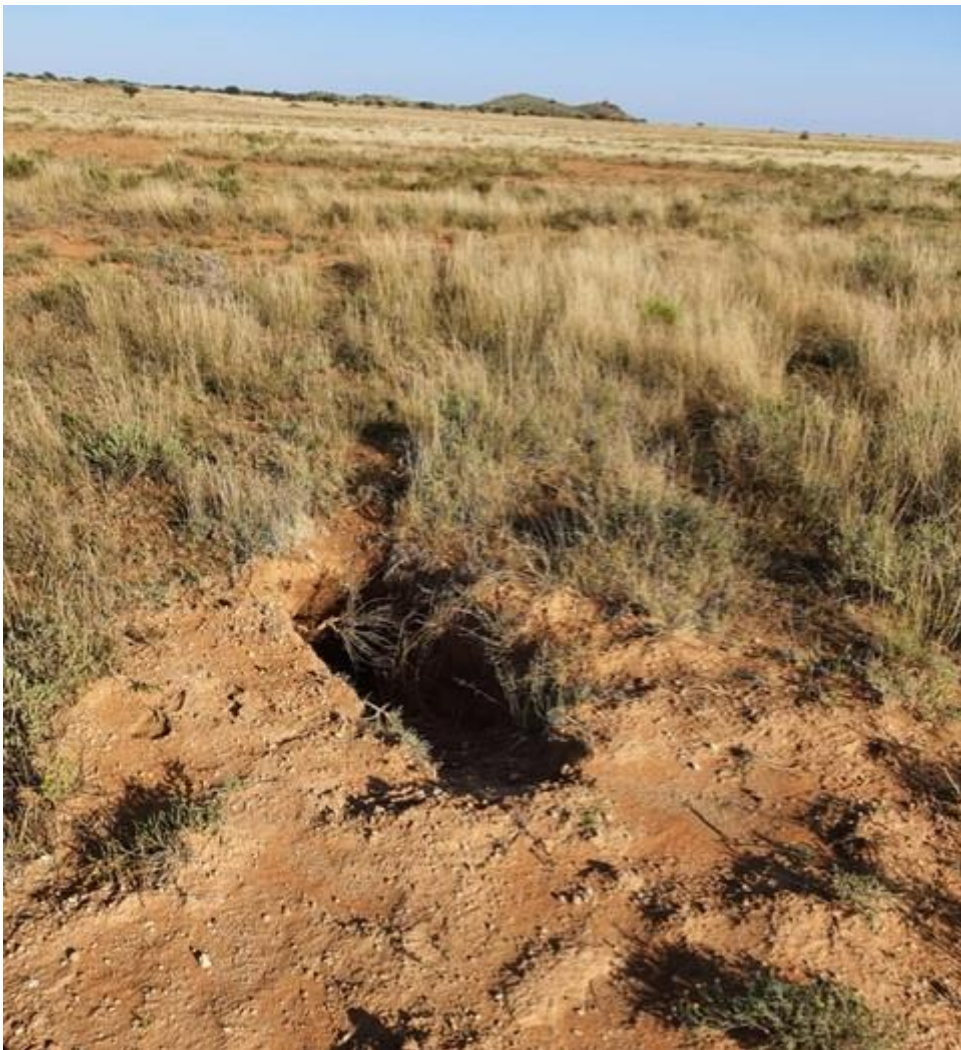
Figure 4: The animal burrow next to the RWY31.

The aircraft rotated at low airspeed which led to a stall and, thus, caused the aircraft's nose gear to impact the runway. As a result, the pilot lost directional control; this was followed by the nose wheel which ran into an animal burrow and, thus, the aircraft nosed over.
