UAS LIMITED OCCURRENCE INVESTIGATION REPORT – FINAL

Reference Number	CA18/2/3/10303					
Classification	Accident	Date	12 May 2023	Time	0037Z	
Type of Operation	Remotely Piloted Aircraft Systems – Aerial Survey (Part 101)					
Location						
Place of Departure	Lonmin Mine, near Marikana, North West Province		Place of Intended Landing	Lonmin Mine, near Marikana, North West Province		
Place of Occurrence	Lonmin Mine, near Marikana, North West Province					
GPS Co-ordinates	Latitude	25°42'48.97" S	Longitude	027°31'02.31" E	Elevation	3670 ft
Aircraft Information						
Registration	ZT-XXC		Class	3A		
Make; Model; S/N	Arace Sirin (Serial Number: SIR0061)					
Damage to Aircraft	Minor		Total UAS Hours	702.17		
Pilot-in-command						
Licence Type	Remote Pilot Licence (RPL)		Gender	Male		Age 27
Licence Valid	Yes	Total Hours	1127.57	Total Hours on Type	1127.57	
Total Hours 30 Days	71.7		Total Flying on Type Past 90 Days	215.23		
People Controlling	1	Injuries	0	Fatalities	0	Injuries (On ground) 0

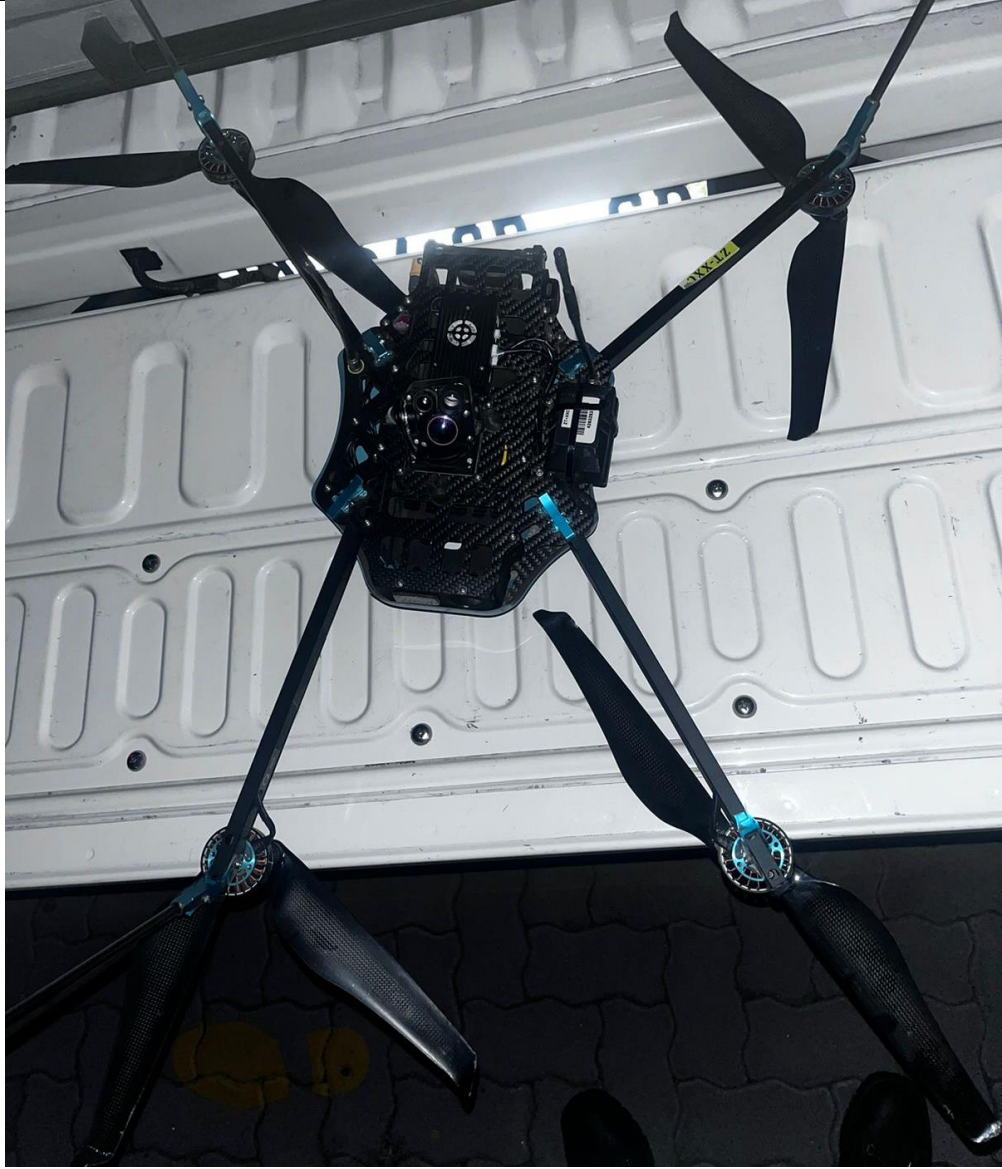
Figure 2: The aircraft during recovery. (Source: Operator)

Incorrect flight mode selection led to the loss of control and the subsequent crash during landing.

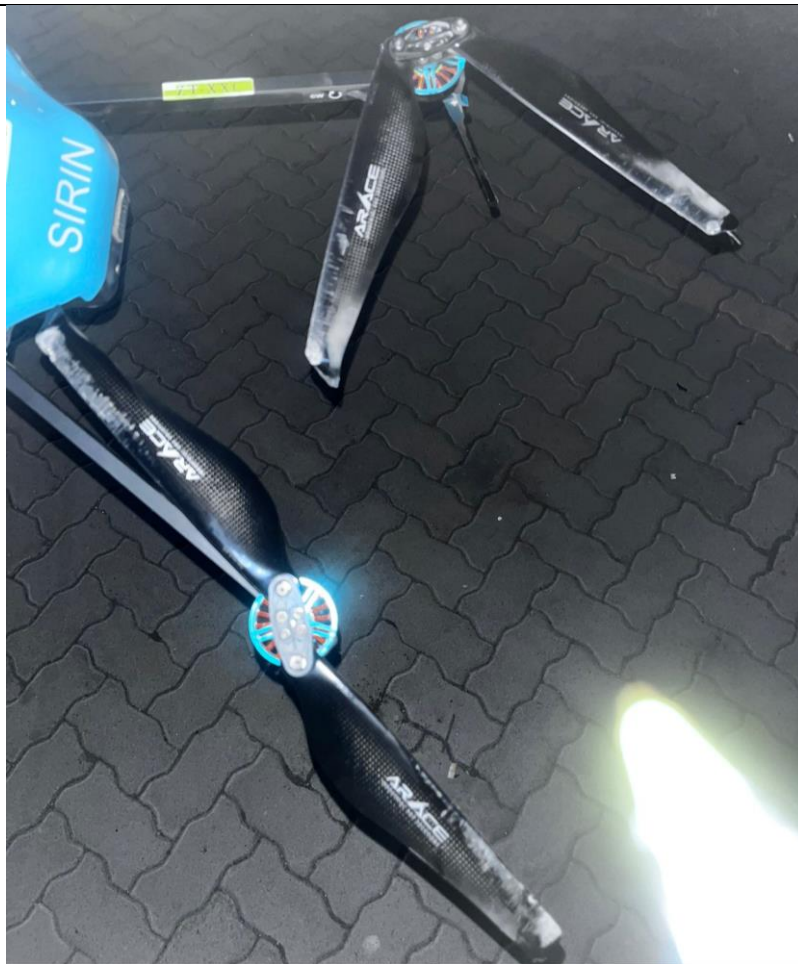
Figure 3: The damaged propeller, motor and landing gear assembly. (Source: Operator)
