**LIMITED OCCURRENCE INVESTIGATION REPORT – FINAL**

<b>Reference Number</b>	CA18/2/3/10305						
<b>Classification</b>	Accident	<b>Date</b>	14 May 2023		<b>Time</b>	1245Z	
<b>Type of Operation</b>	Operation of Non-type Certificated Aircraft (Part 94)						
<b>Location</b>							
Place of Departure	Worcester Aerodrome (FAWC), Western Cape Province			Place of Intended Landing	Worcester Aerodrome (FAWC), Western Cape Province		
Place of Occurrence	Private farm near Villiersdorp, Western Cape Province						
GPS Co-ordinates	Latitude	33°58'09.53" S	Longitude	019°18'14.07" E	Elevation	1 250 feet	
<b>Aircraft Information</b>							
Registration	ZS-GMK						
Make; Model; S/N	Alexander Schleicher GmbH & CO, ASW-20 (Serial Number: 20349)						
Damage to Aircraft	Substantial			Total Aircraft Hours	2 111.0		
<b>Pilot-in-command</b>							
Licence Type	Glider Pilot Licence		Gender	Male		Age	75
Licence Valid	Yes	Total Hours	1 900.0		Total Hours on Type	238.0	
Total Hours 90 Days	7.0		Total Flying on Type Past 90 Days	7.0

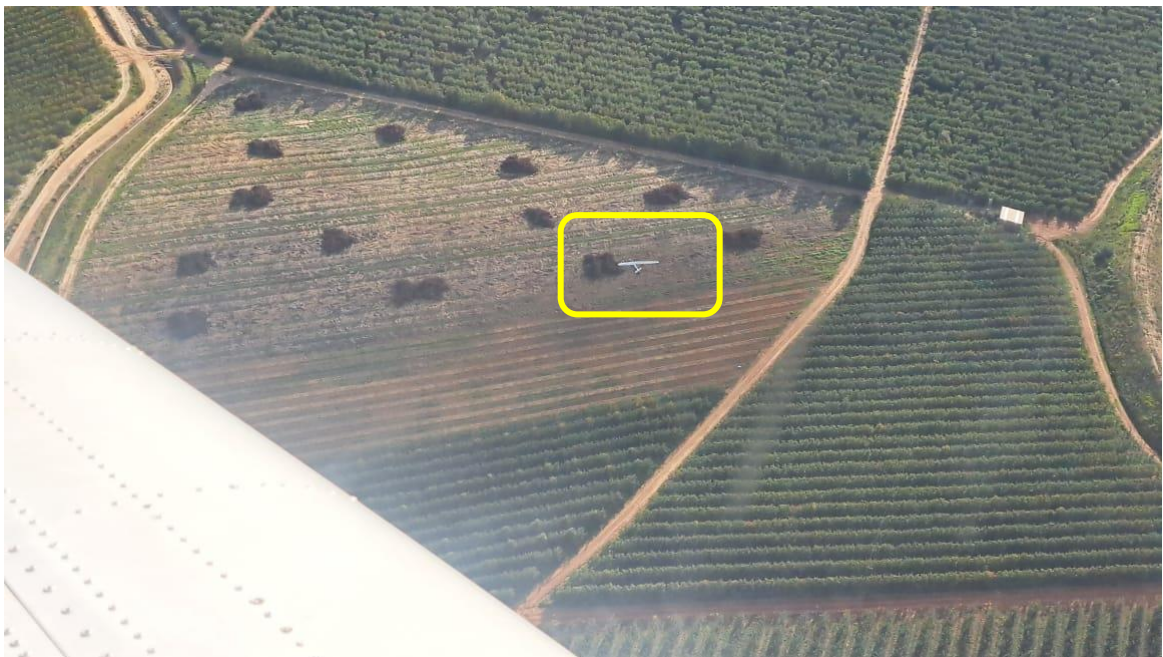
During an interview with the tug pilot, he stated that they took off at approximately 1200Z and, after approximately 10 minutes of aerotowing, the glider pilot disconnected from the tug aircraft. The tug pilot then returned to FAWC for landing, and another glider was attached to the tow rope. Approximately 35 minutes since the tug pilot's first take-off (with ZS-GMK), he was contacted by a person on the ground to look for ZS-GMK glider in Villiersdorp area. The tug pilot located the wreckage from the air approximately 20 nautical miles (nm) south-west of FAWC where it had crashed on an open piece of ploughed farmland. Thereafter, he informed the relevant parties who responded by road to the scene.

**Figure 1:** Aerial picture taken by the tug pilot with the glider in the yellow window. (Source: Tug pilot)

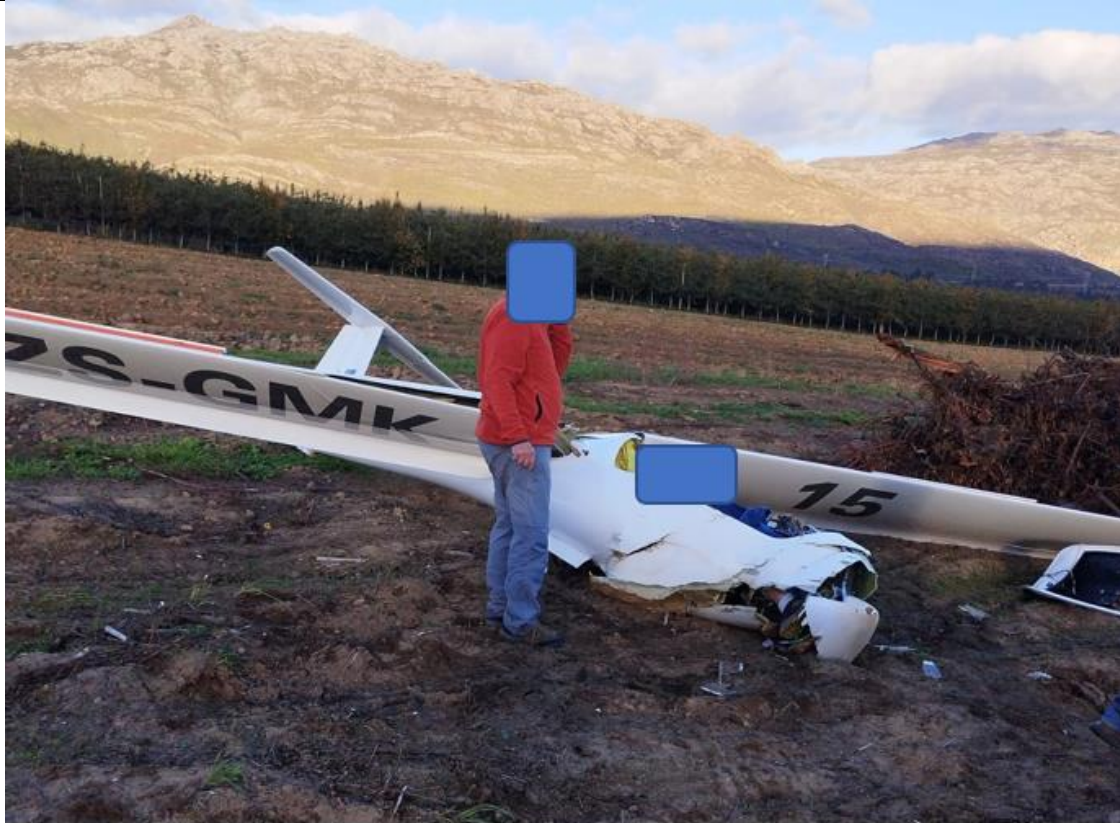
<b>People On-board</b>	1 + 0	<b>Injuries</b>	1	<b>Fatalities</b>	0	<b>Other (on ground)</b>	0
<b>What Happened</b>							
<p>On Sunday afternoon, 14 May 2023, a pilot on-board an ASW-20 glider with registration ZS-GMK was aerotowed by a tug aircraft from Worcester Aerodrome (FAWC). The glider pilot intended to return to FAWC. The private flight was conducted under visual meteorological conditions (VMC) by day and under the provisions of Part 94 of the Civil Aviation Regulations (CAR) 2011 as amended.</p> <p>The ZS-GMK glider was the first of the two gliders to be towed by the same tug aircraft from FAWC. The glider pilot stated that the wind was brisk at the time, and he needed only 10 minutes of aerotowing before releasing the tow rope from the tug aircraft. It took him two passes to reach the cloud base, which was at a height of approximately 4 300 feet (ft). According to the glider pilot, the flight was normal for the terrain but once the glider passed Villiersdorp, the lift started to deteriorate due to topography (see Figure 3). The glider lost lift and height despite the glider pilot's attempts to maintain it. It headed further down the valley, continuing to lose lift and, at that point, the glider pilot realised that an out landing was imminent. He then selected an open field to land, lowered the undercarriage, and selected the landing flaps. The glider pilot further stated that whilst he manoeuvred the glider for landing, it had turned right at that time and, during the turn, it stalled and the right wing dropped. The glider impacted the terrain in a right-wing low nose-down attitude, and was damaged beyond economical repair (see Figure 2).</p>

**Figure 2:** The glider as it came to rest with the pilot still trapped inside. (Source: ARCC)

4.5	The glider lost lift and height and, during a right turn, the aircraft stalled and the pilot could not recover due to the low height of the glider. The glider subsequently crashed in a right-wing low nose-down attitude.
<b>Probable Cause</b>	
The glider stalled and crashed during a right turn after losing lift and height. The pilot could not recover due to the glider's low height.
