UAS LIMITED OCCURRENCE INVESTIGATION REPORT – FINAL

Reference Number	CA18/2/3/10306						
Classification	Accident	Date	10 May 2023	Time	1940Z		
Type of Operation	Unmanned Aircraft System – Surveillance (Part 101)						
Location							
Place of Departure	Vrede, Free State Province		Place of Intended Landing	Vrede, Free State Province			
Place of Occurrence	Vrede, Free State Province						
GPS Co-ordinates	Latitude	27° 27' 16.6" S	Longitude	29° 08' 27.6" E	Elevation	5 561 ft	
Aircraft Information							
Registration	ZT-XVM		Class	3A			
Make; Model; S/N	Arace, Sirin (Serial Number: SIR0053)						
Damage to Aircraft	Substantial		Total UAS Hours	679.22			
Pilot-in-command							
Licence Type	Remote Pilot Licence (RPL)		Gender	Male	Age	29	
Licence Valid	Yes	Total Hours	352.98	Total Hours on Type	352.98		
Total Hours 30 Days	38.55		Total Flying on Type Past 90 Days	170.45			
People Controlling	1	Injuries (On ground)	0	Fatalities	0	Fatalities (on ground)	0
What Happened

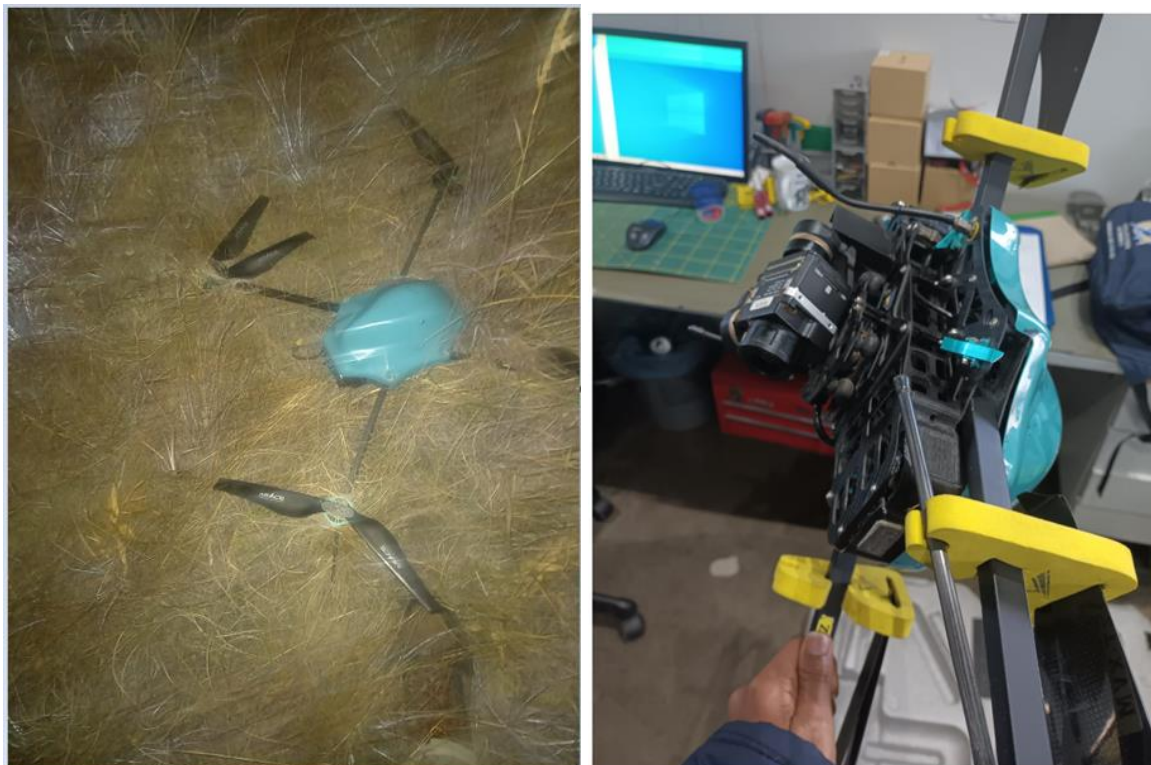
which had sustained substantial damage to the landing gear and gimbal. There were no reported injuries to persons on the ground.

Figures 2 and 3: The UAS at the accident site (left), and after its recovery (right). (Source: Operator)

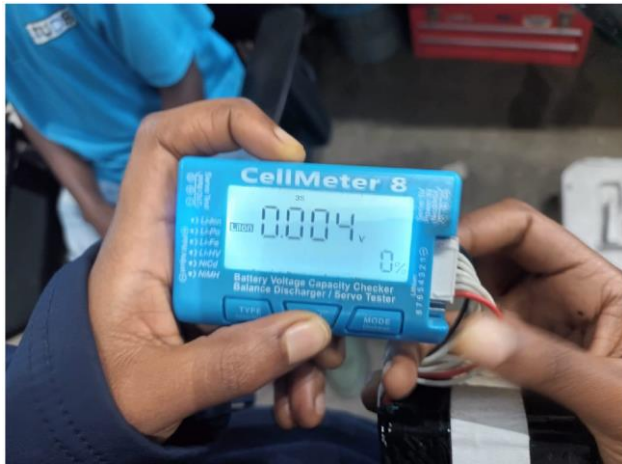
The images below show individual battery cells of the UAS. It can be noted that cell 3 is damaged; and all four cells have a different cell percentage.

Figure 5: Cell 3 is at 0%. (Source: Operator)

7. The downloaded logs showed that the pilot made inputs to the UAS which caused it to crash.
8. The UAS battery had a cell failure which likely caused an unstable power output, which resulted in multiple failure indications and a signal disconnection from the remote pilot station before it crashed.

The UAS battery had a cell failure which likely caused an unstable power output that resulted in multiple failure indications and a signal disconnection from the remote pilot station before it crashed.

1. The pilot must follow Sirin Critical Battery Failsafe Procedure.
2. The pilot must check the batteries' cell-specific integrity before and after each flight.
3. The pilot must maintain situational awareness regarding on-screen vitals and flight modes.

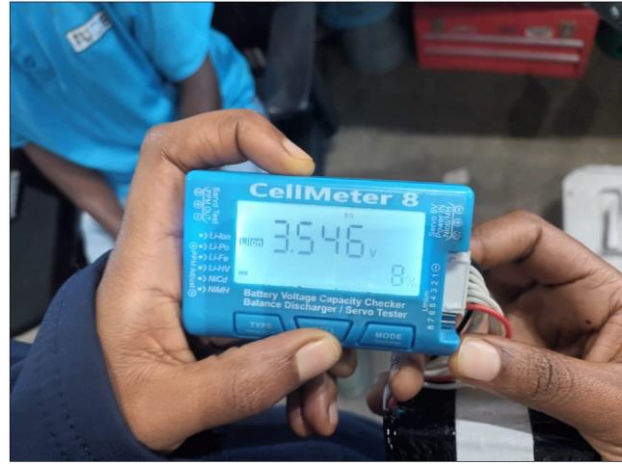
Figure 6: Cell 5 is at 8%. (Source: Operator)

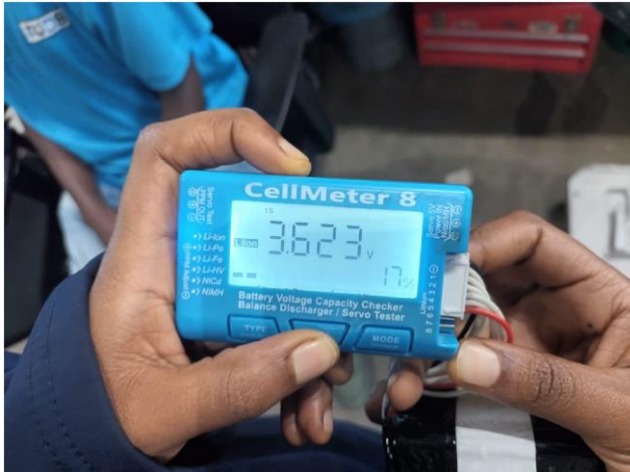
Figure 7: Cell 1 is at 17%. (Source: Operator)

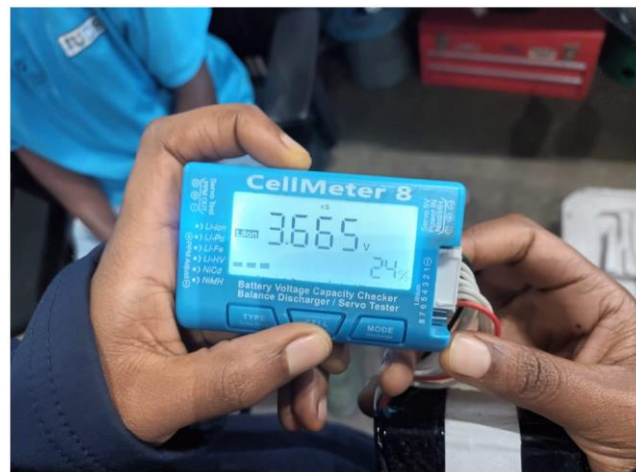
Figure 8: Cell 4 is at 24%. (Source: Operator)
