UAS LIMITED OCCURRENCE INVESTIGATION REPORT – FINAL

Reference Number	CA18/2/3/10307						
Classification	Accident	Date	10 May 2023	Time	0139Z		
Type of Operation	Unmanned Aircraft System – Surveillance (Part 101)						
Location							
Place of Departure	Balfour, Mpumalanga Province		Place of Intended Landing	Balfour, Mpumalanga Province			
Place of Occurrence	6nm south of Balfour, Mpumalanga Province						
GPS Co-ordinates	Latitude	26° 44' 56" S	Longitude	28° 37' 48" E	Elevation	5 352 feet	
Aircraft Information							
Registration	ZT-YHR		Class	3A			
Make; Model; S/N	Arace Sirin (Serial Number: SIR122)						
Damage to Aircraft	Substantial		Total UAS Hours	127.16			
Pilot-in-command							
Licence Type	Remote Pilot Licence (RPL)		Gender	Male	Age	30	
Licence Valid	Yes	Total Hours	234.57	Total Hours on Type	234.57		
Total Hours 30 Days	65.03		Total Flying on Type Past 90 Days	114.32			
People Controlling	1	Injuries (On ground)	0	Fatalities	0	Fatalities (on ground)	0

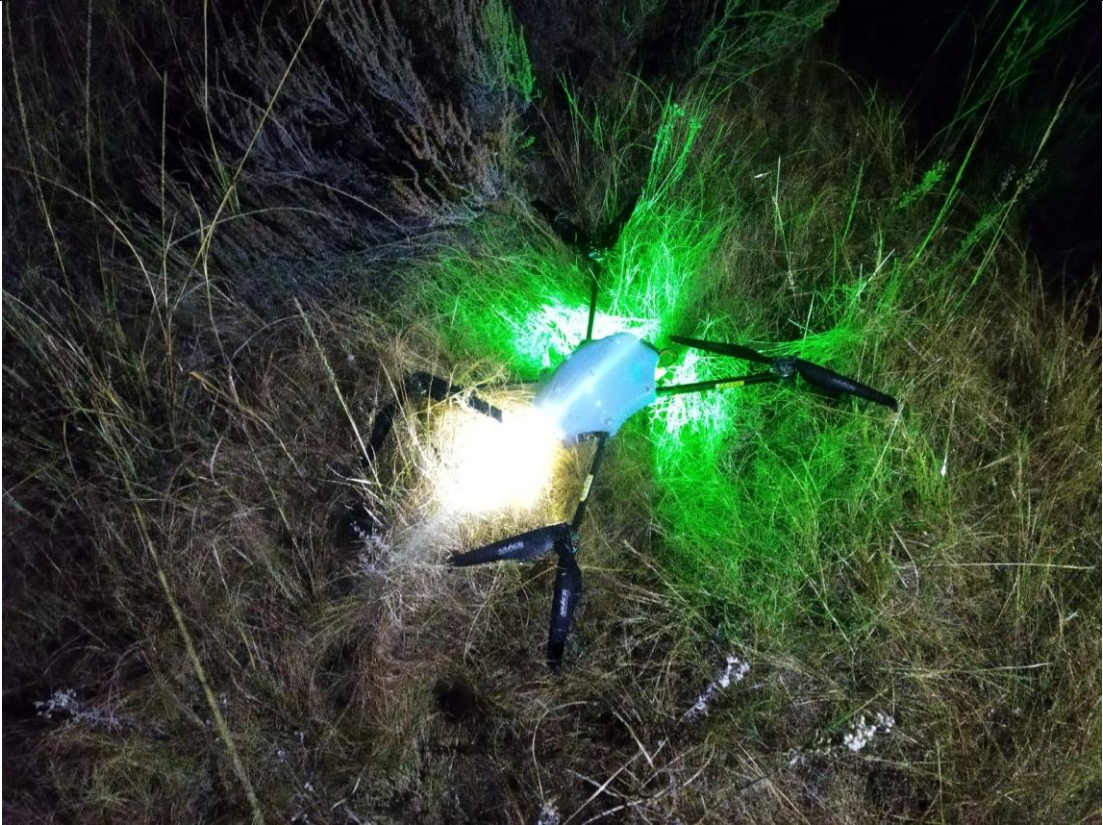
What Happened							
<p>On Wednesday morning, 10 May 2023 at 0048Z, an unmanned aircraft system (UAS) Arace Sirin with registration ZT-YHR was launched from a launch pad in Balfour, Mpumalanga province, to conduct security surveillance in the area with the intention to return to the same take-off launch pad. The flight was conducted under beyond visual line of sight (BVLOS) rules by night and under the provisions of Part 101 of the Civil Aviation Regulations (CAR) 2011 as amended.</p> <p>The pilot reported that he conducted the pre-flight checks with no anomalies noted. He then armed and launched the UAS for the mission with 95% battery power available. The UAS climbed to 410 feet (ft) above ground level (AGL) to start the mission which lasted approximately 55 minutes (see Figure 3). Whilst the UAS was on its return flight to the launch pad, the pilot noticed a fail-safe 'EKF3 lane switch' (estimate vehicle position, velocity and angular orientation) warning on the remote pilot station display. Shortly thereafter, the UAS disconnected from the remote pilot station. The pilot switched on the strobe lights to visually locate the UAS; he located it on the ground approximately 10 metres from the launch pad with damage to the landing legs, fuselage and camera gimbal. No injuries to persons on the ground were reported.</p>

Figure 1: ZT-YHR at the accident site. (Source: Operator)

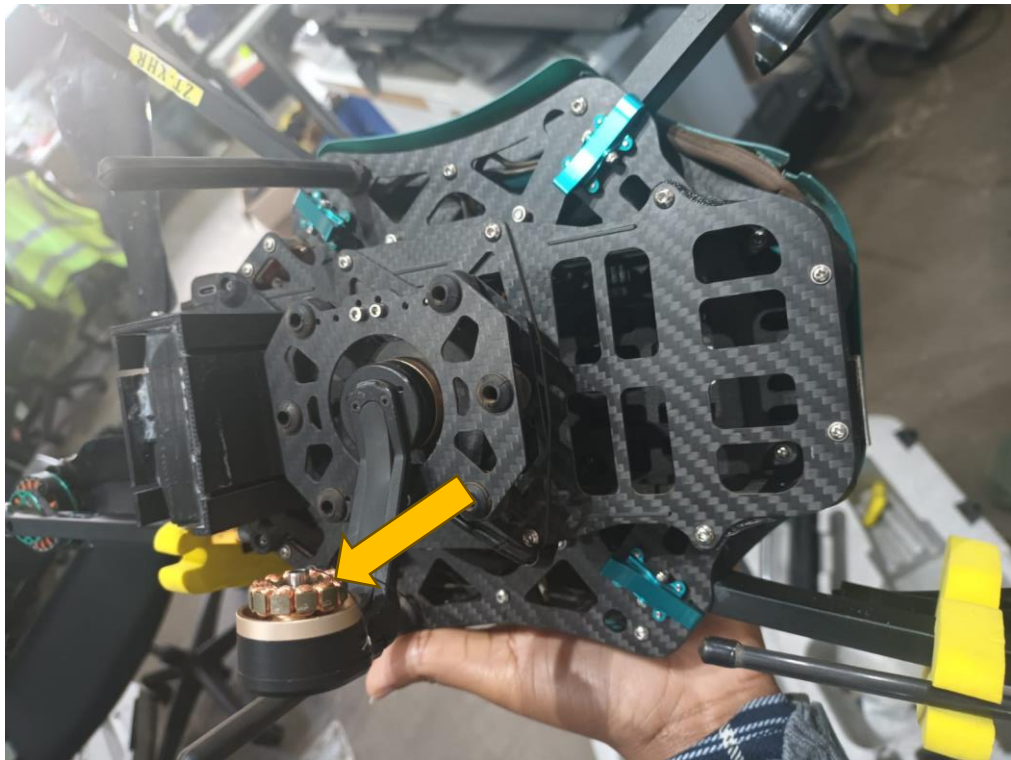
Figure 2: Damage to the camera. (Source: Operator)

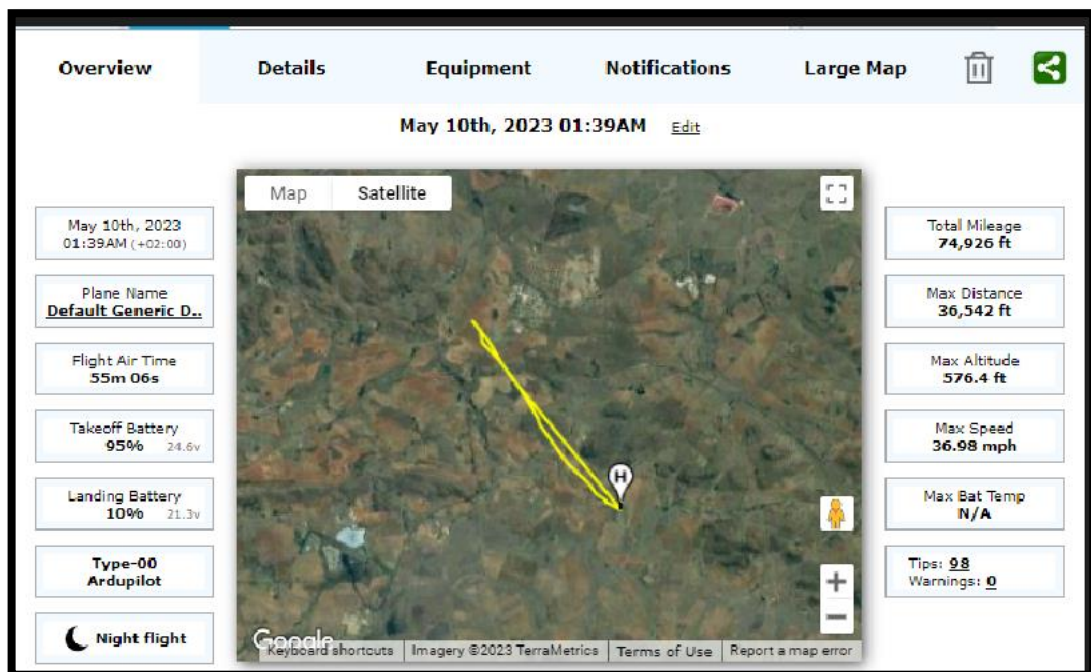
Figure 4: Total elapsed time and power, launch and landing. (Source: Operator)

<p>5. A mandatory periodic inspection (MPI) at 118.58 was completed on 05 May 2023. The next MPI was due at 193.58.</p> <p>6. The EFK3 lane switch activated, and the battery was at critical level to depletion at 10%, hence, the UAS defaulted to landing. The flight endurance was almost 60 minutes (Figure 3).</p> <p>7. The operator's standard operating procedure (SOP) states that the UAS must be landed with at least 25% battery capacity still remaining (Figure 5).</p>
<p>Probable Cause(s)</p> <p>The UAS initiated an unsuccessful land mode after EFK3 lane switch warning activated, and the battery was close to depletion at below the SOP recommended 25%.</p>
<p>Contributing Factor(s)</p> <p>None.</p>
<p>Safety Action(s)</p> <p>None.</p>
<p>Safety Message</p> <p>UAS pilots are reminded to always adhere to the operator's SOP limitations and advisory messages.</p>
<p>About this Report</p> <p><i>The decision to conduct a limited investigation is based on factors including whether the cause is known and the evidence supporting the cause is clear, the level of safety benefit likely to be obtained from an investigation and that will determine the scope of an investigation. For this occurrence, a limited investigation has been conducted, and the Accident and Incident Investigations Division (AIID) has relied on the information submitted by the affected person/s and organisation/s to compile this limited report. The report has been compiled using information supplied in the initial notification, as well as from follow-up desk top enquiries to bring awareness of potential safety issues to the industry in respect of this occurrence, as well as possible safety action/s that the industry might want to consider in preventing a recurrence of a similar occurrence.</i></p> <p><i>All times given in this report are Co-ordinated Universal Time (UTC) and will be denoted by (Z). South African Standard Time is UTC plus 2 hours.</i></p>
