**RPAS/UAS LIMITED OCCURRENCE INVESTIGATION REPORT – FINAL**

<b>Reference Number</b>	CA18/2/3/10308						
<b>Classification</b>	Accident	<b>Date</b>	19 April 2023	<b>Time</b>	2013Z		
<b>Type of Operation</b>	Remotely Piloted Aircraft System – Surveillance (Part 101)						
<b>Location</b>							
Place of Departure	Nottingham Road, KwaZulu-Natal Province		Place of Intended Landing	Nottingham Road, KwaZulu-Natal Province			
Place of Occurrence	Nottingham Road, on the ground approximately 20 metres from the launch pad, KwaZulu-Natal (KZN) Province						
GPS Co-ordinates	Latitude	29°22'37.1" S	Longitude	030°00'37.8" E	Elevation	4631 ft	
<b>Aircraft Information</b>							
Registration	ZT-YAA		Class	3A			
Make; Model; S/N	Arace Sirin (Serial Number: SIR0081)						
Damage to Aircraft	Substantial		Total UAS Hours	621.14			
<b>Pilot-in-command</b>							
Licence Type	Remote Pilot Licence (RPL)		Gender	Male	Age	22	
Licence Valid	Yes	Total Hours	142.8	Total Hours on Type	142.4

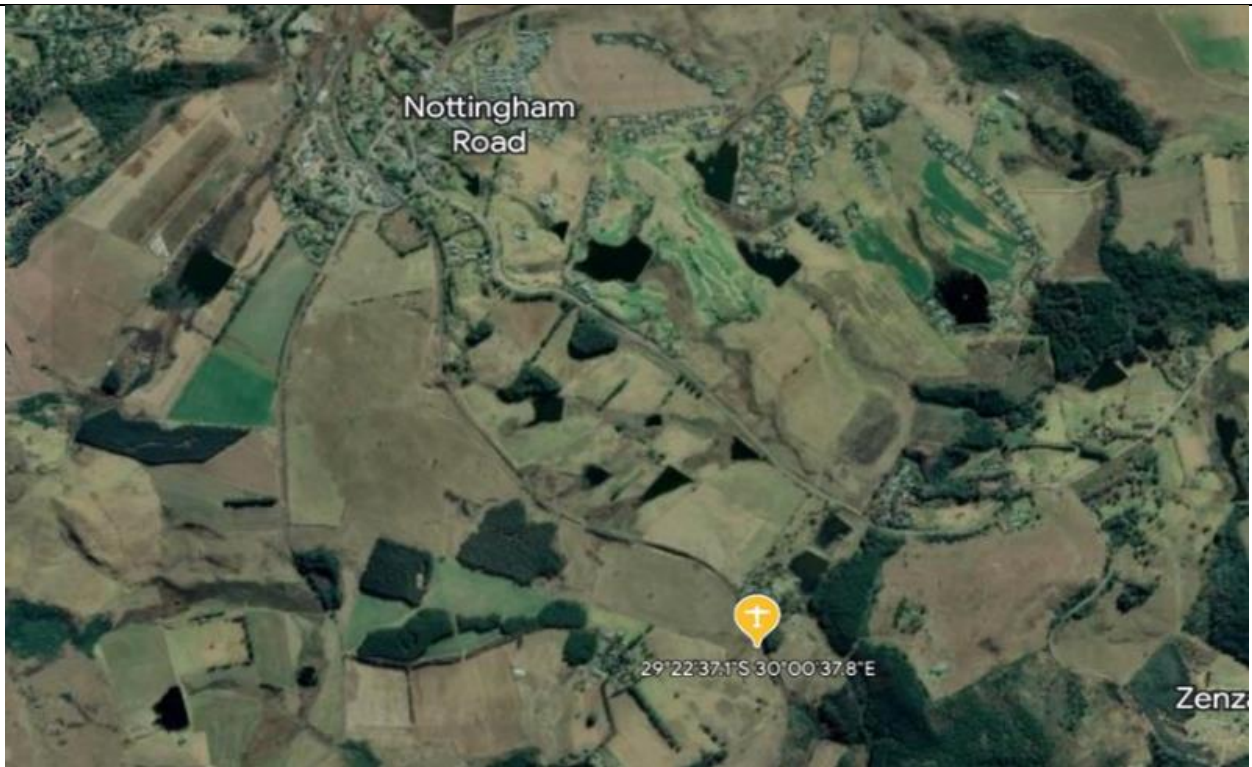
Figure 1: A view of the accident site. (Source: Google Earth)

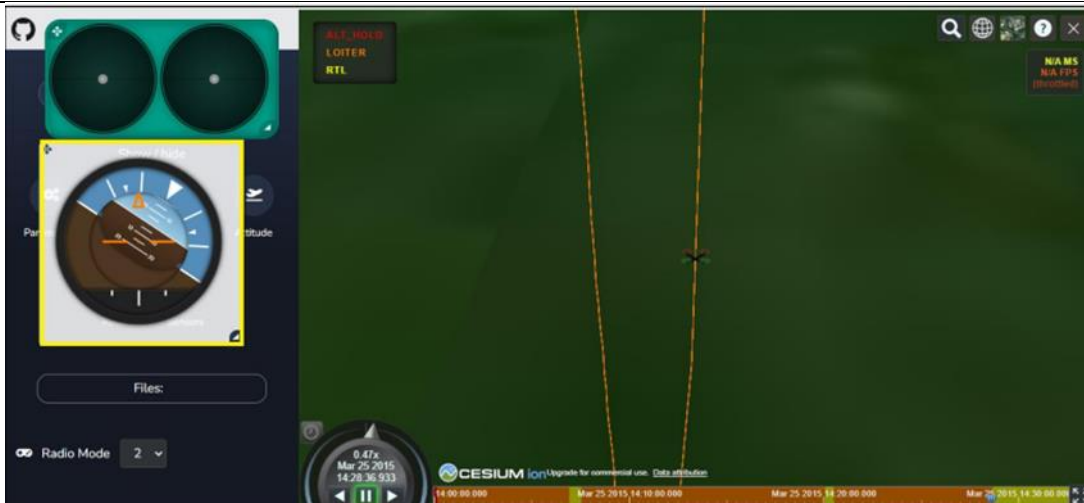
Figure 3: The UAS rolling to the right. (Source: Operator)

6. The flight logs recorded potential thrust loss from the number 2 and 4 motors, which is consistent with vortex ring state. This caused the aircraft to roll sharply to the right and lose altitude rapidly before it crashed to the ground.

7. It is likely that the loss of control was because of a rapid depletion of the battery below 50% which caused the loss of thrust on the number 2 and 4 motors, therefore, caused an imbalance of the motors and a loss of control before the UAS crashed.
