**LIMITED OCCURRENCE INVESTIGATION REPORT – FINAL**

<b>Reference Number</b>	CA18/2/3/10309						
<b>Classification</b>	Accident	<b>Date</b>	10 April 2023			<b>Time</b>	1100Z
<b>Type of Operation</b>	Private (Part 94)						
<b>Location</b>							
Place of Departure	Worcester Aerodrome (FAWC), Western Cape Province		Place of Intended Landing	Private Farm in Piketburg, Western Cape Province			
Place of Occurrence	Private Farm in Piketburg, Western Cape Province						
GPS Co-ordinates	Latitude	32° 48' 06" S	Longitude	018° 51' 50" E	Elevation	493ft	
<b>Aircraft Information</b>							
Registration	ZU-FCB						
Make; Model; S/N	Ekolot JK-05-Junior (Serial Number: JK-05 Junior)						
Damage to Aircraft	Substantial			Total Aircraft Hours	552.6		
<b>Pilot-in-command</b>							
Licence Type	National Pilot Licence		Gender	Male		Age	53
Licence Valid	Yes	Total Hours	215.1		Total Hours on Type	207.8	
Total Hours 30 Days	8.0			Total Flying on Type Past 90 Days	30.9		
<b>People On-board</b>	1+1	<b>Injuries</b>	0	<b>Fatalities</b>	0	<b>Other (on ground)</b>	0

**This report is issued by:**  
**Accident and Incident Investigations Division**  
**South African Civil Aviation Authority**  
**Republic

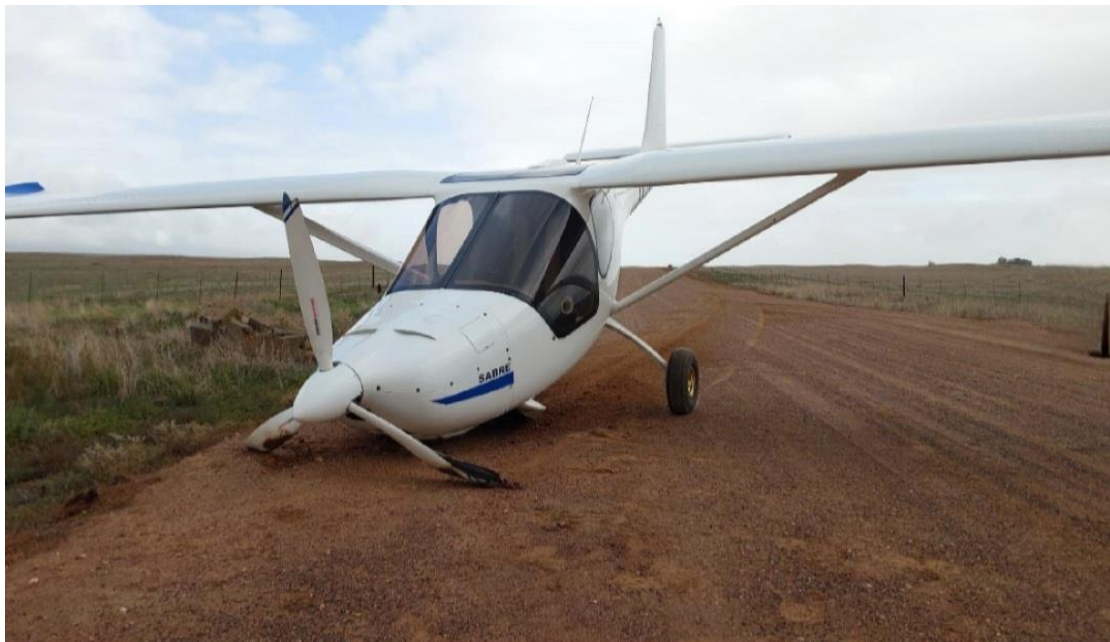
**Figure 1:** The aircraft at the accident site. (Source: Operator)

<p>8. The pilot stated that the aircraft bounced twice and landed hard with the nose gear, which broke off; this was followed by the propeller strike on the ground.</p> <p>9. The aircraft was too fast on approach due to the tailwind. As a result, the aircraft touched down hard with the nose gear and bounced.</p>
<p><b>Probable Cause</b></p> <p>The aircraft landed with a tailwind; it initially bounced and finally landed hard and, as a result, the nose gear broke off and the propeller struck the ground.</p>
<p><b>Contributing Factors</b></p> <p>Incorrect landing technique. Tailwind during landing.</p>
<p><b>Safety Action(s)</b></p> <p>None.</p>
<p><b>Safety Message and/or Safety Recommendation(s)</b></p> <p>None.</p>
<p><b>About this Report</b></p> <p><i>The decision to conduct a limited investigation is based on factors including whether the cause is known and the evidence supporting the cause is clear, the level of safety benefit likely to be obtained from an investigation and that will determine the scope of an investigation. For this occurrence, a limited investigation has been conducted, and the Accident and Incident Investigations Division (AIID) has relied on the information submitted by the affected person/s and organisation/s to compile this limited report. The report has been compiled using information supplied in the initial notification, as well as from follow-up desk top enquiries to bring awareness of potential safety issues to the industry in respect of this occurrence, as well as possible safety action/s that the industry might want to consider in preventing a recurrence of a similar occurrence.</i></p> <p><i>All times given in this report are Co-ordinated Universal Time (UTC) and will be denoted by (Z). South African Standard Time is UTC plus 2 hours.</i></p>

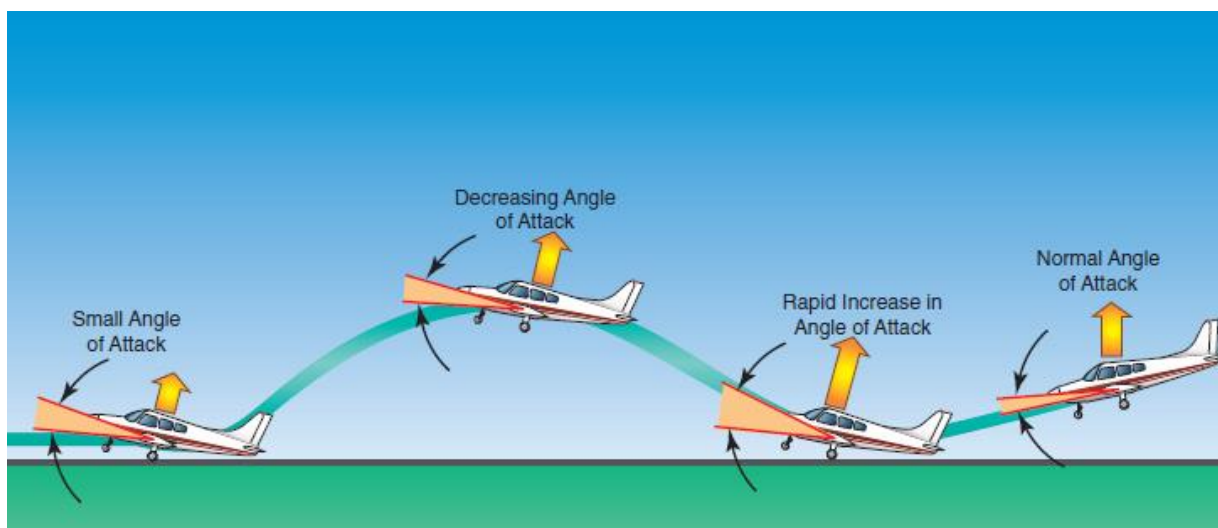
**Illustration 1:** Illustration shows how the aircraft bounce. (Source: FAA Airplane Flying Handbook)
