**LIMITED OCCURRENCE INVESTIGATION REPORT – FINAL**

<b>Reference Number</b>	CA18/2/3/10310						
<b>Classification</b>	Accident	<b>Date</b>	23 May 2023	<b>Time</b>	1438Z		
<b>Type of Operation</b>	General Aviation and Operating Flight Rules (Part 91)						
<b>Location</b>							
Place of Departure	Laseria International Airport (FALA), Gauteng Province		Place of Intended Landing	Laseria International Airport (FALA), Gauteng Province			
Place of Occurrence	Runway 07 at Laseria International Airport (FALA), Gauteng Province						
GPS Co-ordinates	Latitude	S25°56'30.91"	Longitude	E027°55'19.98"	Elevation	4 478 ft	
<b>Aircraft Information</b>							
Registration	ZS-IKY						
Make; Model; S/N	Piper Cherokee, PA 28-140 (Serial Number: 28-7225160)						
Damage to Aircraft	Substantial		Total Airframe Hours	8 321.25			
<b>Pilot-in-command</b>							
Licence Type	Private Pilot Licence (PPL)			Gender	Male	Age	28
Licence Valid	Yes	Total Hours on Type	2.7	Total Flying Hours	104.7

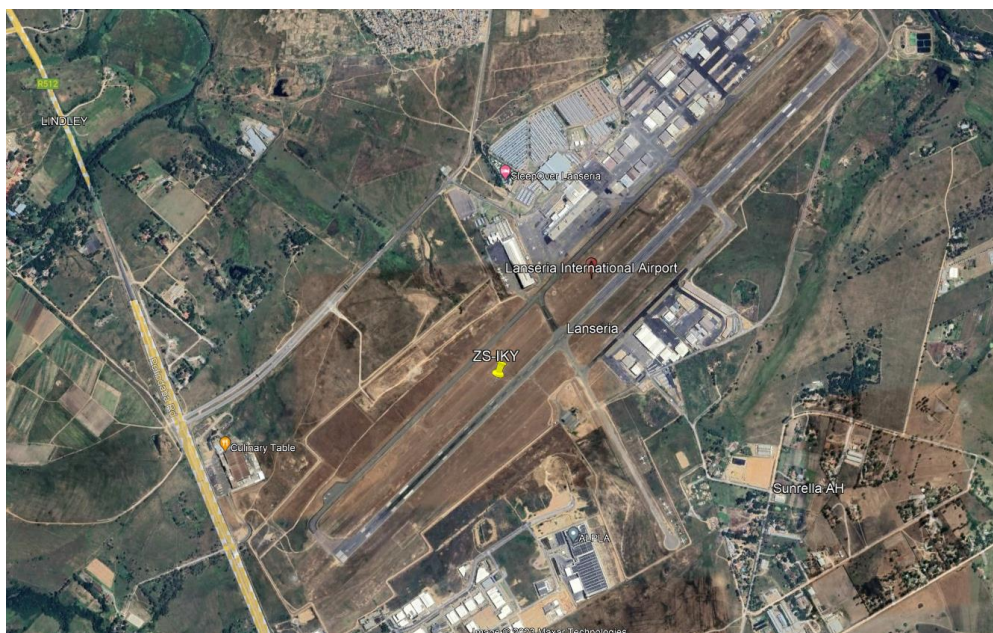
**Figure 1:** Overlay of the accident site. (Source: Google Earth)

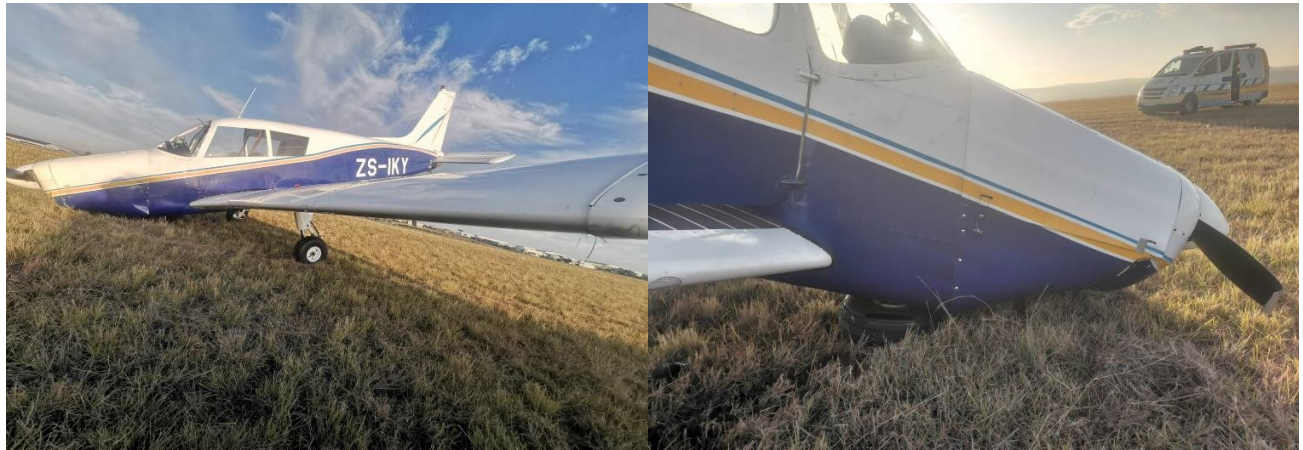
the pilot lost directional control of the aircraft. To regain control, he applied the brakes at different strengths which caused the aircraft to veer off to the left of the runway. The aircraft skidded for 23 metres from the edge of the runway before it came to a stop facing a northerly direction. During the sequence of events, the nose gear collapsed, and the right wing and the propeller blades contacted the runway surface.

The aircraft sustained substantial damage to the right wing tip, nose gear, lower engine cowling and propellers. No persons were injured.

**Figures 2 and 3:** The aircraft after it was repositioned from the runway edge. (Source: Operator)
