UAS LIMITED OCCURRENCE INVESTIGATION REPORT – FINAL

Reference Number	CA18/2/3/10311						
Classification	Accident	Date	27 May 2023		Time	1701Z	
Type of Operation	Remotely Piloted Aircraft System – Surveillance (Part 101)						
Location							
Place of Departure	Harmony Savuka Mine, Gauteng Province		Place of Intended Landing	Harmony Savuka Mine, Gauteng Province			
Place of Occurrence	Harmony Savuka Mine in Gauteng Province						
GPS Co-ordinates	Latitude	26° 24' 58.24" S	Longitude	27° 24' 26.61" E	Elevation	5303 ft	
Aircraft Information							
Registration	ZT-XOD		Class	3A			
Make; Model; S/N	Arace; Sirin (Serial Number: SIR0024)						
Damage to Aircraft	Substantial		Total UAS Hours	534.2			
Pilot-in-command							
Licence Type	Remote Pilot Licence (RPL)		Gender	Male		Age	27
Licence Valid	Yes	Total Hours	755.3		Total Hours on Type	755.3	
Total Hours Past 90 Days	240.3		Total Flying Past 90 Days on Type	240.3			
Injuries	0	Injuries (On Ground)	0	Fatalities (On Ground)	0

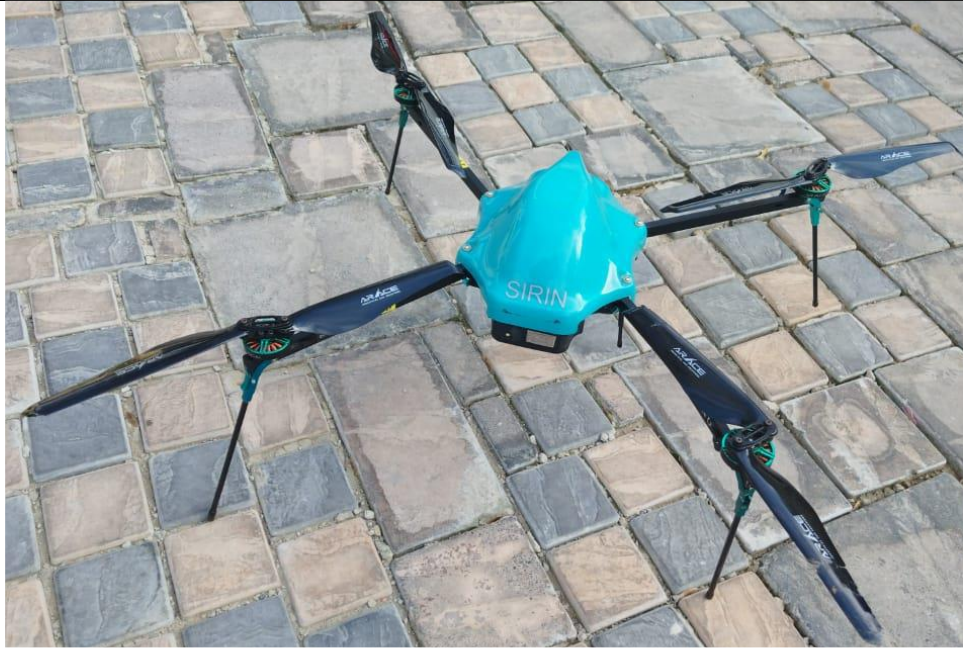
People Controlling	1						
What Happened							
<p>On 27 May 2023, an Unmanned Aircraft System (UAS) with registration ZT-XOM was engaged in a security surveillance flight at Harmony Savuka Mine in Carletonville, Gauteng province, when the accident occurred. The flight was conducted under beyond visual line of sight (BVLOS) rules by night and under the provisions of Part 101 of the Civil Aviation Regulations (CAR) 2011 as amended.</p> <p>The pilot reported that he conducted all the pre-flight checks before lift-off. The UAS was launched in ALT Hold (assisted flight mode with altitude hold only, used especially in windy environment) mode. As soon as the UAS took off, a sudden gust of wind pushed it towards the power cables and the wall. The pilot redirect the UAS away from the cables, but it was too late; the UAS impacted the power cables and the wall before it fell to the ground about 2 metres (m) from the pilot's position.</p> <p>The UAS sustained substantial damage to the propeller blades; there was no injury to persons on the ground.</p>

Figure 1: The UAS after the accident. (Source: Operator)

During lift-off, the UAS drifted off course due to a sudden gust of wind and impacted the power cables and the wall before it fell to the ground.

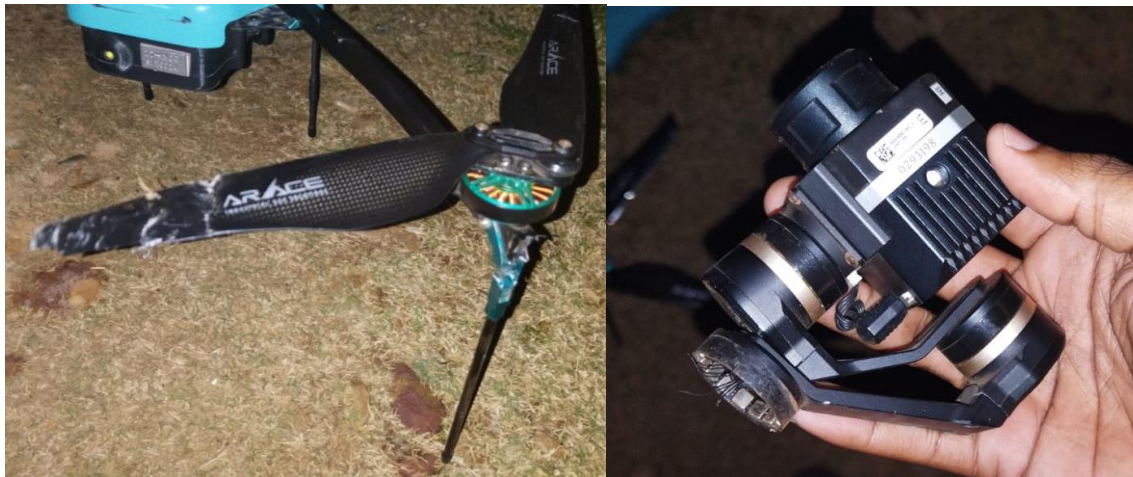
Figure 2: The damaged propeller (left) and gimbal (right). (Source: Operator)
