AIRCRAFT ACCIDENT REPORT AND EXECUTIVE SUMMARY

Reference:		CA18/2/3/10312	
Aircraft Registration	ZU-IMB	Date of Accident	28 May 2023		Time of Accident	0910Z	
Type of Aircraft	Dyn'Aéro MCR4S			Type of Operation	Private (Part 94)		
Pilot-in-command Licence Type	Airline Transport Pilot Licence (ATPL)		Age	59	Licence Valid	Yes	
Pilot-in-command Flying Experience	Total Flying Hours			18 075	Hours on Type	250.7	
Last Point of Departure	Petit Airfield (FARA), Gauteng Province						
Next Point of Intended Landing	Tranquillity Spa Lodge, Gauteng Province						
Damage to Aircraft	Substantial						
Location of the accident site with reference to easily defined geographical points (GPS readings if possible)							
Tranquillity Spa Lodge (GPS co-ordinates: 25° 28' 29.57" South 028°27' 44.33" East, elevation 3 890 feet)							
Meteorological Information	Surface wind: 060°/ 9 kt; temperature: 21°C; dew point: 8°C; CAVOK						
Number of People On-board	1 + 0	Number of People Injured	0	Number of People Killed	0	Other (On Ground)	0

Reference Number	: CA18/2/3/10312
Occurrence Category	: Accident (Category 1)
Type of Operation	: Private (Part 94)
Name of Operator	: A M Lange
Aircraft Registration	:

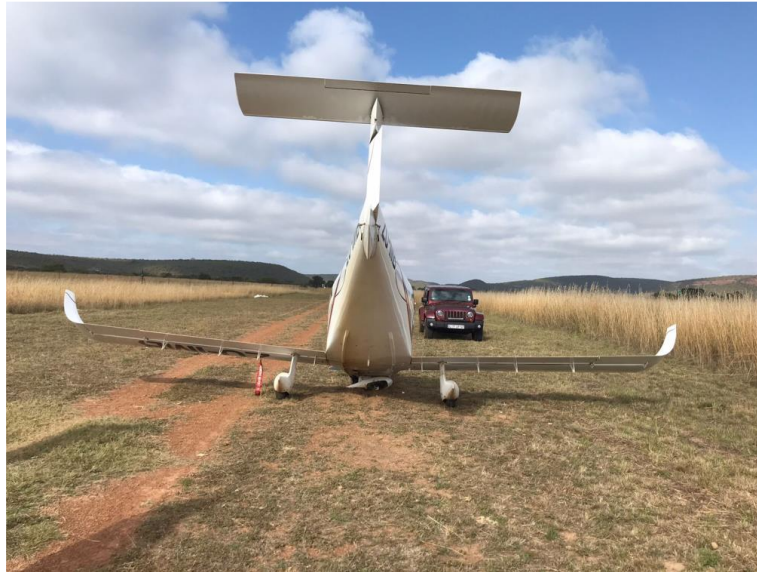
- 1.3.1. The aircraft sustained substantial damage to the propeller tips, and the nose wheel separated from the nose wheel strut.

Figure 2: The aircraft as it came to rest.

1.12.1 After landing whilst the aircraft was taxiing, the nose wheel separated from the nose wheel strut and the propeller tips struck the ground before the aircraft came to a stop.

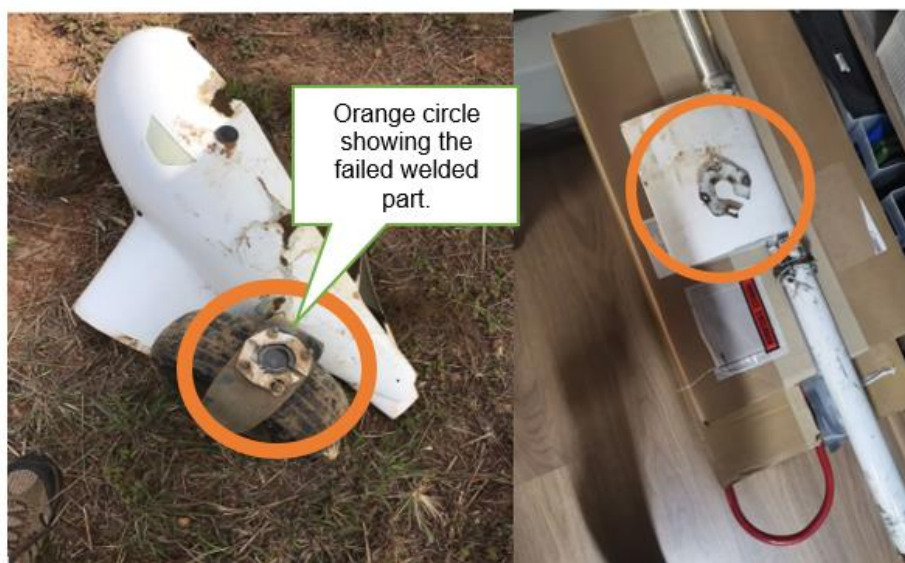
1.18.1 Post-accident inspection conducted by the AMO found that there was a crack caused by stress on the welded section that connect the nose strut and the nose fork. The AP stated that the aircraft was operated on an uneven surface of the airfield.

Figure 4: The welded section that failed.

2.2.3 It is likely that a small crack formed at the welded section where the nose landing gear fork and the nose wheel strut connect due to stress load which occurred over time. The aircraft was operated on an uneven surface of the airfield, which contributed to the ultimate failure of the nose landing gear.

- 3.3.1 The nose landing gear fork separated from the nose wheel strut during taxi due to a crack on the welded area of the nose wheel strut which was not identified during maintenance that was conducted 11.7 hours before the accident flight.
