**UAS LIMITED OCCURRENCE INVESTIGATION REPORT – FINAL**

<b>Reference Number</b>	CA18/2/3/10313						
<b>Classification</b>	Accident	<b>Date</b>	28 May 2023		<b>Time</b>	1802Z	
<b>Type of Operation</b>	Unmanned Aircraft System – Surveillance (Part 101)						
<b>Location</b>							
Place of Departure	Welgedacht near Springs, Gauteng Province		Place of Intended Landing	Welgedacht near Springs, Gauteng Province			
Place of Occurrence	Welgedacht near Springs, Gauteng Province						
GPS Co-ordinates	Latitude	26°12'43.91"S	Longitude	28°30'04.08"E	Elevation	5 237ft	
<b>Aircraft Information</b>							
Registration	ZT-XDT		Class	3A			
Make; Model; S/N	Arace Sirin (Serial Number: SIR0004)						
Damage to Aircraft	Substantial		Total UAS Hours	1460.36			
<b>Pilot-in-command</b>							
Licence Type	Remote Pilot Licence (RPL)		Gender	Male	Age	22	
Licence Valid	Yes	Total Hours	166.02	Total Hours on Type	166.02		
Total Hours 30 Days	27.6		Total Flying on Type Past 90 Days	82.9

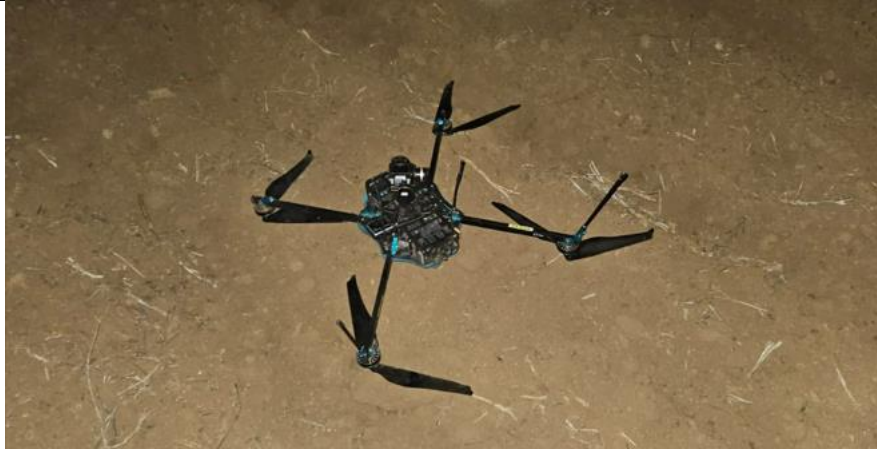
<b>People Controlling</b>	1	<b>Injuries (On ground)</b>	0	<b>Fatalities</b>	0	<b>Fatalities (on ground)</b>	0
<b>What Happened</b>							
<p>On Sunday night, 28 May 2023, an unmanned aircraft system (UAS) with registration ZT-XDT was engaged in a surveillance flight over Transnet railway lines at Welgedacht near Springs, Gauteng province, when the accident occurred. The flight was conducted under beyond visual line of sight (BVLOS) rules and under the provisions of Part 101 of the Civil Aviation Regulations (CAR) 2011 as amended.</p> <p>The pilot stated that after conducting the pre-flight checks with no anomalies detected, he launched the UAS at 1726Z with 99% battery voltage and 60 minutes endurance. The pilot reported that he engaged the Loiter mode (manually operated) and climbed to 400 feet (ft) above ground level (AGL) for surveillance for approximately 9 kilometres (km) over a 36-minute period. When the battery voltage dropped to 29%, the pilot decided to bring in the UAS for landing so as to change the battery. Whilst flying the UAS back, the pilot was fatigued and he struggled to keep his eyes open and eventually fell asleep. Later when he woke up, he could not locate the UAS on his remote pilot station unit. The pilot contacted the dispatcher to ask for a pin drop of the UAS's last location. The pilot and the security official tracked the UAS from the last recorded location, which was approximately 2 kilometres from the launch site. They found it crashed on the ground, and the two landing legs were broken.</p>

**Figure 2:** The UAS at the accident site. (Source: Operator)

9. The investigation concluded that the pilot had not rested enough prior to reporting for duty, which resulted in him being fatigued and falling asleep, and thus, the UAS ran out of battery power and crashed.
<b>Probable Cause</b>
The pilot fell asleep whilst flying the UAS and, thus, the battery depleted as the UAS was not monitored. The UAS subsequently crashed.
<b>Contributing Factor</b>
The pilot was fatigued and fell asleep.
<b>Safety Action(s)</b>
None.
<b>Safety Message and/or Safety Recommendation/s</b>
None.
<b>About this Report</b>
<i>The decision to conduct a limited investigation is based on factors including whether the cause is known and the evidence supporting the cause is clear, the level of safety benefit likely to be obtained from an investigation and that will determine the scope of an investigation. For this occurrence, a limited investigation has been conducted, and the Accident and Incident Investigations Division (AIID) has relied on the information submitted by the affected person/s and organisation/s to compile this limited report. The report has been compiled using information supplied in the initial notification, as well as from follow-up desk top enquiries to bring awareness of potential safety issues to the industry in respect of this occurrence, as well as possible safety action/s that the industry might want to consider in preventing a recurrence of a similar occurrence.</i>
