UAS LIMITED OCCURRENCE INVESTIGATION REPORT – FINAL

Reference Number	CA18/2/3/10315						
Classification	Accident	Date	30 May 2023			Time	0049Z
Type of Operation	Remotely Piloted Aircraft Systems – Surveillance (Part 101)						
Location							
Place of Departure	Zungwini near Vryheid, KwaZulu-Natal Province		Place of Intended Landing		Zungwini near Vryheid, Kwa-Zulu-Natal Province		
Place of Occurrence	Zungwini near Vryheid, KwaZulu-Natal Province						
GPS Co-ordinates	Latitude	27° 37'49" S	Longitude	20° 49'35" E	Elevation	3805ft	
Aircraft Information							
Registration	ZT-XUR		Class	3A			
Make; Model; S/N	Arace Sirin (Serial Number: SIR0064)						
Damage to Aircraft	Substantial		Total UAS Hours	698.46			
Pilot-in-command							
Licence Type	RPL Multirotor		Gender	Male		Age	29
Licence Valid	Yes	Total Hours	728.09	Total Hours on Type		493.81	
Total Hours 30 Days	92.17		Total Flying on Type Past 90 Days		266.67		
People Controlling	1	Injuries	None	Injuries (On ground)	0	Fatalities	0

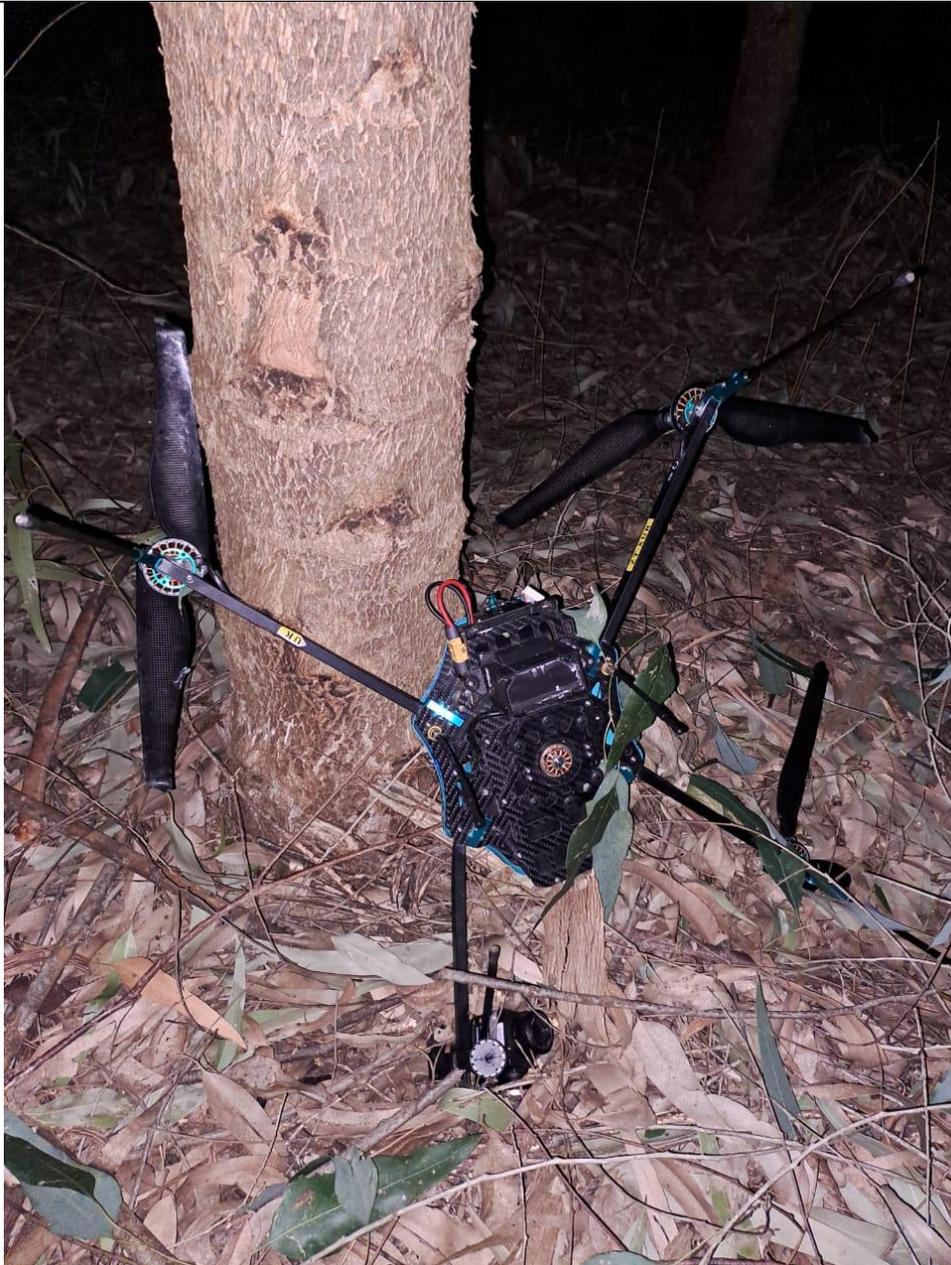
Fatalities (on ground)	0
What Happened							
<p>On 30 May 2023, an Arace Sirin Unmanned Aircraft System with registration ZT-XUR was launched for security surveillance at Zungwini railway lines in Vryheid, KwaZulu-Natal province. The operation was conducted under beyond visual line of sight (BVLOS) rules by night and under the provisions of Part 101 of the Civil Aviation Regulations (CAR) 2011 as amended.</p> <p>The pilot stated that he conducted a pre-flight inspection, and no anomalies were found. The battery was at 99% prior to take-off. After the UAS was launched, it climbed to 402.672 metres (1321.102 feet [ft]) above ground level (AGL). Twelve minutes into the flight at approximately 2.4 kilometres (km) from the take-off position, the UAS lost Command and Control (C2) connection with the remote pilot station and crashed. The pilot waited a few minutes for the UAS to activate the return-to-launch (RTL) function, however, the UAS did not return. The pilot set out to look for it at its last known location and found it on the ground after it had impacted a tree (Figure 1).</p> <p>The UAS had damage to the landing gear, arm, gimbal and propeller blades.</p>

Figure 1: The ZT-XUR at the crash site. (Source: Operator)

Probable Cause
The UAS lost a C2 connection after the pilot's slight roll and forward pitch inputs; the UAS descended and impacted a tree.
Contributing Factor(s)
None.
Safety Action(s)
None
Safety Message and/or Safety Recommendation(s)
None.
About this Report
<p><i>The decision to conduct a limited investigation is based on factors including whether the cause is known and the evidence supporting the cause is clear, the level of safety benefit likely to be obtained from an investigation and that will determine the scope of an investigation. For this occurrence, a limited investigation has been conducted, and the Accident and Incident Investigations Division (AIID) has relied on the information submitted by the affected person/s and organisation/s to compile this limited report. The report has been compiled using information supplied in the initial notification, as well as from follow-up desk top enquiries to bring awareness of potential safety issues to the industry in respect of this occurrence, as well as possible safety action/s that the industry might want to consider in preventing a recurrence of a similar occurrence.</i></p> <p><i>All times given in this report are Co-ordinated Universal Time (UTC) and will be denoted by (Z). South African Standard Time is UTC plus 2 hours.</i></p>
