UAS LIMITED OCCURRENCE INVESTIGATION REPORT – FINAL

Reference Number	CA18/2/3/10316								
Classification	Accident	Date	29 December 2022	Time	0715Z				
Type of Operation	Remotely Piloted Aircraft Systems (Surveillance) (Part 101)								
Location									
Place of Departure	Grootegeluk Mine, Lephalale, Limpopo Province		Place of Intended Landing	Grootegeluk Mine, Lephalale, Limpopo Province					
Place of Occurrence	Grootegeluk Mine in Lephalale, Limpopo Province								
GPS Co-ordinates	Latitude	23° 39' 57" S	Longitude	027° 32' 26" E	Elevation	2945 ft			
Aircraft Information									
Registration	ZT-WWR		Class	4A					
Make; Model; S/N	Premier Aviation; Cullinan PA290E (Serial Number: PAV29001E2020)								
Damage to Aircraft	Substantial		Total UAS Hours	81.28					
Pilot-in-command									
Licence Type	Remote Pilot Licence (RPL)		Gender	Male		Age	39		
Licence Valid	Yes	Total Hours	36.7	Total Hours on Type	6.56				
Total Hours 30 Days	8.05		Total Flying on Type Past 90 days	6.56

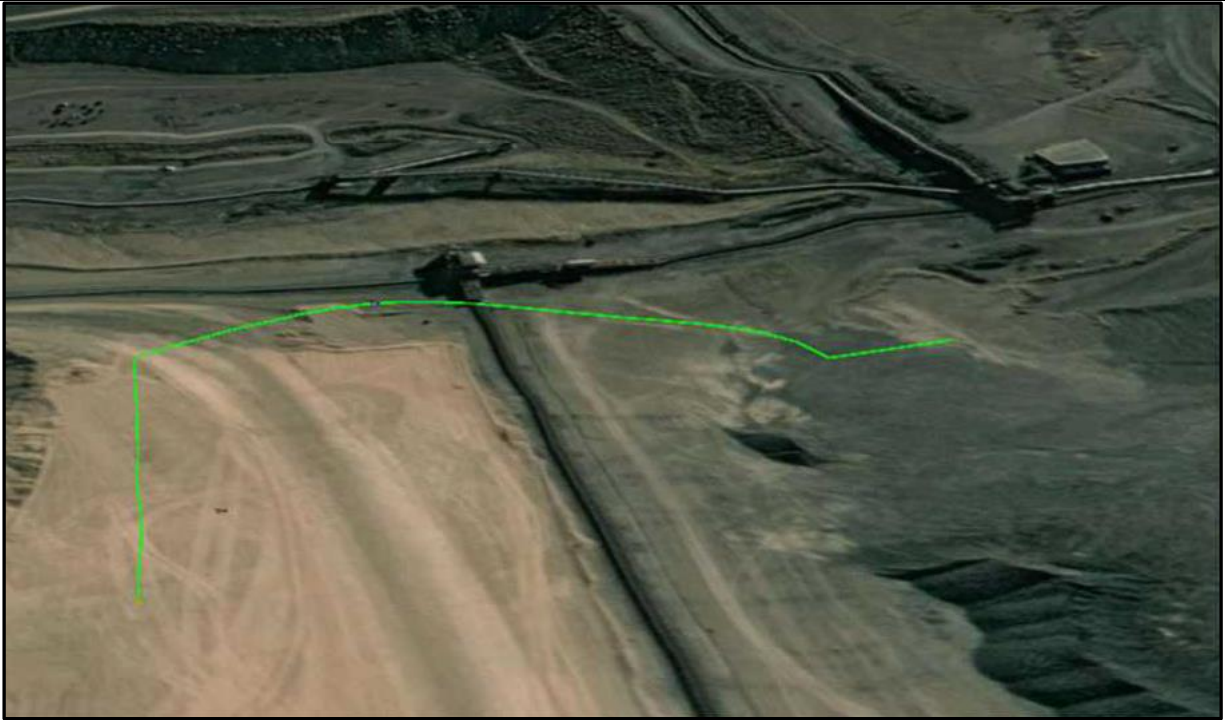
Figure 1: The UAS route after it was launched. (Source: Operator)

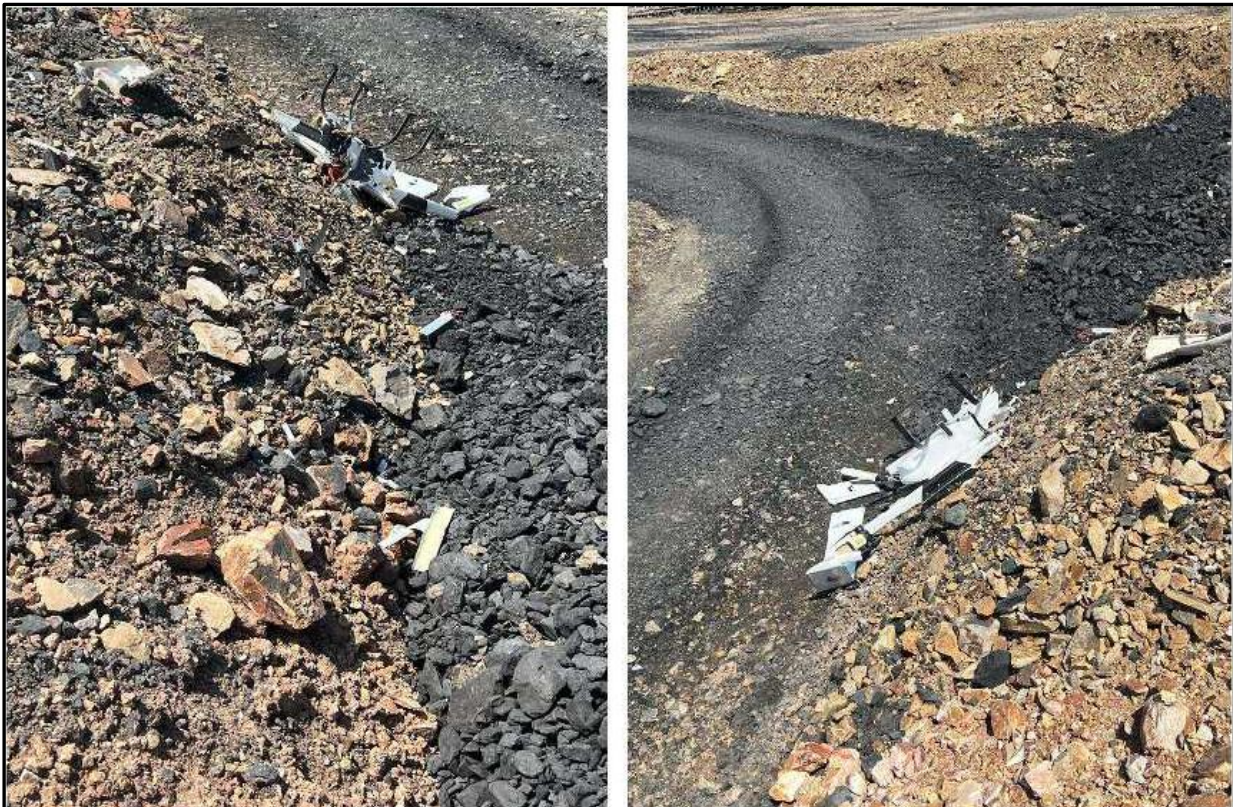
Figures 2 and 3: The accident site (left) and the UAS wreckage post-accident (right). (Source: Operator)

5. The UAS's wings were not connected during pre-flight inspection, which caused the UAS to lose height after it was launched. According to the pilot, he omitted to connect the wings during the flight inspection.

The UAS's wings were not attached during the pre-flight inspection, which resulted in the inability of the UAS to gain lift, and it subsequently crashed to the ground.
