UAS LIMITED OCCURRENCE INVESTIGATION REPORT – FINAL

Reference Number	CA18/2/3/10317						
Classification	Accident	Date	15 February 2023	Time	1245Z		
Type of Operation	Remotely Piloted Aircraft Systems – Surveillance (Part 101)						
Location							
Place of Departure	Chilwavhusika Mine, Bronkhorstspuit, Gauteng Province		Place of Intended Landing	Chilwavhusika Mine, Bronkhorstspuit, Gauteng Province			
Place of Occurrence	Chilwavhusika Mine in Bronkhorstspuit, Gauteng Province						
GPS Co-ordinates	Latitude	25°46'46.23" S	Longitude	028°48'47.40" E	Elevation	4 662 feet	
Aircraft Information							
Registration	ZT-XCI						
Make; Model; S/N	Matrice 300 (Serial Number: 1ZNBHBU00C00G0)						
Damage to UAS	Substantial		Total UAS Hours	82.56			
Pilot-in-command							
Licence Type	Remote Pilot Licence		Gender	Male		Age	36
Licence Valid	Yes	Total Hours	Unknown	Total Hours on Type		3.7	
Total Hours 90 Days	Unknown		Total Flying on Type Past 90 Days	Unknown			
People Controlling	1	Injuries	0	Fatalities	0	Injuries (on ground)	0

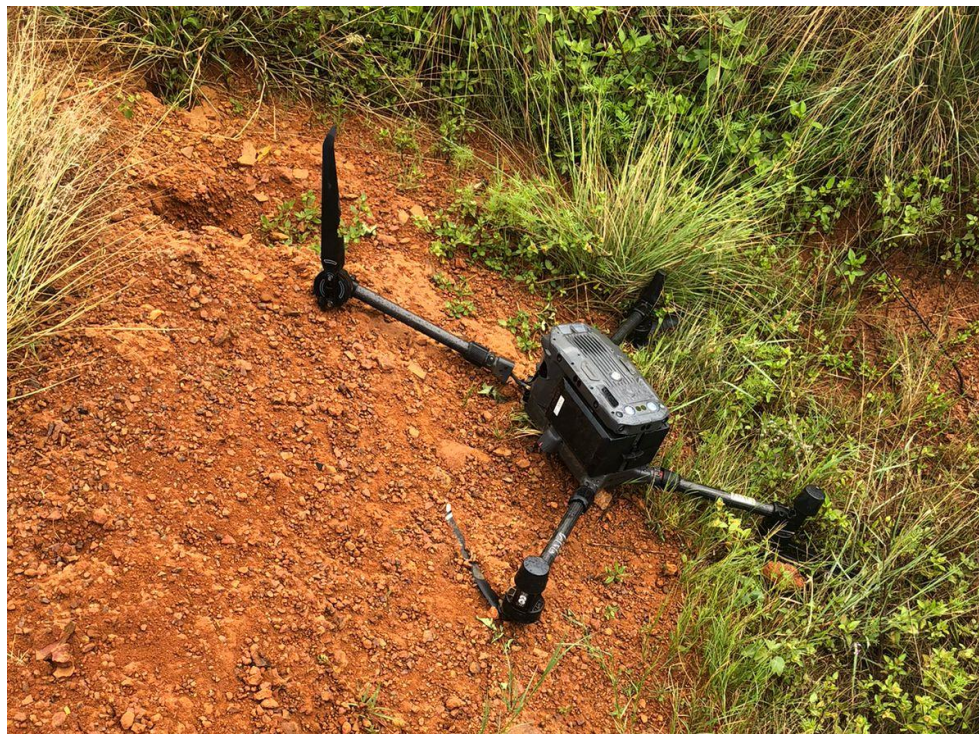
What Happened							
<p>On 15 February 2023, a pilot launched an Unmanned Aircraft System (UAS) with registration ZT-XCI for surveillance from Chilwavhusika Mine in Bronkhorstspuit, Gauteng province. The flight was conducted under beyond visual line of sight (BVLOS) rules by day and under the provisions of Part 101 of the Civil Aviation Regulations (CAR) 2011 as amended.</p> <p>The pilot stated that the launch and the initial flight of the UAS were normal during the survey on the mine. About 10 minutes into the flight whilst he was on a radio call, he noticed that the UAS was no longer capturing images and that there was a “sensor system error return-to-home or land” message displayed on the remote pilot station. The pilot then engaged the return-to-home button, and the UAS executed the command. When the UAS was closer to the home point, it changed course and headed in the opposite direction. The pilot decreased altitude as much as possible to prevent the UAS from gaining height. Although the pilot had altitude under control, he had no directional control. The pilot then engaged the return-to-home button a few more times, but the UAS did not respond. Moments later, the UAS crashed. It sustained substantial damage; no injuries were reported on the ground.</p>

Figure 2: The UAS at the crash site. (Source: Operator)

The investigation could not determine the reason the UAS changed course and flew in the opposite direction of the “home point” because the operator did not download the flight logs.
