UAS LIMITED OCCURRENCE INVESTIGATION REPORT – FINAL

Reference Number	CA18/2/3/10319				
Classification	Accident	Date	31 May 2023	Time	0935Z
Type of Operation	Remotely Piloted Aircraft Systems (Aerial survey) – Part 101				
Location					
Place of Departure	Seriti Klipspruit Mine near Ogies, Mpumalanga Province		Place of Intended Landing	Seriti Klipspruit Mine near Ogies, Mpumalanga Province	
Place of Occurrence	Klipspruit Mine near Ogies				
GPS Co-ordinates	Latitude	26° 00' 13.4" S	Longitude	029° 00' 13.04" E	Elevation 5188 ft
Aircraft Information					
Registration	ZT-XHA		Class	Class 4A	
Make; Model; S/N	Sensefly; eBee X (Serial Number: IX-12-17181)				
Damage to Aircraft	Destroyed		Total UAS Hours	309.59	
Pilot-in-command					
Licence Type	Remote Pilot Licence (RPL)		Gender	Male	Age 29
Licence Valid	Yes	Total Hours	120.09	Total Hours on Type	85.84
Total Hours 30 Days	8.92		Total Flying on Type Past 90 Days	26.75	
Injuries	0	Injuries (On ground)	0	Fatalities	0

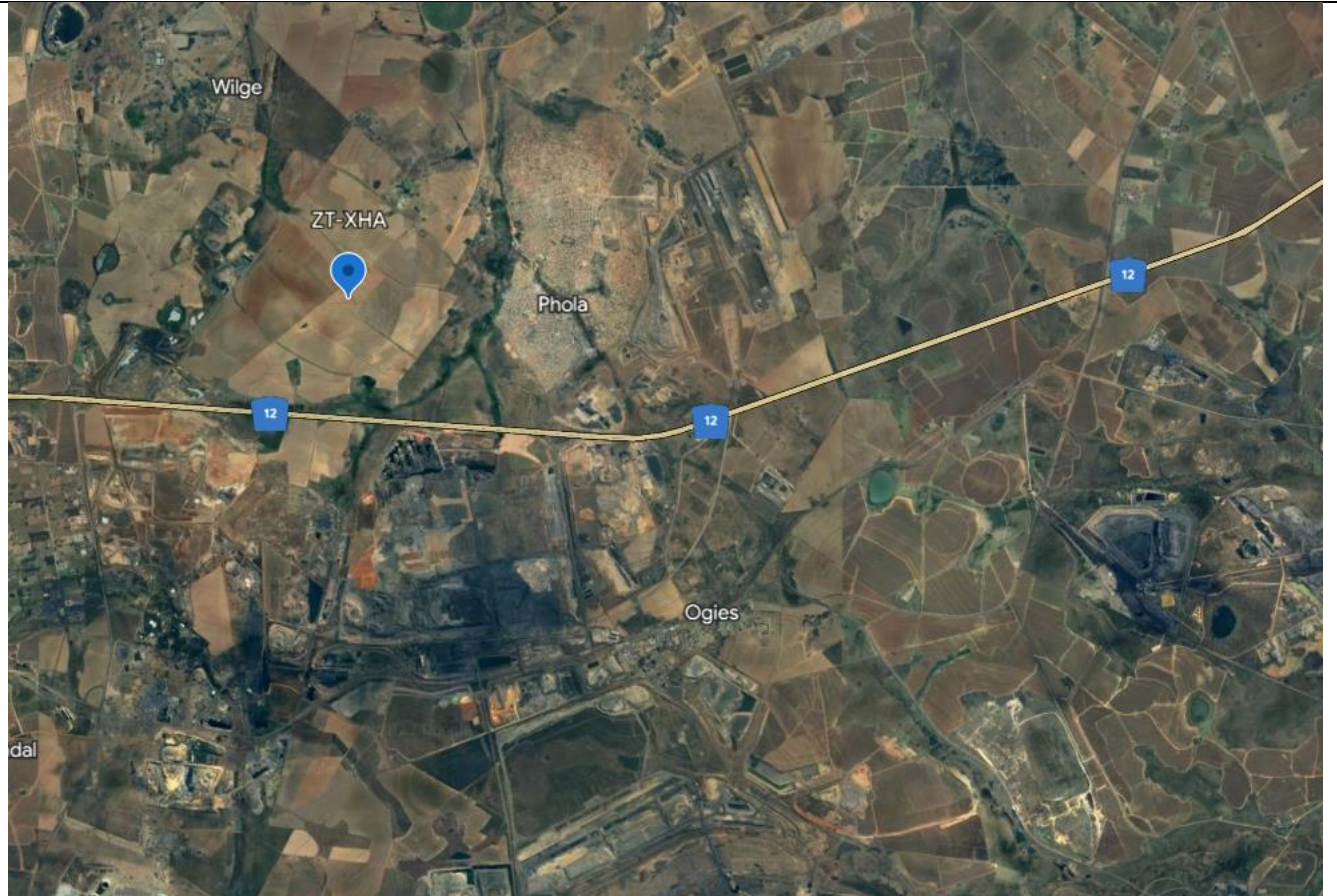
Figure 1: A view of the accident site. (Source: Google Earth)

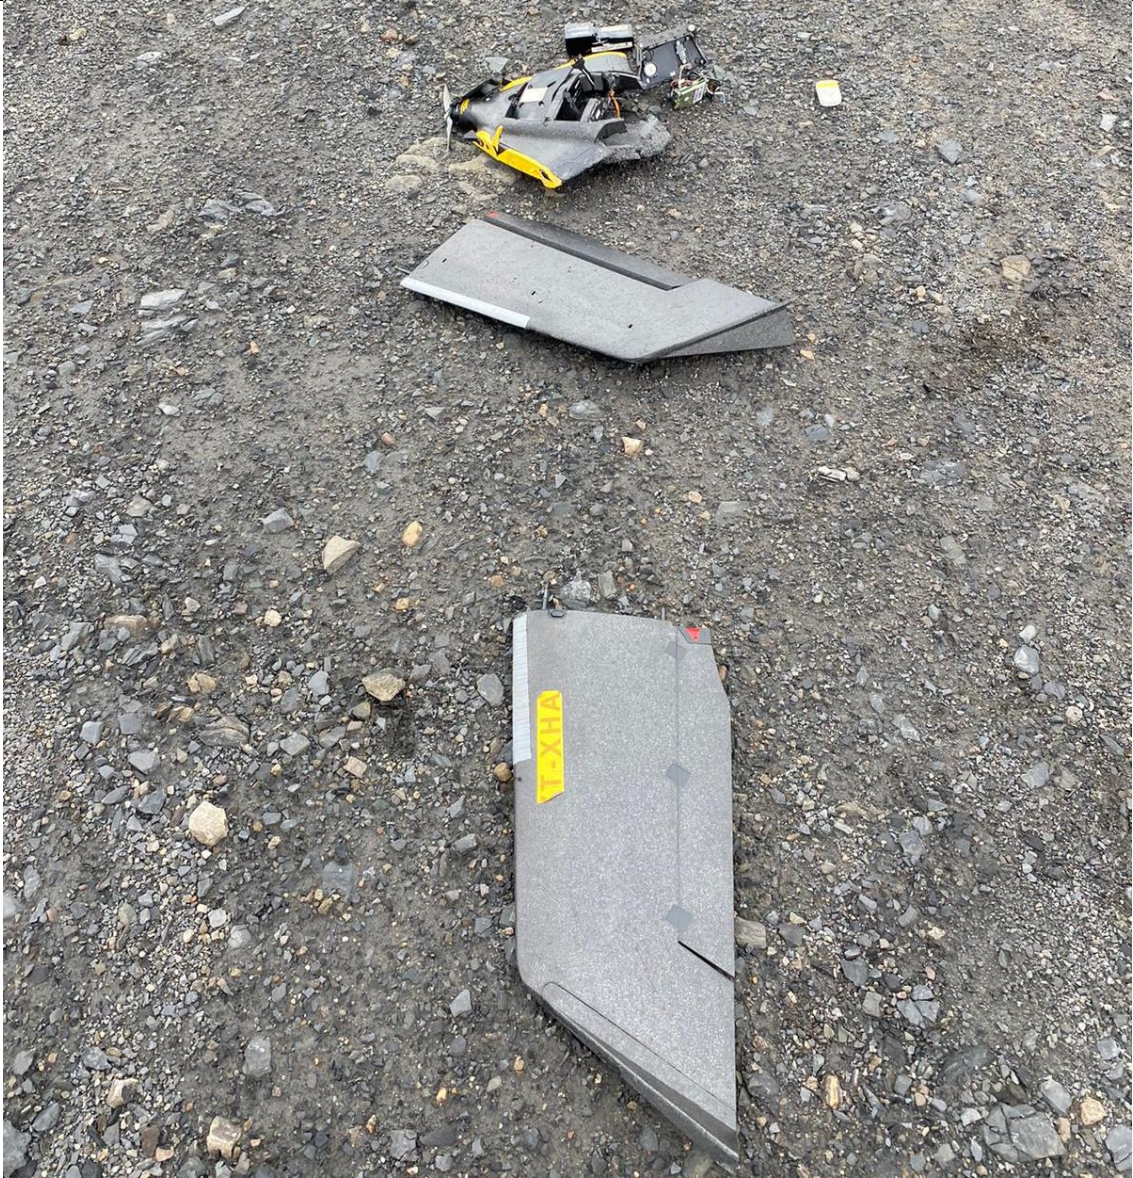
Number of People Controlling	1
What Happened					
<p>On Wednesday, 31 May 2023, an unmanned aircraft system (UAS) with registration ZT-XHA was engaged in an aerial survey flight at Klipspruit Mine, near Ogies in Mpumalanga province. The flight was conducted beyond visual line of sight (BVLOS) rules by day and under the provisions of Part 101 of the Civil Aviation Regulations (CAR) 2011 as amended.</p> <p>The pilot reported that he launched the UAS, which he operated overhead the mine pit. During the fifth line of aerial survey in crosswind conditions, the pilot observed the UAS flying in an inverted attitude before it spiralled uncontrollably towards the ground. He engaged the 'fast climb' button on the remote pilot station to stop the UAS from spiralling down and that is when he noticed a 'data downlink' warning on the remote pilot station. The UAS stalled and descended until it impacted the ground. The wings detached from the fuselage on impact. The UAS sustained substantial damage, however, no person was injured on the ground. There were no flight logs for the flight.</p>

Figure 2: The wreckage post-accident. (Source: Pilot)
