LIMITED OCCURRENCE INVESTIGATION REPORT – FINAL

Reference Number	CA18/2/3/10321						
Classification	Accident	Date	3 June 2023		Time	0640Z	
Type of Operation	Operation of Non-type Certificated Aircraft (Part 94)						
Location							
Place of Departure	Potchefstroom Aerodrome (FAPS), North West Province			Place of Intended Landing	Parys Aerodrome (FAPY), Free State Province		
Place of Occurrence	On the grass, left of Runway 06 at FAPY, Free State Province						
GPS Co-ordinates	Latitude	26°53'29.26" S	Longitude	27°30'2.29" E	Elevation	4 678 feet	
Aircraft Information							
Registration	ZU-BMD						
Make; Model; S/N	Cessna Aircraft Company: 185A Skywagon (Serial Number: 185-1359)						
Damage to Aircraft	Substantial			Total Aircraft Hours	8 789.21		
Pilot-in-command							
Licence Type	Private Pilot Licence (PPL)		Gender	Male		Age	30
Licence Valid	Yes	Total Hours	1 288		Total Hours on Type	38.8	
Total Hours 90 Days	38.8		Total Flying on Type Past 30 Days		38.8

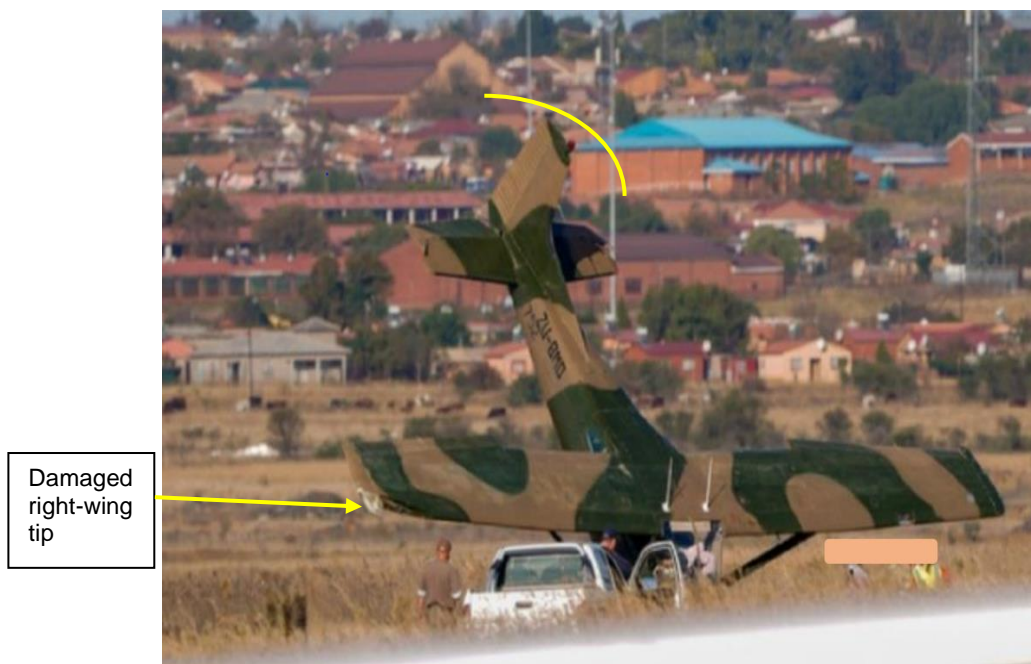
The eyewitness (another pilot who was on-board the RV-8 aircraft at FAPY and who saw ZU-BMD land) informed the investigator-in-charge (IIC) that there was gusting wind exceeding 15 kts from the left side of Runway 06 at the time of landing. The eyewitness further stated that during the landing roll with the tail still airborne, he observed the aircraft veering off to the left of the runway and onto the grass area. The aircraft nosed over and came to rest on its spinner and right-wing tip. It was stuck in a near vertical position (See Figure 1).

Figure 1: The aircraft post-accident with the tail lifted, indicated by the yellow arch. (Source: Pilot)

Probable Cause
Failure to compensate sufficiently for the gusting wind from the left resulted in the aircraft veering off to the left of Runway 06 centreline; the subsequent use of excessive braking led to the aircraft nosing over.
Contributing Factors
None.
Safety Action
None.

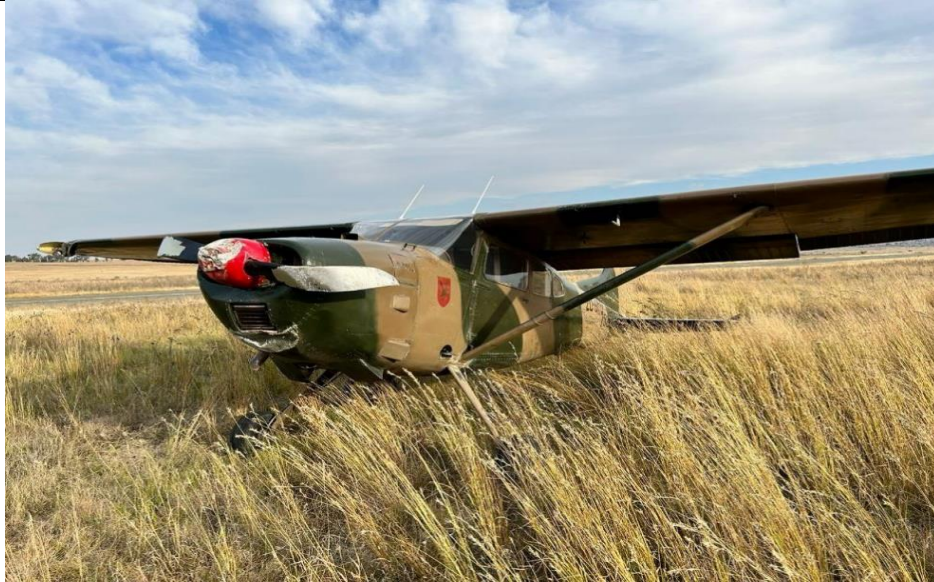
Figure 2: The aircraft with damaged propeller blades and spinner. (Source: Pilot)
