LIMITED OCCURRENCE INVESTIGATION REPORT – FINAL

Reference Number	CA18/2/3/10322						
Classification	Accident	Date	3 June 2023		Time	0908Z	
Type of Operation	Private (Part 91)						
Location							
Place of Departure	Grand Central Airport (FAGC), Gauteng Province		Place of Intended Landing		Bona-Bona Airstrip, North West Province		
Place of Occurrence	Runway 35 at Bona-Bona Airstrip near Wolmaransstad, North West Province						
GPS Co-ordinates	Latitude	27° 01' 5.65" S	Longitude	26° 12' 56.3" E	Elevation	4 794 ft	
Aircraft Information							
Registration	ZS-EDI						
Make; Model; S/N	Cessna 172F (Serial Number: 172-52863)						
Damage to Aircraft	Substantial		Total Aircraft Hours		5 681.4		
Pilot-in-command							
Licence Type	Private Pilot Licence (PPL) Aeroplane		Gender	Female		Age	21
Licence Valid	Yes	Total Hours	98		Total Hours on Type	95.4	
Total Hours 90 Days	38.2		Total Flying on Type Past 90 Days		38.2		
People On-board	1 + 1	Injuries	1	Fatalities	0	Other (on ground)	0

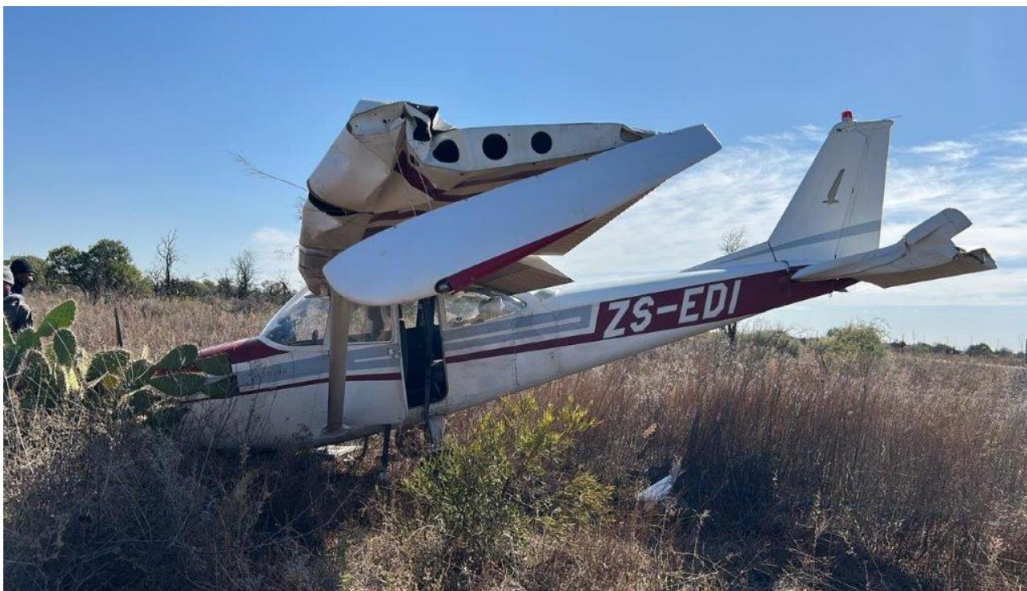
Figure 2: The aircraft's resting position after the accident. (Source: Pilot)

6. It is likely that the aircraft experienced a sudden crosswind during the flare which resulted in a stall and a hard landing before it bounced; thereafter, the pilot lost directional control.
Probable Cause(s)
It is likely that the aircraft experienced a sudden crosswind during a flare which resulted in a stall and a hard landing before it bounced; thereafter, the pilot lost directional control.
Contributing Factor(s)
None.
Safety Action(s)
None.
Safety Message
To avoid injury and damage to property, pilots should always be vigilant when executing critical phases of flight such as take-offs and landings.
About this Report
<i>The decision to conduct a limited investigation is based on factors including whether the cause is known and the evidence supporting the cause is clear, the level of safety benefit likely to be obtained from an investigation and that will determine the scope of an investigation. For this occurrence, a limited investigation has been conducted, and the Accident and Incident Investigations Division (AIID) has relied on the information submitted by the affected person/s and organisation/s to compile this limited report. The report has been compiled using information supplied in the initial notification, as well as from follow-up desk top enquiries to bring awareness of potential safety issues to the industry in respect of this occurrence, as well as possible safety action/s that the industry might want to consider in preventing a recurrence of a similar occurrence.</i>

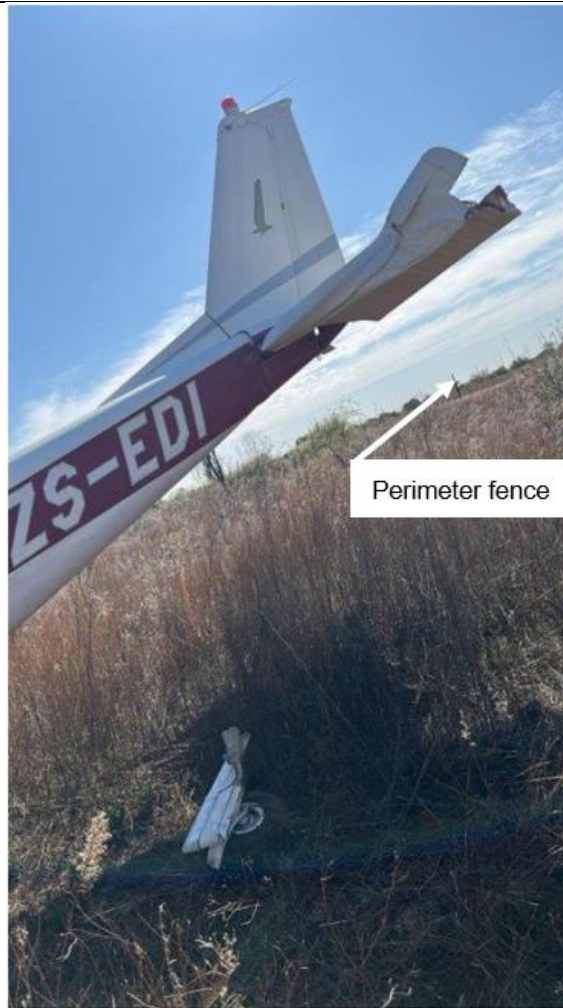
Figure 3: The damaged perimeter fence and the broken nose gear assembly. (Source: Operator)

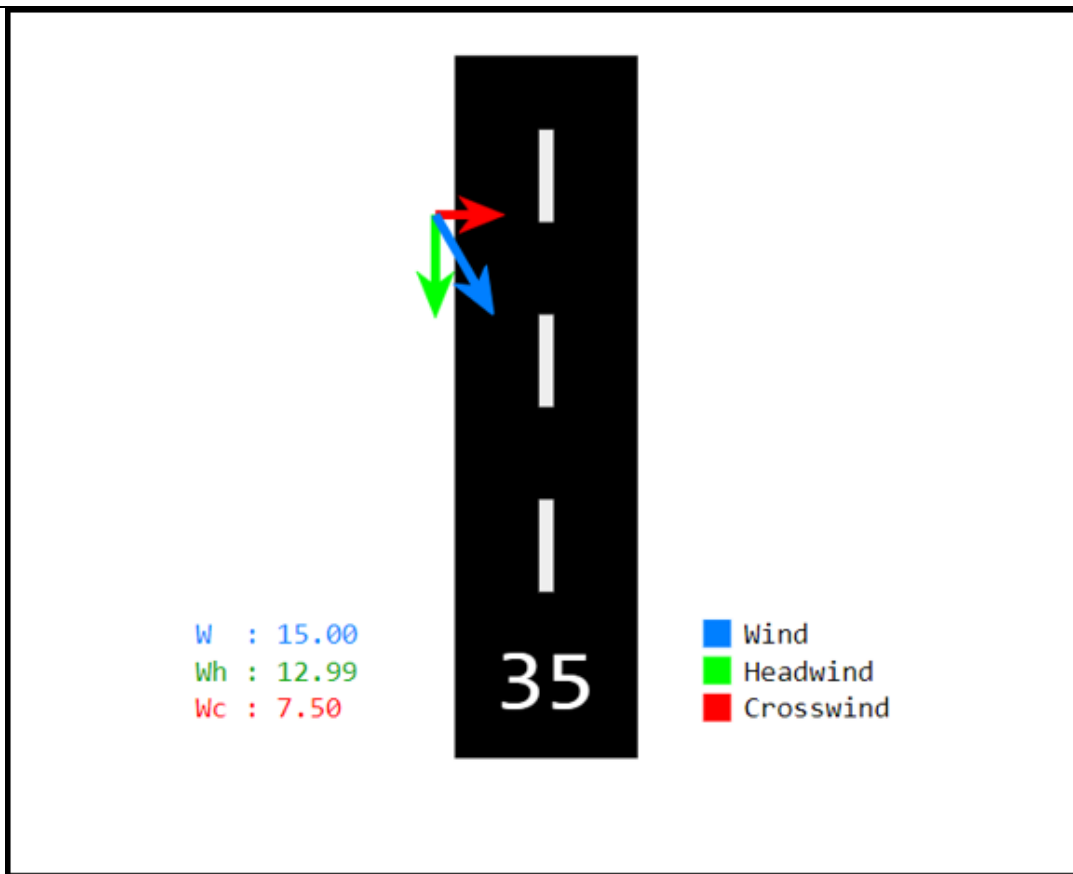
Figure 4: Crosswind component.

5. The aircraft touched down at a speed of between 70-75 miles per hour (60-65 kts) with flaps set at 20°. According to the Pilot's Operating Handbook, the aircraft's landing speed is between 65 and 75 miles per hour (56 and 65 kts) at a desired flap setting, therefore, the aircraft's landing speed was within the limit. The crosswind component during this landing was 7.5 knots. The POH does not indicate how much wind component can the aircraft withstand; however, 7.5 knots would not result in the aircraft being unstable.
