UAS LIMITED OCCURRENCE INVESTIGATION REPORT – FINAL

Reference Number		CA18/2/3/10323								
Classification		Accident	Date		6 June 2023	Time		2247Z		
Type of Operation		Remotely Piloted Aircraft Systems – Surveillance (Part 101)								
Location										
Place of Departure		Seriti Mine, Viljoensdrif, Free State Province		Place of Intended Landing		Seriti Mine, Viljoensdrif, Free State Province				
Place of Occurrence		Seriti Mine in Viljoensdrif, Free State Province								
GPS Co-ordinates		Latitude	26°44'02.1" S	Longitude	27°55'54.4" E	Elevation	4 761 feet			
Aircraft Information										
Registration		ZT-XGK		Class		Class 3A				
Make; Model; S/N		Condor VTOL (Serial Number: CON0005)								
Damage to Aircraft		Substantial		Total UAS Hours		408.7				
Pilot-in-command										
Licence Type		Remote Pilot Licence (RPL)		Gender		Male		Age	29	
Licence Valid		Yes	Total Hours	494.4		Total Hours on Type		229.3		
Total Hours 30 Days		49.63		Total Flying on Type Past 90 Days		131.23

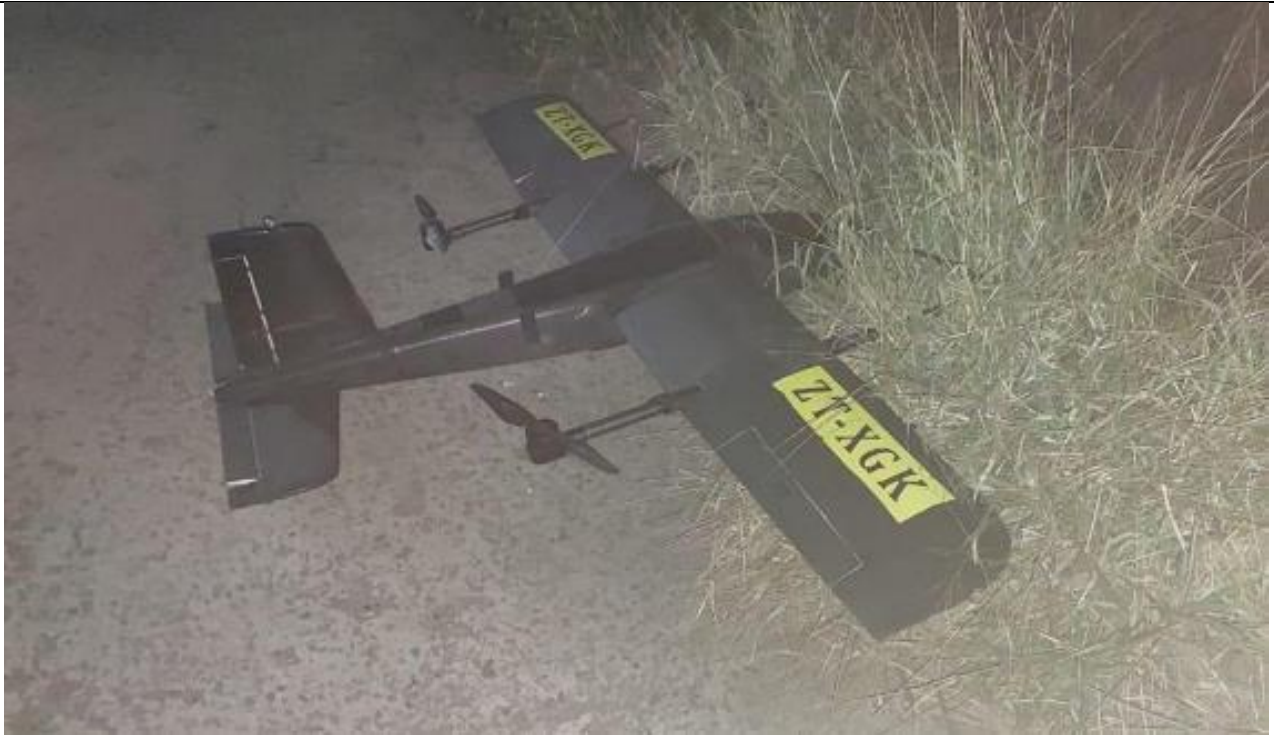
were no flashing lights observed on the UAS and on the remote pilot station to indicate a fault/error. The pilot regained manual control of the UAS and brought it down from 60m (197ft) to 8m (26ft) above ground level (AGL) and away from the security guards that were on foot patrol. Again, the UAS suddenly failed to respond to the pilot's inputs, and it impacted the ground hard. The UAS sustained substantial damage; no persons on the ground were injured.

Figure 1: The UAS after the accident. (Source: Operator)

During transition to land, the UAS spun out of control due to low battery voltage before it crashed.

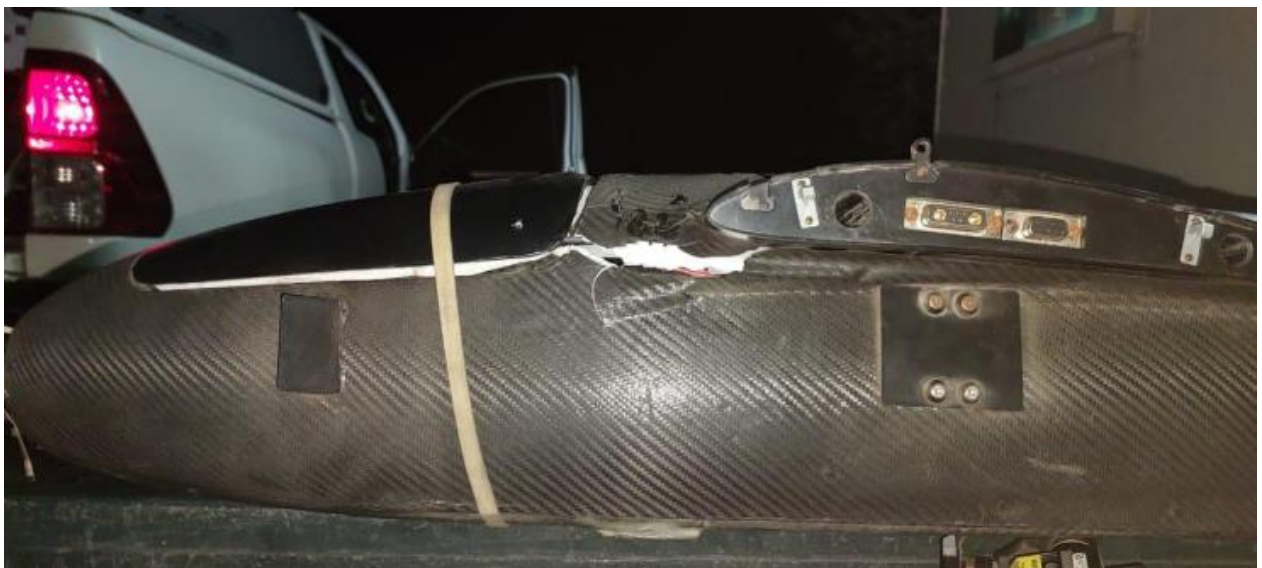
Figure 2: Damage to the airframe. (Source: Operator)

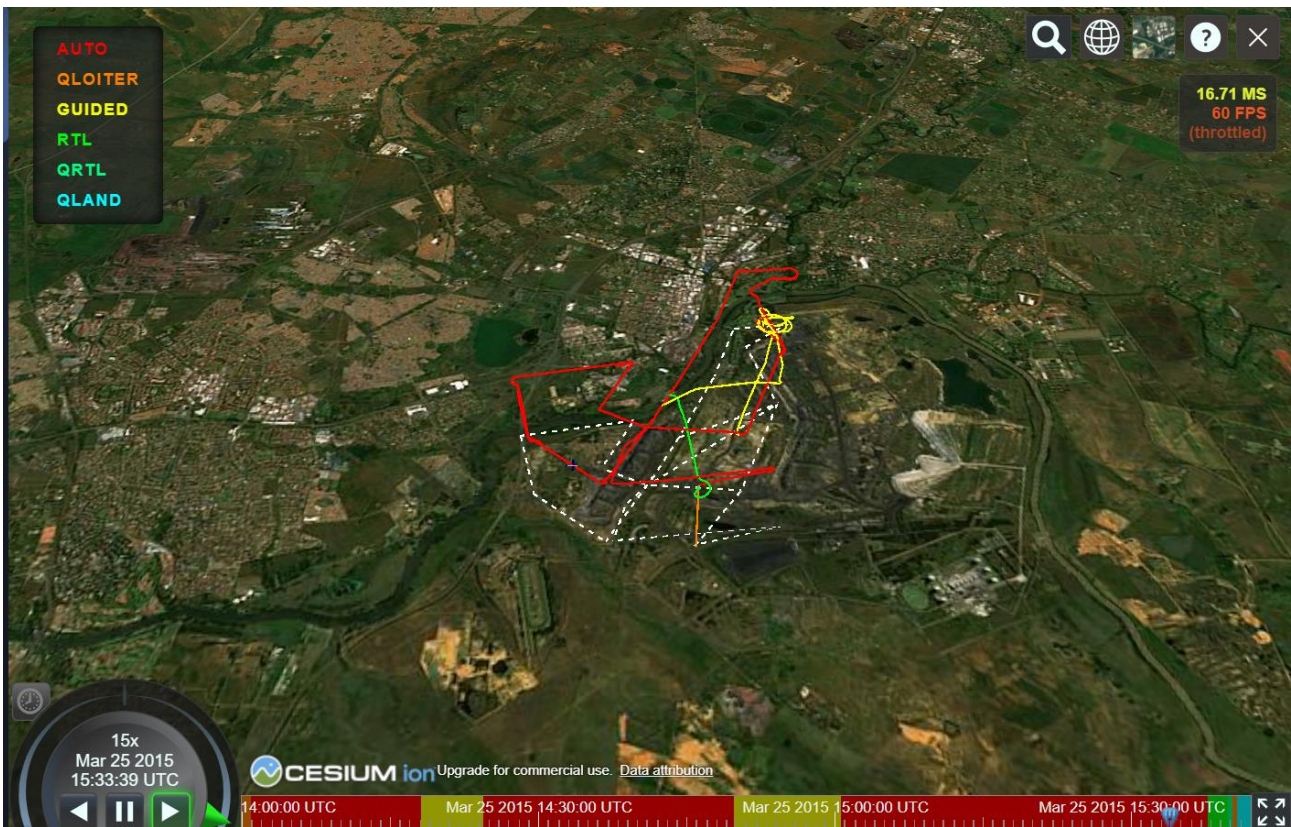
Figure 3: An overlay of waypoints and the mission track. (Source: [UAV Log Viewer \(ardupilot.org\)](#))

After the accident, the operator shared a flight log data with the investigator-in-charge (IIC). Figure 3 depicts the mission flight and the waypoints. For this mission, the pilot created the desired flight route and waypoints: the red line represents the track on **auto** mode; the yellow line indicates the **guided** mode; the green line indicates **RTL**; and orange line represents the **loiter** mode. At the end of the track, the RTL was activated and the Condor was commanded to loiter instead of engaging Vertical Take-Off and Landing (VTOL) to land automatically. According to the Unmanned Aircraft Vehicle (UAV) log viewer, there were no errors recorded prior to impact.

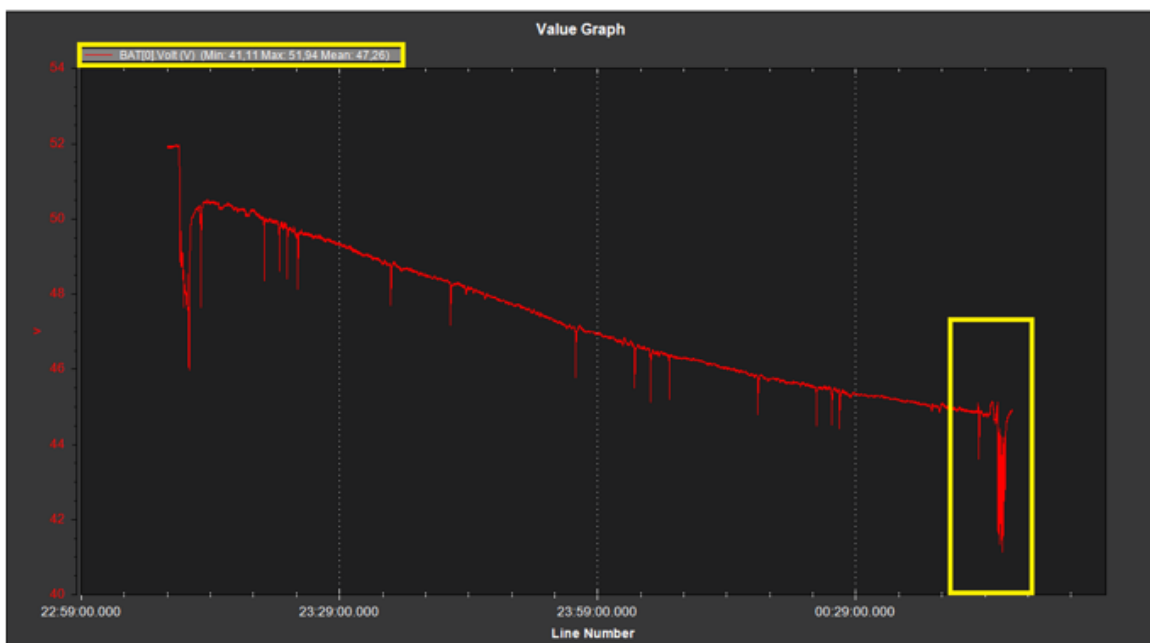
Graph 1: Battery depletion graph depicted in the yellow box. (Source: Technical report)

9. The User Manual states that *flying with a low battery is a safety risk and can render the battery permanently unusable. Always fly with a fully charged battery.* During the descent, the UAS spun uncontrollably. According to the flight data log, the UAS flew for 1 hour and 36 minutes and the scope of coverage is 120 minutes as stated in the manual, this meant that it was 16 minutes over the limit. It is likely that when the UAS was spinning out of control, the battery power was critically low.
