UAS LIMITED OCCURRENCE INVESTIGATION REPORT – FINAL

Reference Number		CA18/2/3/10325													
Classification		Accident		Date	9 June 2023		Time	2334Z							
Type of Operation		Remotely Piloted Aircraft Systems – Surveillance (Part 101)													
Location															
Place of Departure		Transnet Watloo DSV near Mamelodi, Gauteng Province			Place of Intended Landing			Transnet Watloo DSV near Mamelodi, Gauteng Province							
Place of Occurrence		Transnet pipelines at Watloo DSV near Mamelodi, Gauteng Province													
GPS Co-ordinates		Latitude		25° 43'55.0" S		Longitude		028° 20'15.3" E		Elevation		6502.6 ft			
UAS Information															
Registration		ZT-XWG			Class		3A								
Make; Model; S/N		Arace Sirin (Serial Number: SIR0067)													
Damage to UAS		Substantial			Total UAS Hours		1045.13								
Pilot-in-command															
Licence Type		RPL Multirotor			Gender		Male		Age		26				
Licence Valid		Yes		Total Hours		656.0		Total Hours on Type		222.4

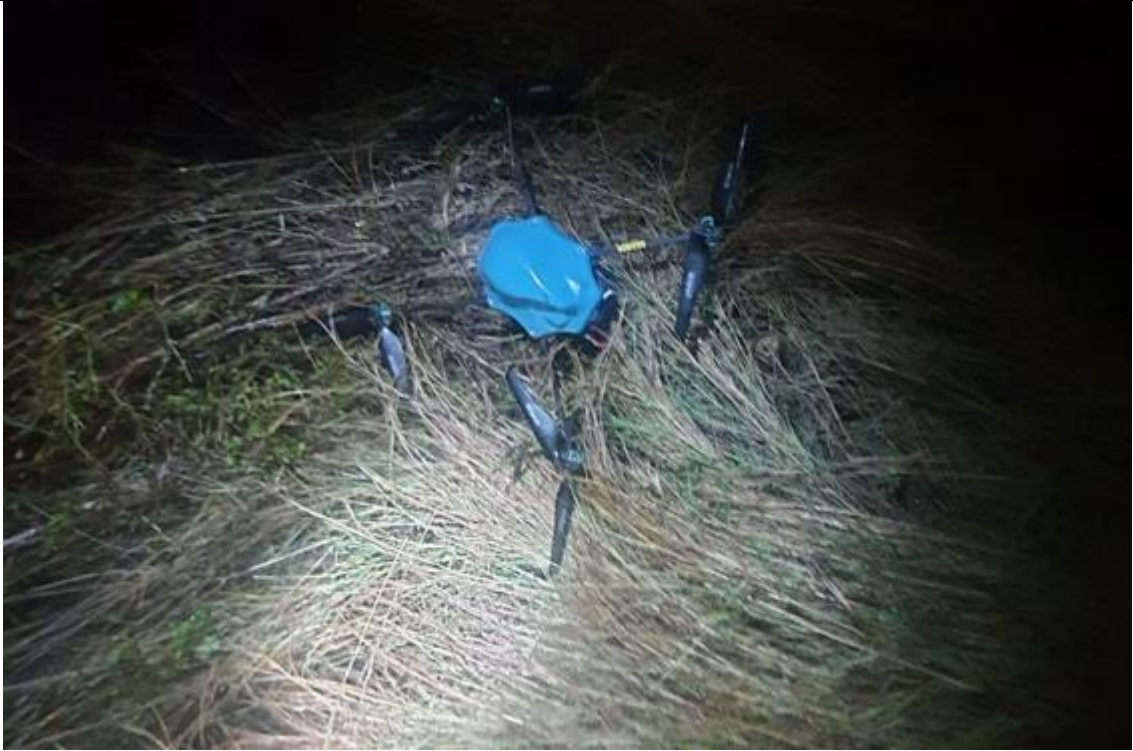
Figure 1: The ZT-XWG at the crash site. (Source: Operator)

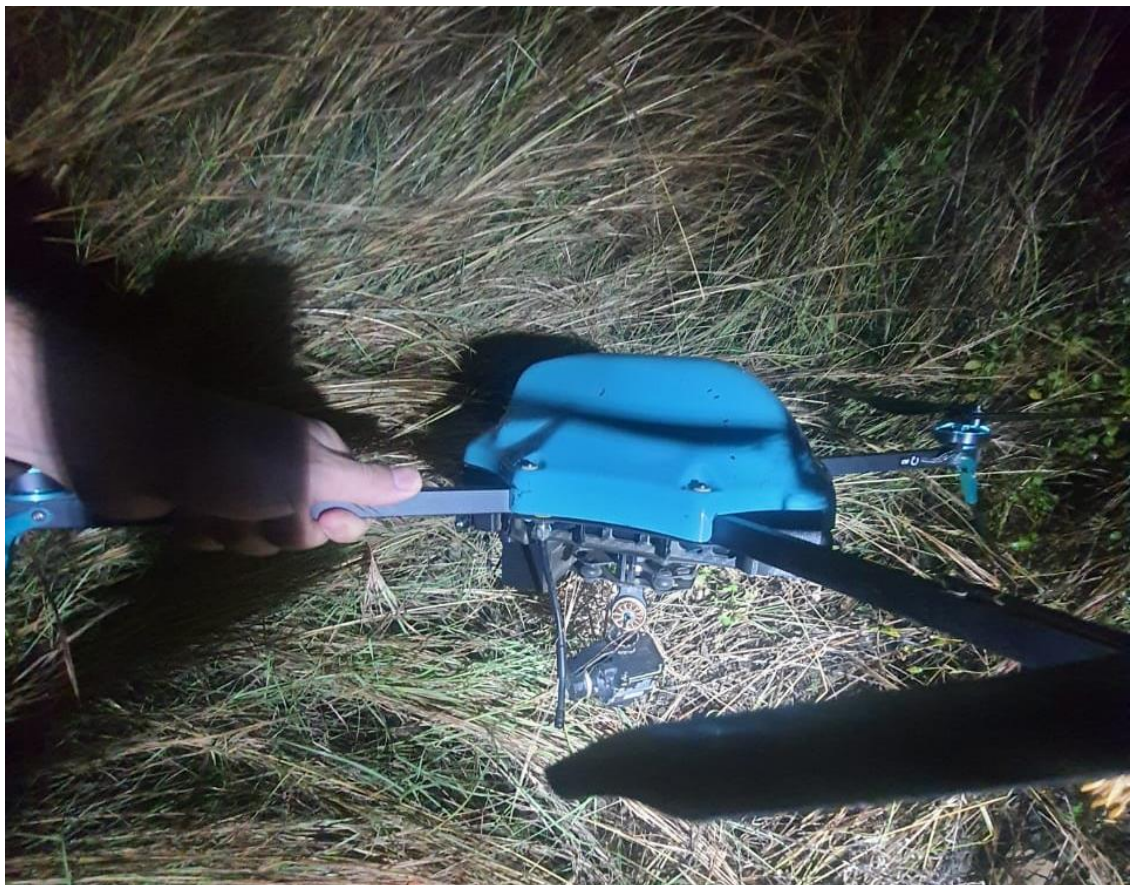
Figure 2: Damaged camera and skid. (Source: Operator)

The UAS was launched with a critical battery voltage and had a potential thrust loss warning before it crashed.

7. According to the LAR, the UAS took off with a low battery (it had 22.2 volts on take-off).
8. After the accident, the UAS was repaired and the battery was replaced.
