LIMITED OCCURRENCE INVESTIGATION REPORT – FINAL

Reference Number	CA18/2/3/10326						
Classification	Accident	Date	8 June 2023		Time	1250Z	
Type of Operation	Operation of Non-type Certificated Aircraft – Private (Part 94)						
Location							
Place of Departure	Letaba Aerodrome, Limpopo Province		Place of Intended Landing	Phalaborwa Aerodrome (FAPH), Limpopo Province			
Place of Occurrence	On S131 gravel road between Letaba and Phalaborwa in the Kruger National Park, Limpopo Province						
GPS Co-ordinates	Latitude	23°52'26.14" S	Longitude	031°23'57.12" E	Elevation	1 165 feet	
Aircraft Information							
Registration	ZU-IXD						
Make; Model; S/N	Micro Aviation SA; Bat Hawk R (Serial Number: 0103)						
Damage to Aircraft	Substantial			Total Aircraft Hours	202.9		
Pilot-in-command							
Licence Type	Private Pilot Licence		Gender	Male		Age	49
Licence Valid	Yes	Total Hours	1 564.7		Total Hours on Type	1 482.6	
Total Hours 90 Days	135.9		Total Flying on Type Past 90 Days	135.9

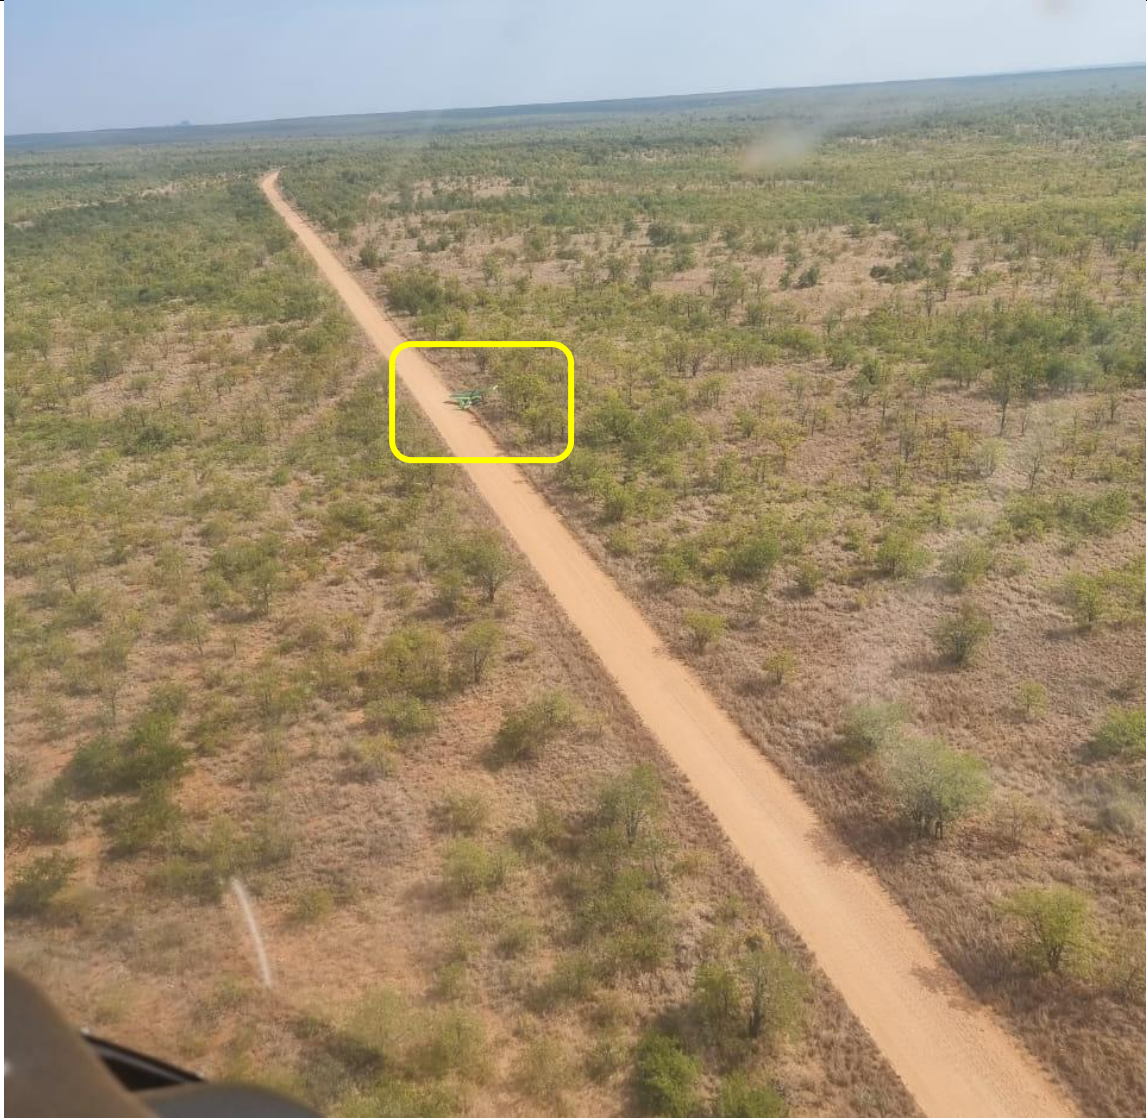
Figure 2: The S131 gravel road on which the pilot landed. (Source: SANParks Airwing)

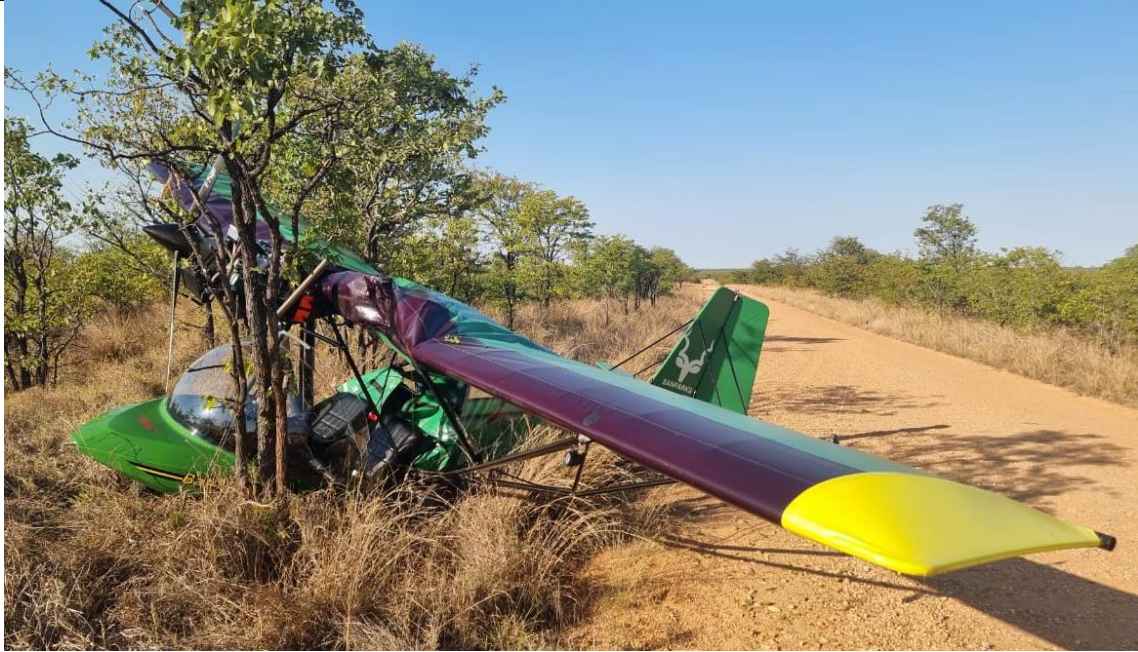
(km/h), the right wing struck a small mopani tree and the aircraft flung to the right and veered off the road, colliding with another mopani tree. The aircraft sustained substantial damage.

Figure 3: The aircraft as it came to rest against a mopani tree. (Source: Pilot)

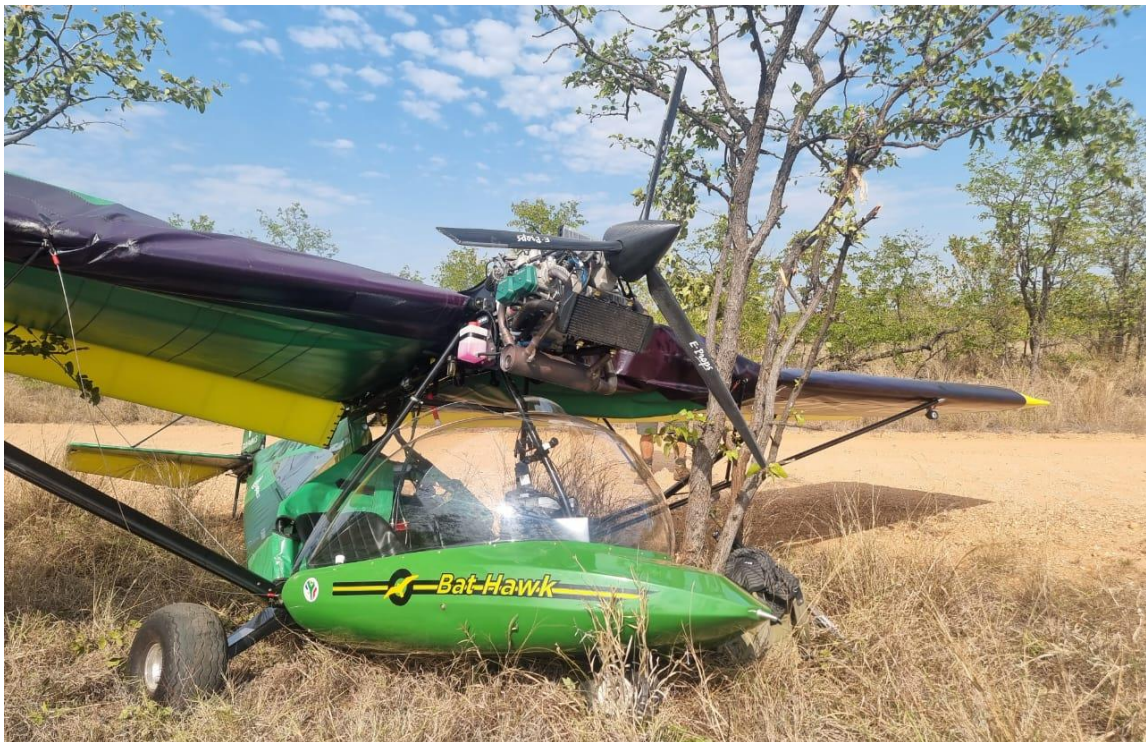
Figure 4: The front view of the aircraft post-accident. (Source: Pilot)

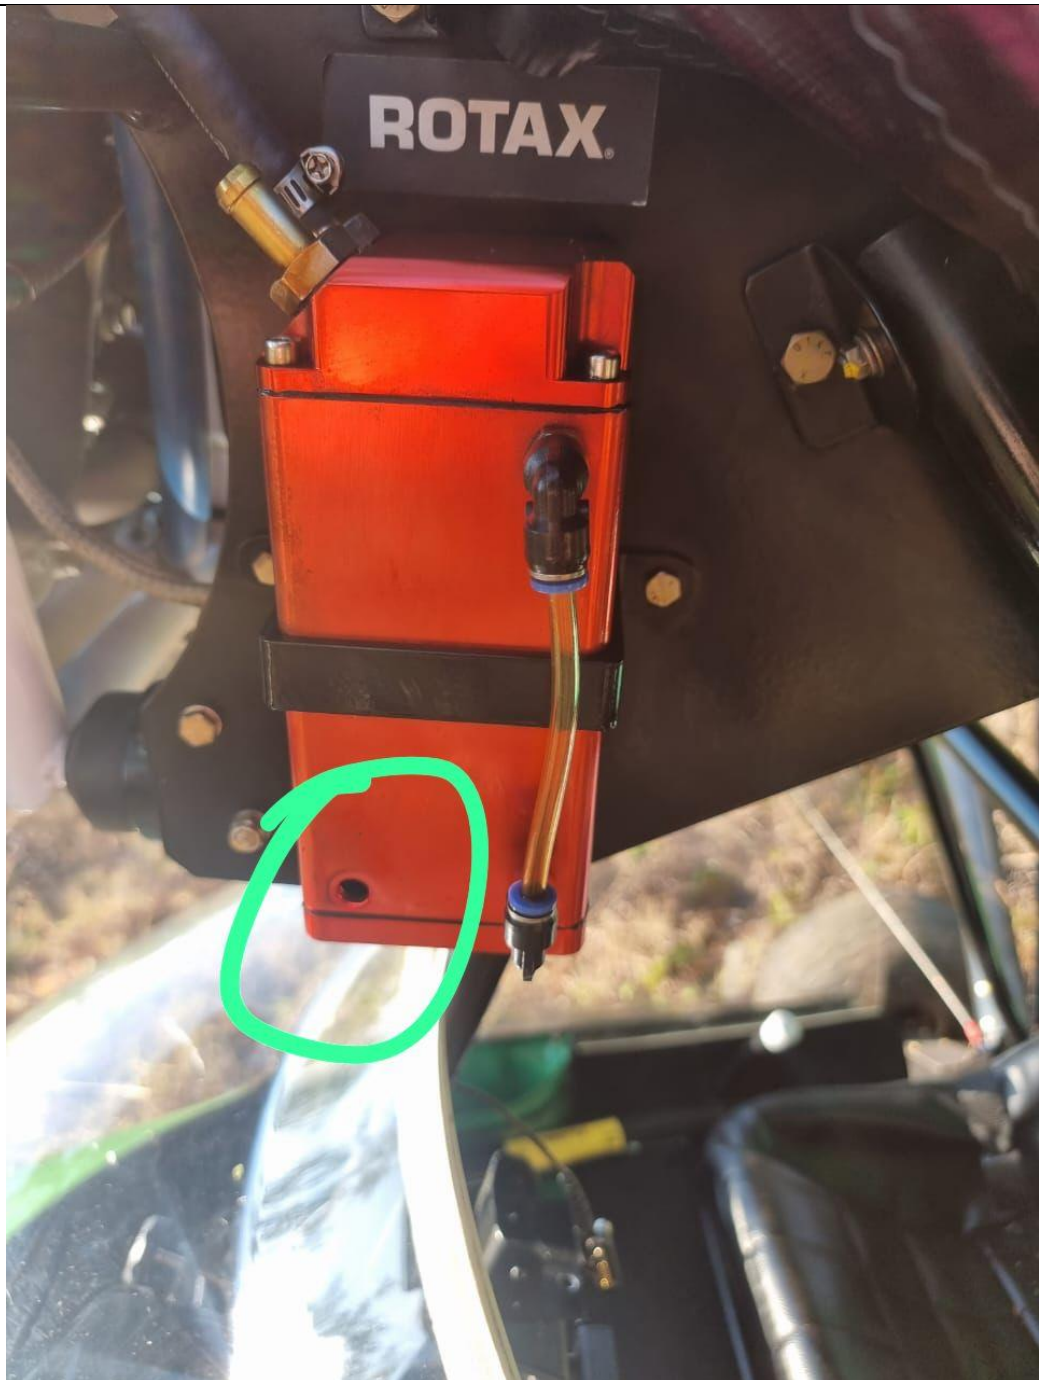
Figure 5: The oil breather container with the drain plug missing. (Source: Pilot)

1.5 The pilot stated that the inspection of the drain plug on the oil breather container is part of the pre-flight inspection, but he could not recall if he had specifically checked the drain plug before the flight. He stated that *“I would have noticed had it been missing as it is quite obvious”*.

1. The drain plug on the oil breather container located on the left side of the engine (when looking from the aft position) had no lock mechanism and, most probably, vibrated and loosened during flight before it fell out. This caused moisture (watery oil-based liquid) that was in the container to drip onto the pilot.
Safety Action(s)
None.
Safety Recommendation

1. It is recommended to the aircraft manufacturer to amend the maintenance manual and issue an advisory letter to all maintenance organisations/facilities that conduct maintenance on the aircraft type to apply torque sealant on the drain plug once it has been properly secured to ensure that it does not loosen during flight. Thus, the seal could be easily identified during the pre-flight inspection to prevent a recurrence of this accident.
About this Report
<i>The decision to conduct a limited investigation is based on factors including whether the cause is known and the evidence supporting the cause is clear, the level of safety benefit likely to be obtained from an investigation and that will determine the scope of an investigation. For this occurrence, a limited investigation has been conducted, and the Accident and Incident Investigations Division (AIID) has relied on the information submitted by the affected person/s and organisation/s to compile this limited report. The report has been compiled using information supplied in the initial notification, as well as from follow-up desk top enquiries to bring awareness of potential safety issues to the industry in respect of this occurrence, as well as possible safety action/s that the industry might want to consider in preventing a recurrence of a similar occurrence.</i>

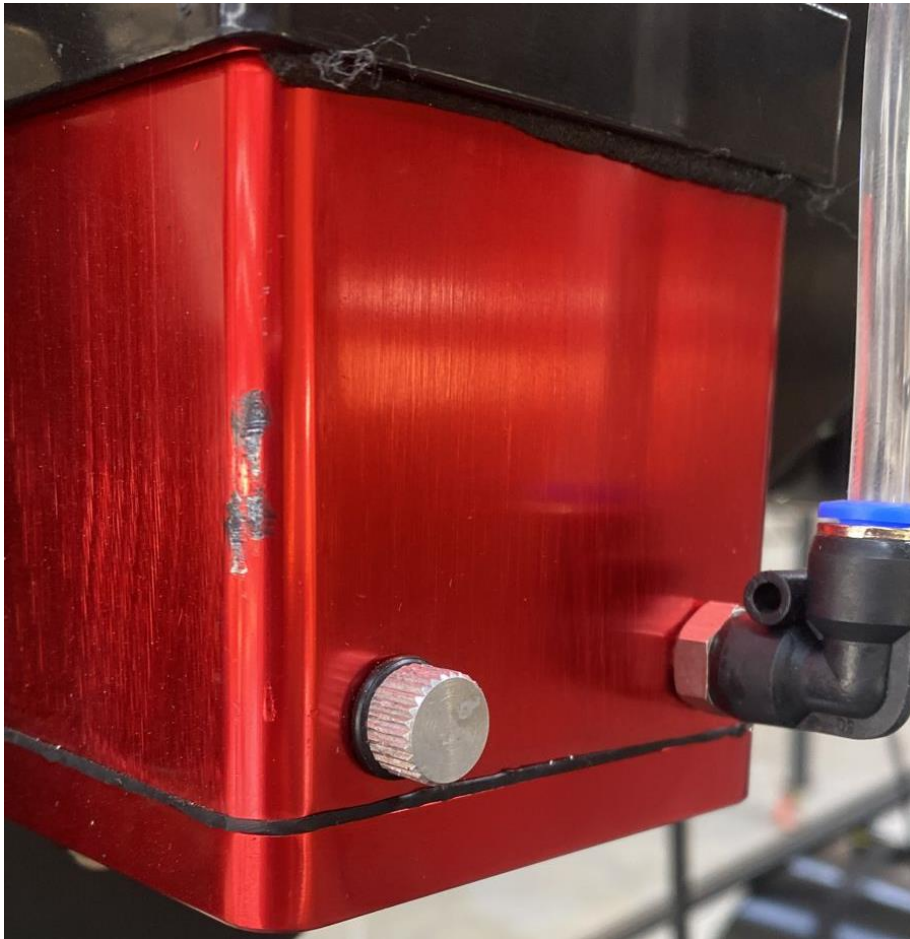
Figure 6: The oil breather container with the drain plug installed. (Source: Micro Aviation)
