LIMITED OCCURRENCE INVESTIGATION REPORT – FINAL

Reference Number	CA18/2/3/10328						
Classification	Accident	Date	9 June 2023		Time	1130Z	
Type of Operation	Agricultural Operations (Part 137)						
Location							
Place of Departure	Private Airstrip in Waterval, Tzaneen, Limpopo Province		Place of Intended Landing	Private Airstrip in Waterval, Tzaneen, Limpopo Province			
Place of Occurrence	Private Airstrip in Waterval, Limpopo Province						
GPS Co-ordinates	Latitude	23°45'8.12"S	Longitude	030° 7'52.80"E	Elevation	2 500 feet	
Aircraft Information							
Registration	ZS-IIN						
Make; Model; S/N	Cessna Aircraft Company; C182N (Serial Number: 182-60505)						
Damage to Aircraft	Substantial			Total Aircraft Hours	5 491.5		
Pilot-in-command							
Licence Type	Commercial Pilot Licence (CPL)		Gender	Male		Age	40
Licence Valid	Yes	Total Hours	2 100		Total Hours on Type	40	
Total Hours 30 Days	3.3		Total Flying on Type Past 90 Days			11.4	
People On-board	1+1	Injuries	0	Fatalities	0	Other (on ground)	0

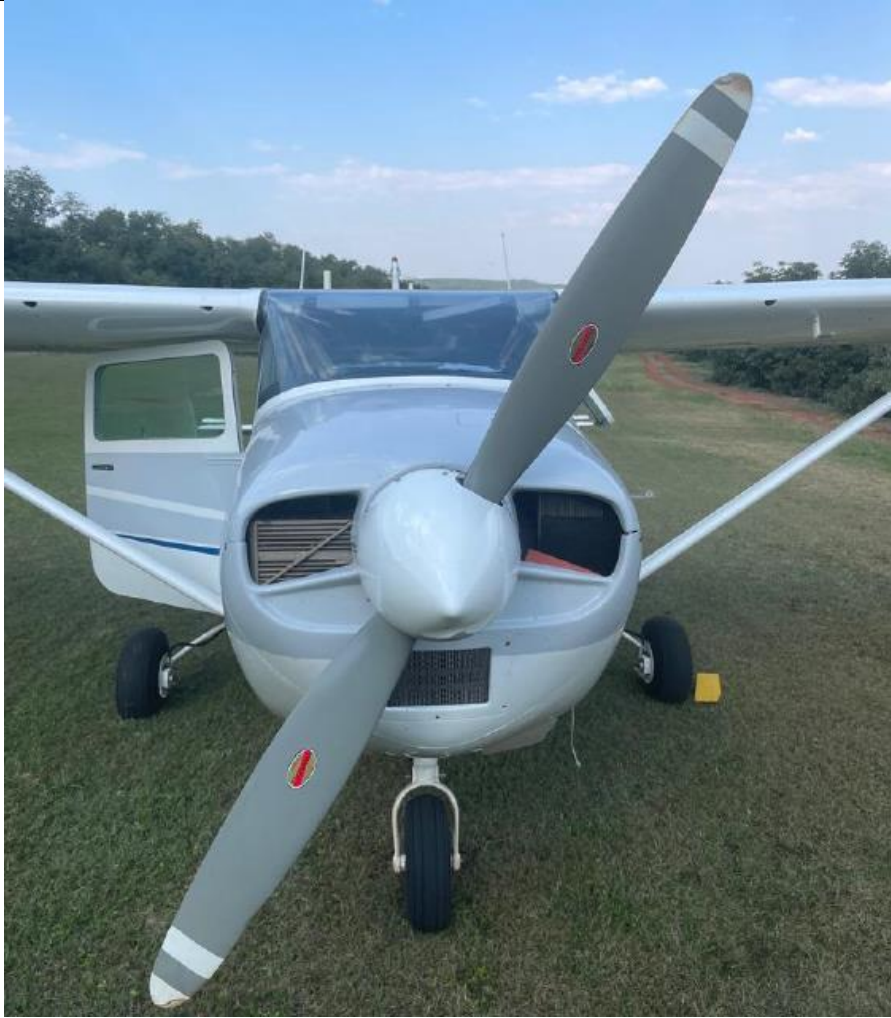
Figure 1: The damaged propeller blade tips. (Source: Operator)

6. A review of the maintenance records revealed no anomalies on any of the aircraft systems that could have caused the accident.
7. The pilot stated that during the take-off run with the aircraft airspeed at 60 MPH and flaps set at 10° on the grass runway, he prematurely lifted off and the aircraft stalled, which led to a crash on the remaining runway and the aircraft careered along the overrun area and onto the road that ran perpendicular to the runway end before it came to a full stop. The aircraft impacted the runway embankment and sustained substantial damage to the nose oleo strut, the propeller blades, and the fuselage. No person was injured during the accident sequence.

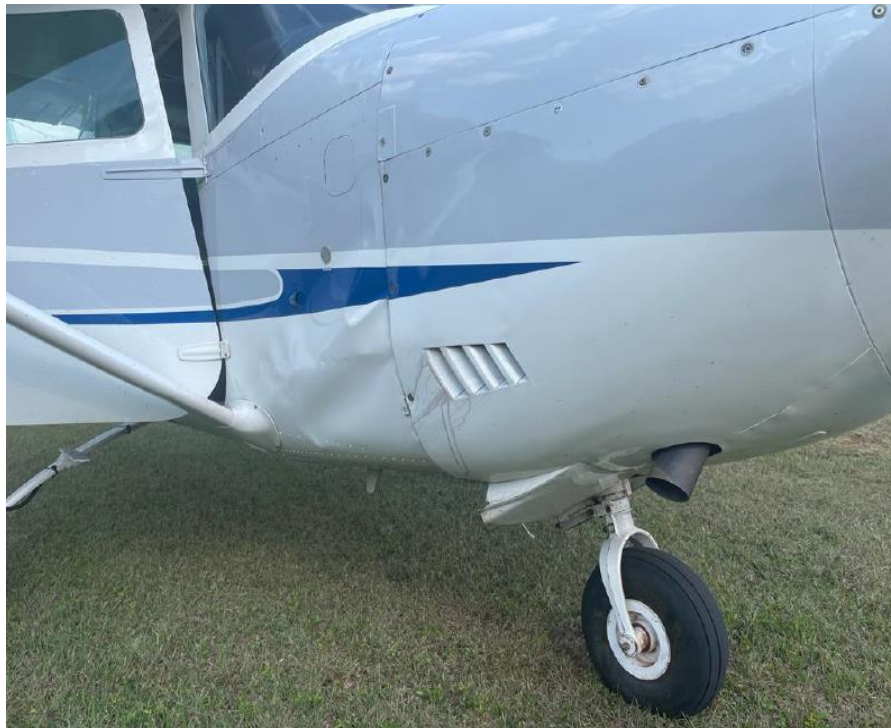
Figure 2: The damaged airframe. (Source: Operator)

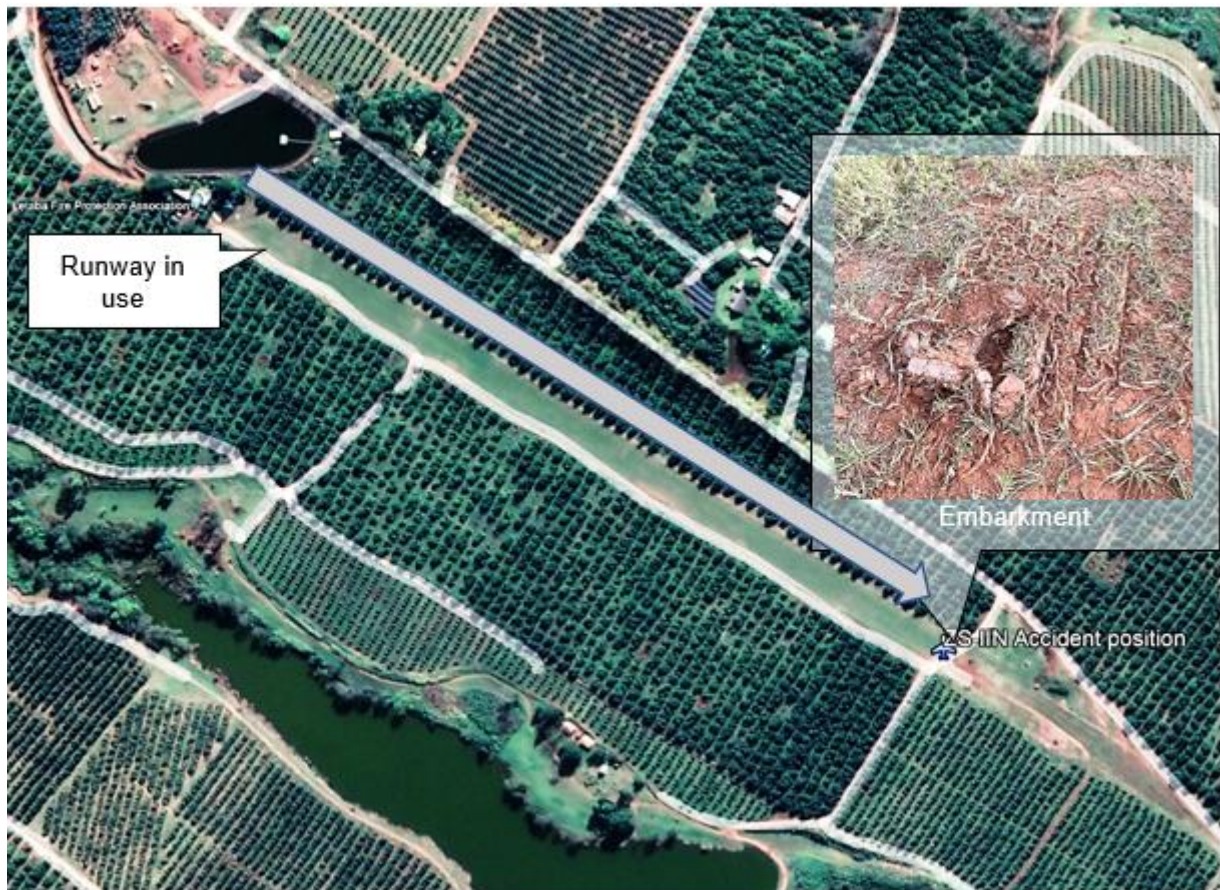
Figure 3: The airstrip (white arrow indicating the direction of flight) and the embankment on the runway end where the aircraft impacted the ground just before it careered onto the road. (Source: Google map)

The pilot prematurely rotated the aircraft and it stalled, thereafter, he landed back on the remaining runway and the aircraft careered along the overrun area. It came to a stop on the roadway that ran perpendicular to the runway.
