LIMITED OCCURRENCE INVESTIGATION REPORT – FINAL

Reference Number	CA18/2/3/10329						
Classification	Accident	Date	13 June 2023	Time	0549Z		
Type of Operation	Training (Part 141)						
Location							
Place of Departure	Ultimate Heli, Waterfall City, Gauteng Province	Place of Intended Landing	Ultimate Heli, Waterfall City, Gauteng Province				
Place of Occurrence	On taxiway at Grand Central Airport, Gauteng Province						
GPS Co-ordinates	Latitude	25°59'16.23" S	Longitude	28°08'25.47" E	Elevation	5 312 ft	
Helicopter Information							
Registration	ZS-HXU						
Make; Model; S/N	Robinson; R22 BETA (Serial Number: 1562)						
Damage to Helicopter	Substantial			Total Helicopter Hours	5 582.5		
Pilot-in-command							
Licence Type	Commercial Pilot Licence (CPL) Helicopter		Gender	Male		Age	56
Licence Valid	Yes	Total Hours	1 496.8		Total Hours on Type	261.6	
Total Hours 30 Days	20.1		Total Flying on Type Past 90 Days	13.4			
People On-board	2 + 0	Injuries	0	Fatalities	0	Other (on ground)	0

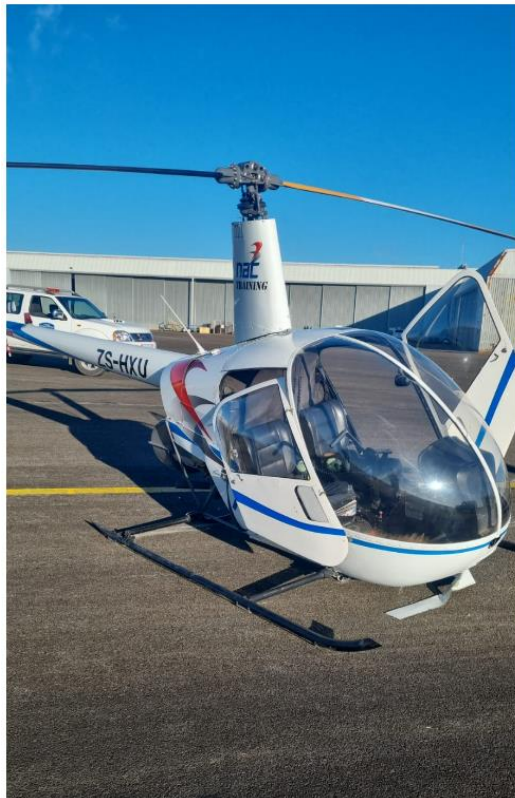
responded to the scene. The instructor and the student pilot evacuated the helicopter unassisted and uninjured. The helicopter rotors had stopped operating during the accident sequence. The helicopter sustained substantial damage.

Figure 2: Final position of the helicopter showing the right side.

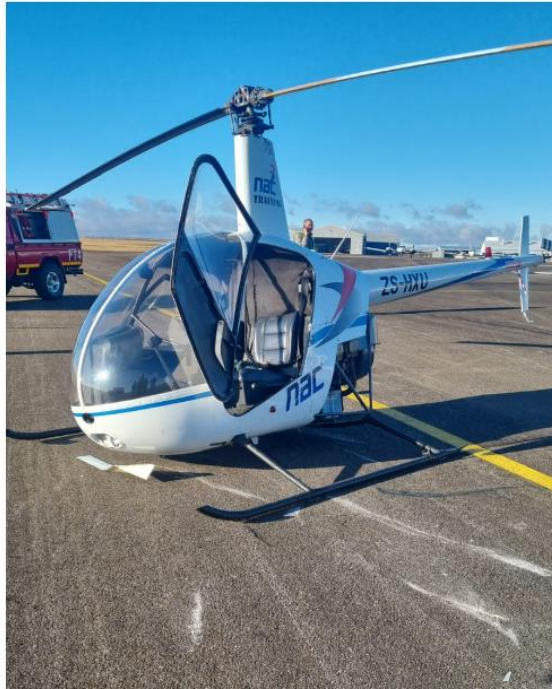
Figure 3: Final position of the helicopter showing the left side.

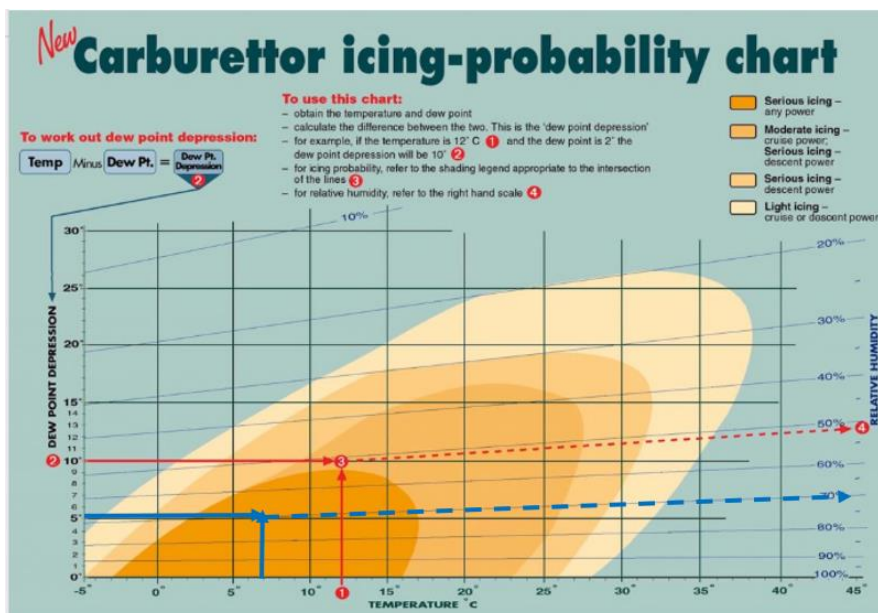
According to the South African Weather Service (SAWS), the official weather was as follows: wind direction was 185°-194°, temperature was 6.8°C and dew point was 1.5°C. Therefore, dew point depression was calculated as 5.3°C.

Figure 4: Carburettor Icing Probability Chart with blue arrows showing serious icing conditions at any power setting.

The dew point depression of 5.3°C gives a 70% relative humidity, which results in serious icing probability in any power setting. The crew stated that the carburettor heat knob was in the “OFF” position during the autorotation practise.
