UAS LIMITED OCCURRENCE INVESTIGATION REPORT – FINAL

Reference Number	CA18/2/3/10330						
Classification	Accident	Date	11 June 2023	Time	2320Z		
Type of Operation	Remotely Piloted Aircraft Systems – Surveillance (Part 101)						
Location							
Place of Departure	Karan Beef Farm in Nigel, Gauteng Province		Place of Intended Landing	Karan Beef Farm in Nigel, Gauteng Province			
Place of Occurrence	Nigel, Gauteng province						
GPS Co-ordinates	Latitude	26° 36' 27" S	Longitude	28° 19' 13" E	Elevation	5 311 ft	
Aircraft Information							
Registration	ZT-YOS	Class	3A				
Make; Model; S/N	Arace Sirin (Serial Number: SIR132)						
Damage to Aircraft	Substantial		Total UAS Hours	282.57			
Pilot-in-command							
Licence Type	Remote Pilot Licence (RPL)		Gender	Male	Age	31	
Licence Valid	Yes	Total Hours	267.24	Total Hours on Type	267.24		
Total Hours 30 Days	60.0		Total Flying on Type Past 90 Days	183.15			
People Controlling	1	Injuries (On ground)	0	Fatalities	0	Fatalities (on ground)	0

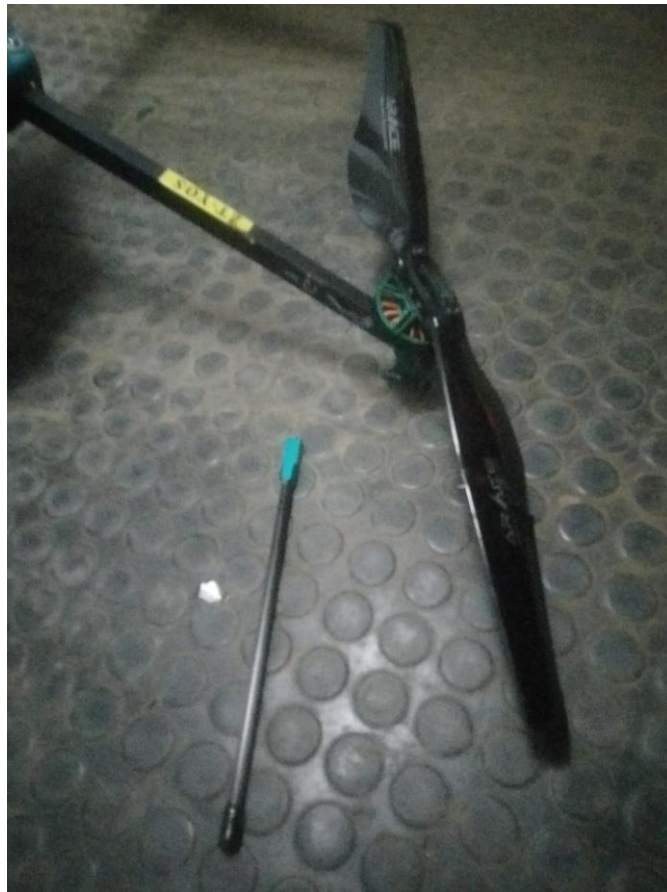
What Happened							
<p>On Sunday evening, 11 June 2023, an Unmanned Aircraft System (UAS) Arace Sirin with registration ZT-YOS was launched from Karan Beef Farm in Nigel, Gauteng province, to conduct security surveillance in the area before returning to the take-off launch pad. The flight was conducted beyond visual line of sight (BVLOS) rules by night and under the provisions of Part 101 of the Civil Aviation Regulations (CAR) 2011 as amended.</p> <p>According to the pilot, this was the fifth flight of the night. He reported that he launched the UAS to a height of 6.3 feet (ft) and switched to Global Positioning System (GPS) mode. The aircraft immediately lost control and began spinning; moreover, it was unresponsive to the pilot's commands. The aircraft eventually struck a tree approximately 10 metres from the launch site and, thereafter, fell to the ground. The pilot stated that the aircraft's GPS had previously been malfunctioning and had been sent for repairs two days prior to this occurrence.</p> <p>The UAS sustained substantial damage to one landing gear and one propeller. No persons on the ground were injured.</p>

Figure 2: Damage to the UAS propeller and landing leg. (Source: Operator)

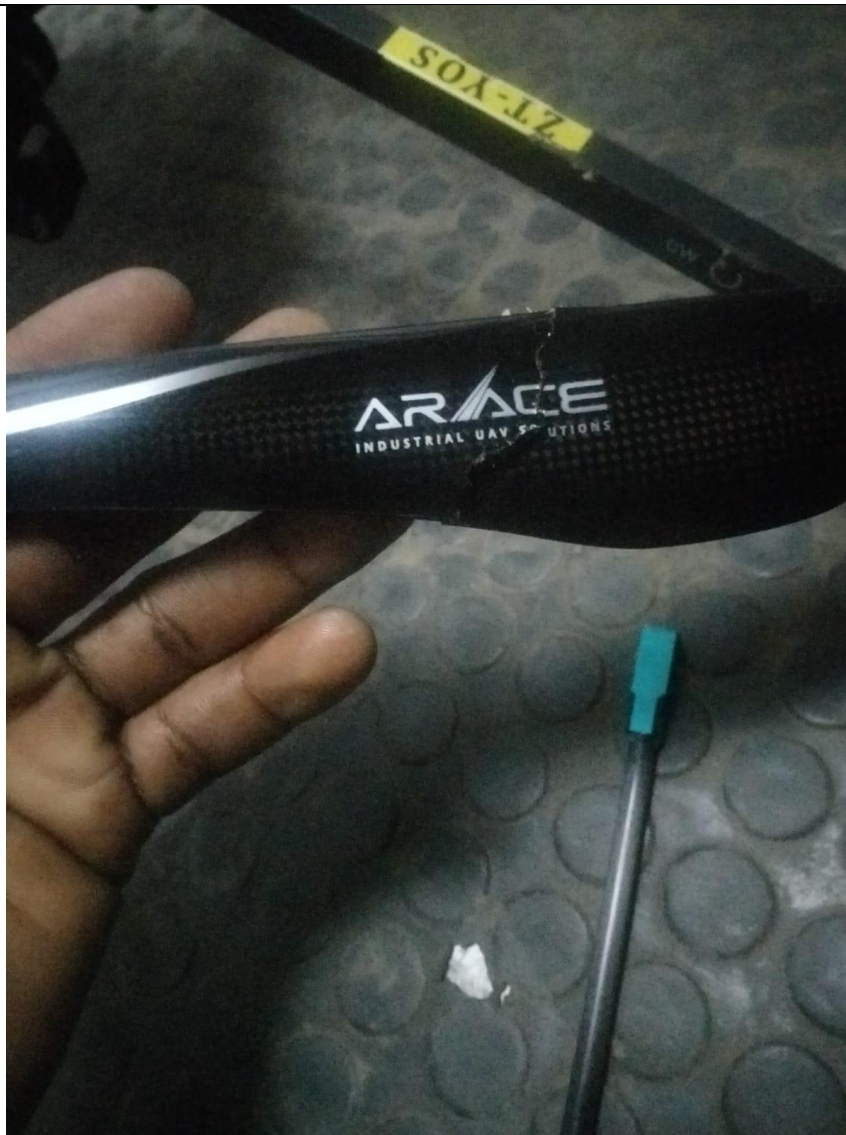
Figure 3: The damaged propeller. (Source: Operator)

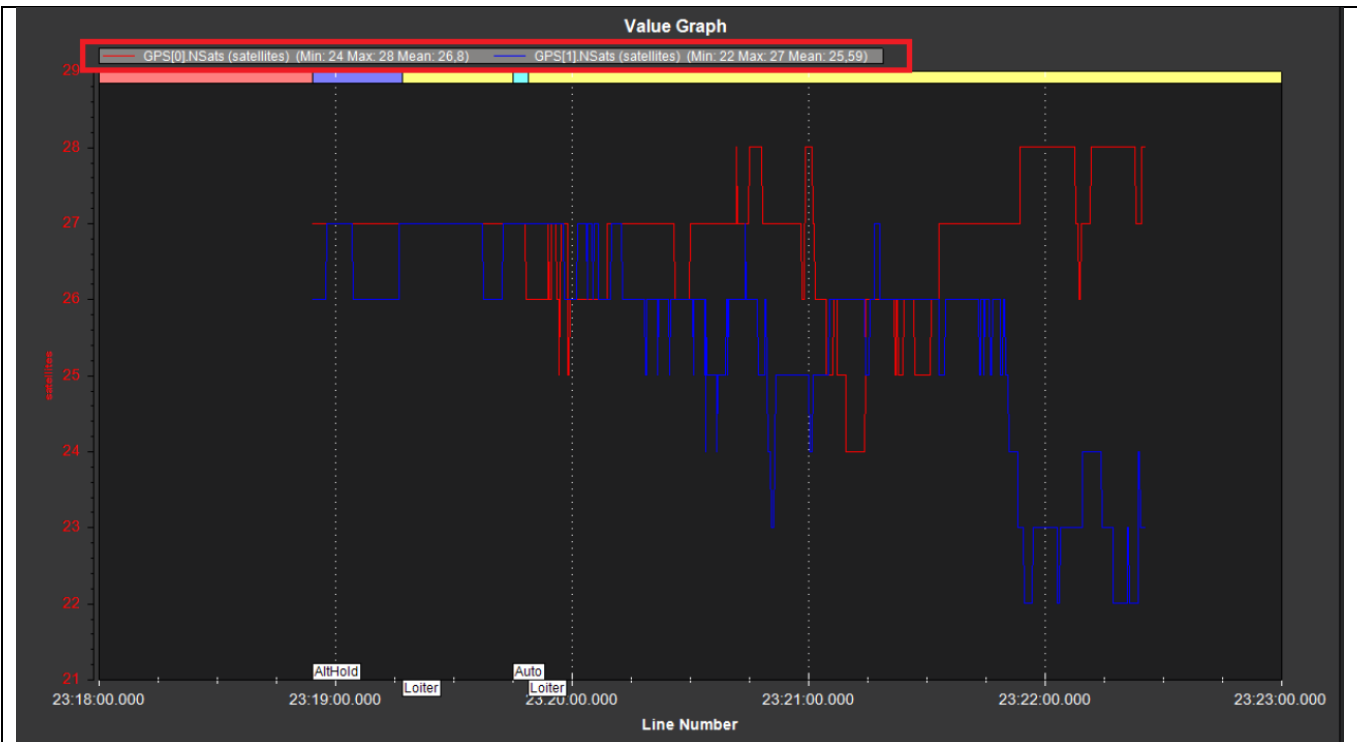
Figure 4: The flight log shows that the UAS had more than 20 satellites in view during the flight. (Source: Operator)

- The flight log showed that the UAS had more than 20 satellites in view during the flight.
- The UAS was registered to the present owner on 18 August 2022.

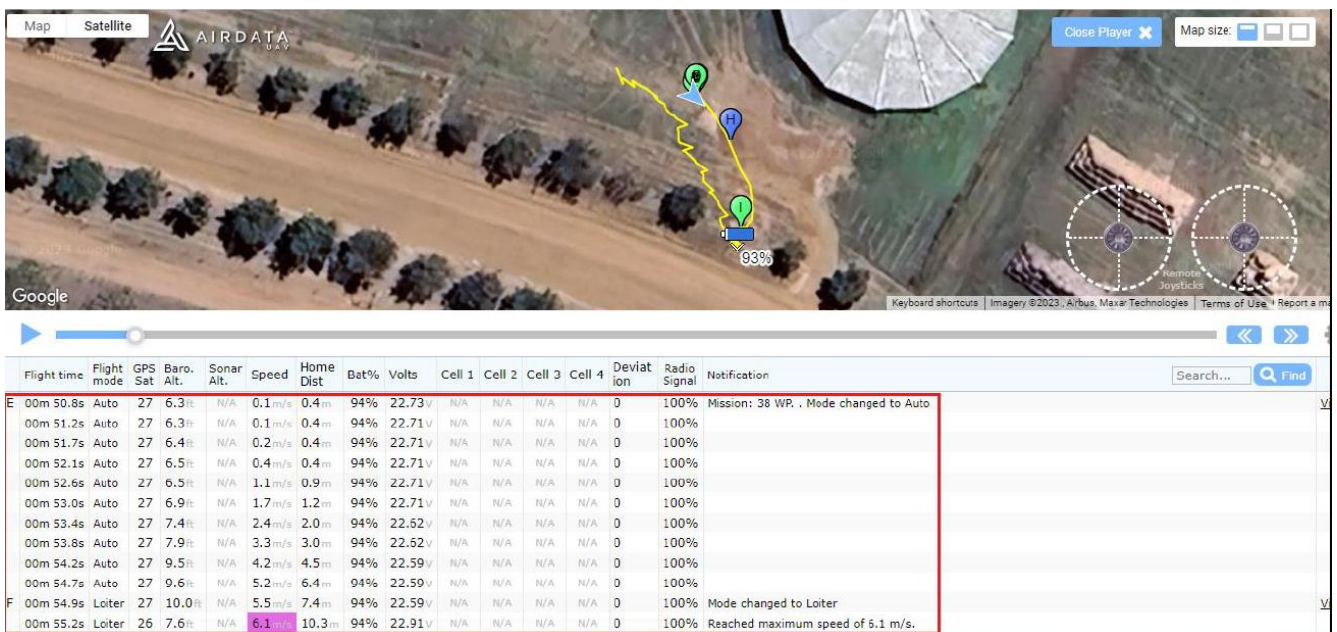
- The flight log showed that the UAS had more than 20 satellites in view (connected) at the time of the accident.
- The pilot armed the UAS in “Alt Hold” mode and switched to “Auto” mode. The UAS rejected the command. The pilot switched to “Loiter” mode then tried to take-off in “Auto” mode, but again the UAS rejected this command.
- The pilot then engaged the “Loiter” mode and the UAS took off and climbed to 6.3 ft above ground level (AGL) then switched to “Auto” mode; the UAS flew to a waypoint without gaining altitude. The pilot switched back to the “Loiter” mode and the UAS drifted towards a tree approximately 10 metres away from the home location.

Figure 5: The flight log shows that the pilot switched back to 'Loiter' mode before the accident. (Source: Operator)

- The pilot switched to “Loiter” mode without choosing the start waypoint or conducting a proper pre-flight check. The UAS drifted towards a tree and impacted it.

The UAS was configured incorrectly for the flight and, after the pilot switched to “Loiter” mode, the UAS drifted towards a tree and impacted it.

Poor pre-flight check.

To avoid injury and damage to property, UAS pilots should ensure proper pre-flight checks by correctly configuring the UAS prior to launch.
