**UAS LIMITED OCCURRENCE INVESTIGATION REPORT – FINAL**

<b>Reference Number</b>	CA18/2/3/10333						
<b>Classification</b>	Accident	<b>Date</b>	18 June 2023			<b>Time</b>	2129Z
<b>Type of Operation</b>	Unmanned Aircraft System – Surveillance (Part 101)						
<b>Location</b>							
Place of Departure	Beatrix West Mine in Welkom, Free State Province		Place of Intended Landing		Beatrix West Mine in Welkom, Free State Province		
Place of Occurrence	Beatrix West Mine, Welkom, Free State Province						
GPS Co-ordinates	Latitude	28°10'58.82" S	Longitude	26°42'53.55" E	Elevation	4416 ft	
<b>Aircraft Information</b>							
Registration	ZT-YIR		Class	3A			
Make; Model; S/N	Mavic 2 Enterprise Advanced (Serial Number: MAV128)						
Damage to Aircraft	Substantial		Total UAS Hours	296.91			
<b>Pilot-in-command</b>							
Licence Type	Remote Pilot Certificate		Gender	Male	Age	28	
Licence Valid	Yes	Total Hours	91.9	Total Hours on Type	91.9		
Total Hours 30 days	75.2		Total Flying on Type Past 90 days	88.38

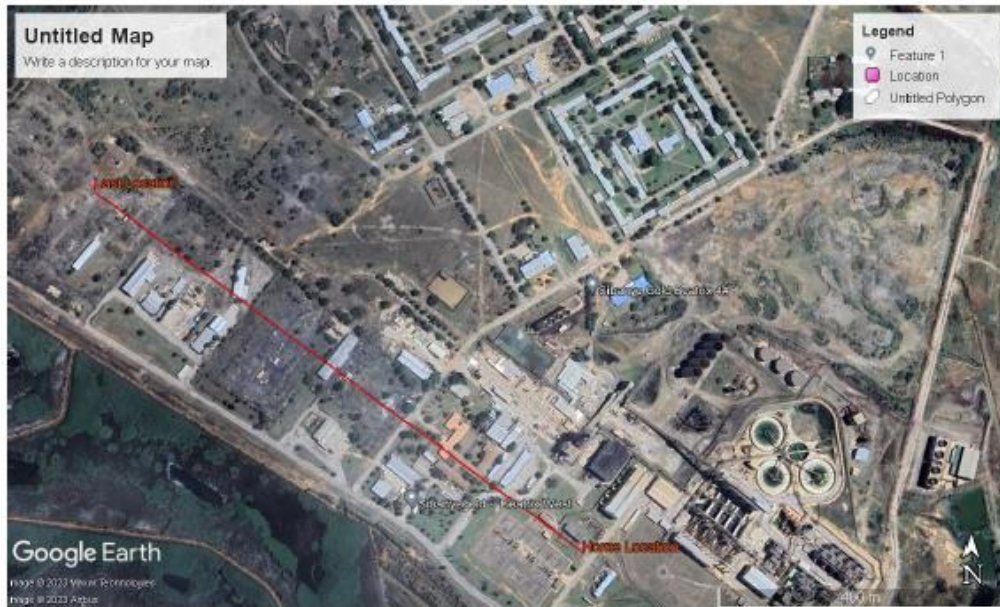
**Figure 1:** Aerial view of the accident site at Beatrix West Mine (Source: Pilot)

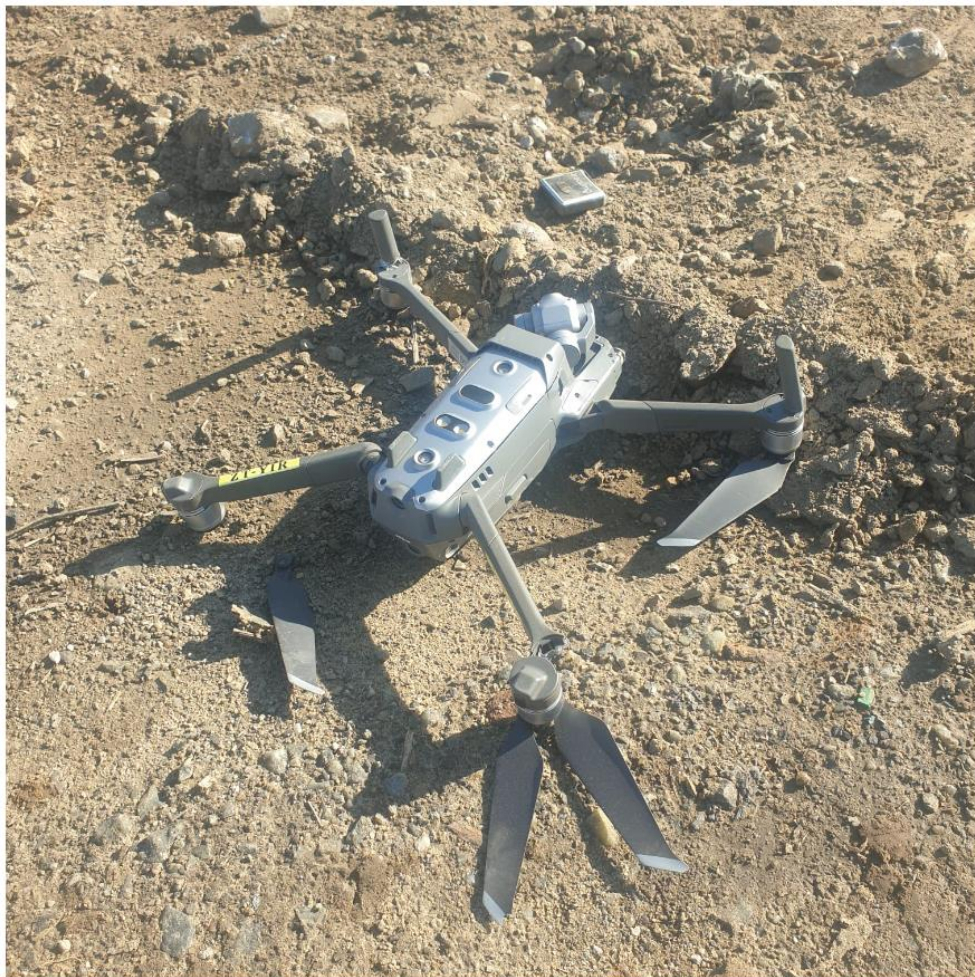
**Figure 2:** The UAS at the accident site. (Source: Pilot)

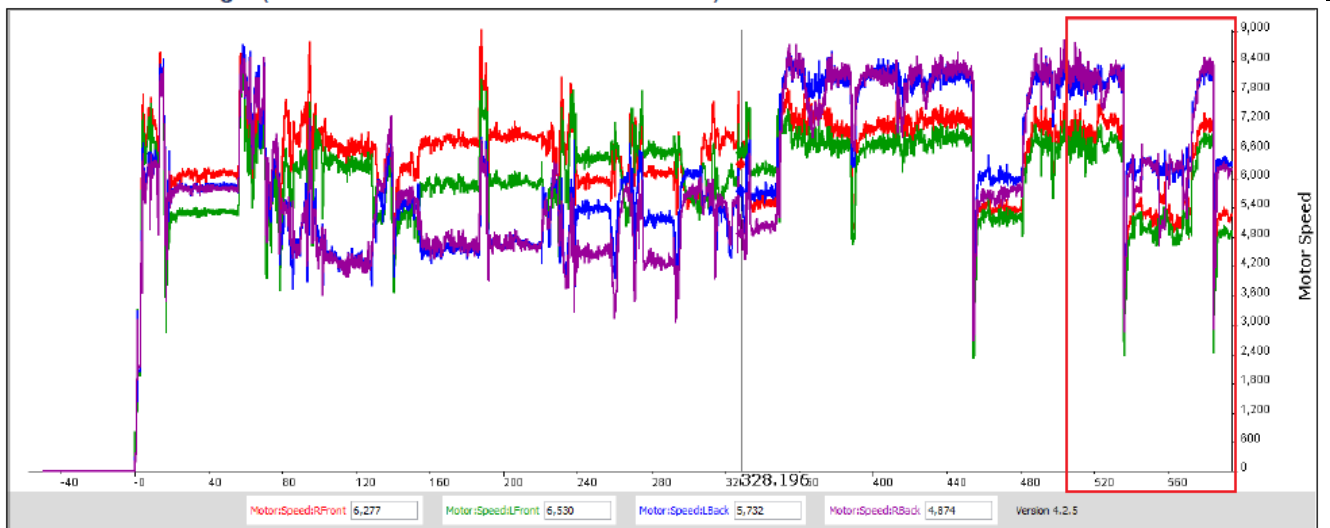
**Graph 1:** It is evident that the motor speed did not decrease at the end of the flight. (This indicates that the aircraft did not land, and disconnected mid-air.) (Source: Operator)

*At 21:39 UTC: 10 minutes into the flight at 800 metres from the home location, the aircraft disconnected from the C2 link.*

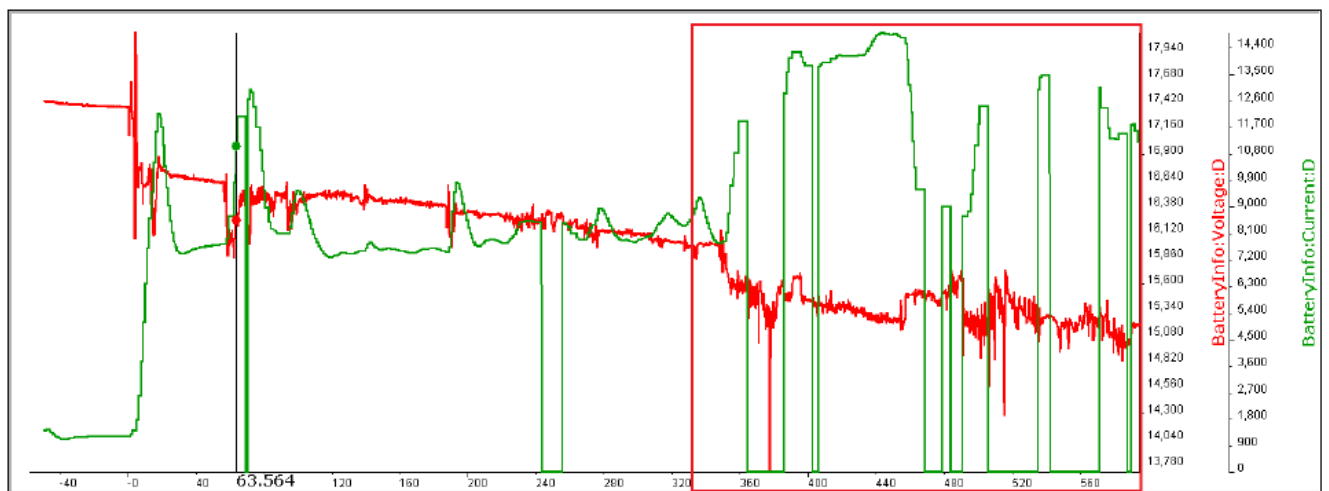
**Graph 2:** It is evident that the battery current (Green) dropped to zero multiple times. (This indicates that the battery terminals did not make proper contact.) (Source: Operator)

8. The downloaded logs showed that the battery current dropped to zero multiple times, an indication that the battery terminals did not make proper contact.

The UAS disconnected from the C2 link due to a faulty battery failure warning as a result of burnt battery terminals, preventing proper contact to complete the circuit.

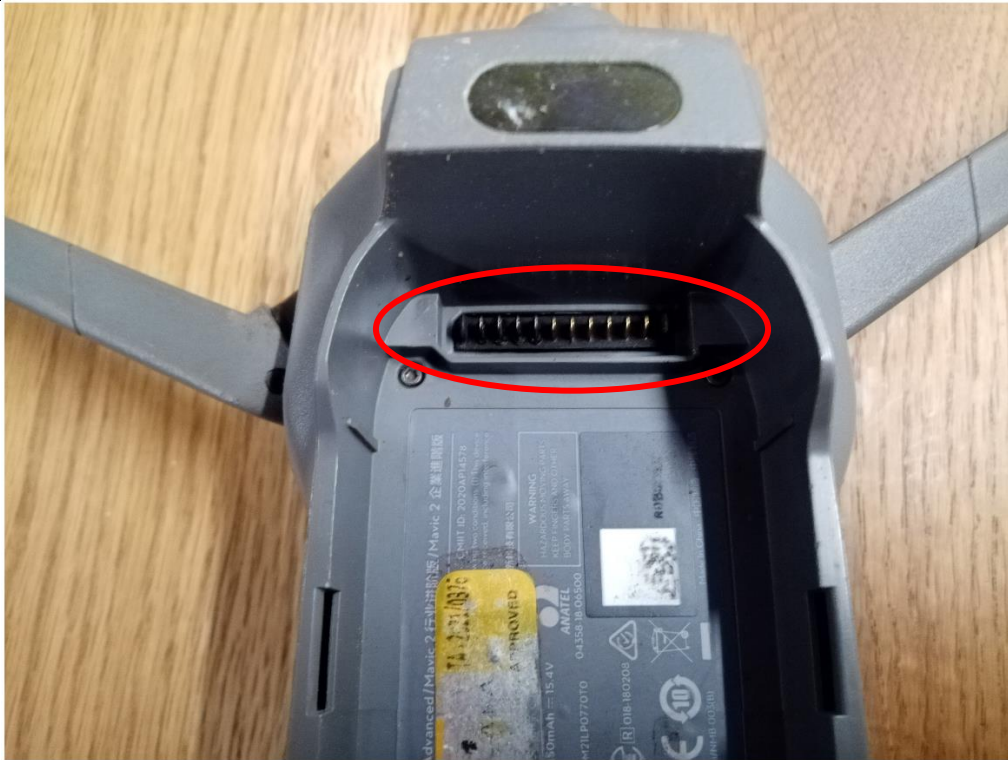
**Figure 4:** Red circle shows the burnt battery terminals. (Source: Operator)

9. The UAS battery did not have any cell damage, however, the battery terminals were severely burnt.

1. Battery terminals should be cleaned on a regular basis.
2. Pilots should not fly with damaged batteries.

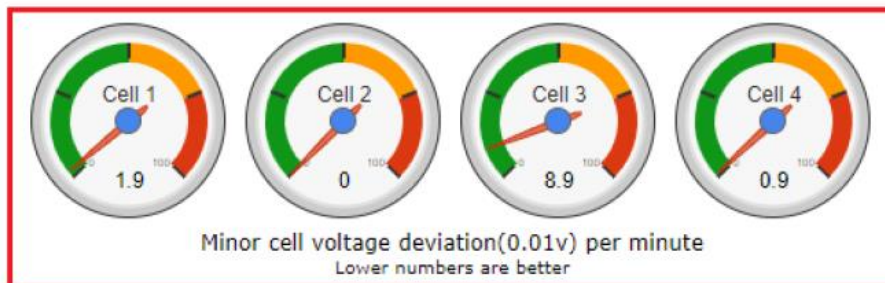
Minor cell voltage deviation(0.01v) per minute  
Lower numbers are better

**Figure 5:** The battery did not have any cell damage. (Source: Operator)
